Defect Listing

Pipe Segment Refere... A27-1_A20-2	City Oliver Springs	Street Springs St	Material Concrete Pipe (non-...	Location C... Light High...	Sewer Use Sanitary
Upstream MH A27-1	Total Length 250.7	Year Laid	Shape Circular	Location Details	
DS Manhole A20-2	Length surveyed 250.7	Year Renewed	Height 8	Width 8	Pipe Joint... 4

SPR N/A	MPR 10	PO Number 4397-03	Customer GRW
SPRI N/A	MPRI 3.3	Work Order 4397-02	Purpose Pre-Rehabilitation Survey
QSR N/A	QMR 4221		
OPR 10	Surveyed By Charlie Gordon	Direction Downstream	Date 20150825
OPRI 3.3	Certificate Number U-615-07000491	Pre-Cleaning Jetting	Time 13:13
	Date Cleaned 20150825	End Time 13:28	Weather Dry
			Media label
			Additional Info

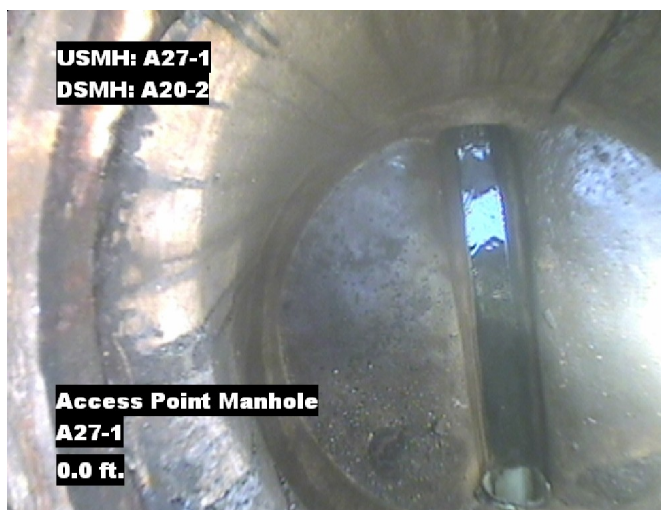
Distance: 0.0 ft. Grade: 0
Condition: Access Point Manhole
Remarks: A27-1

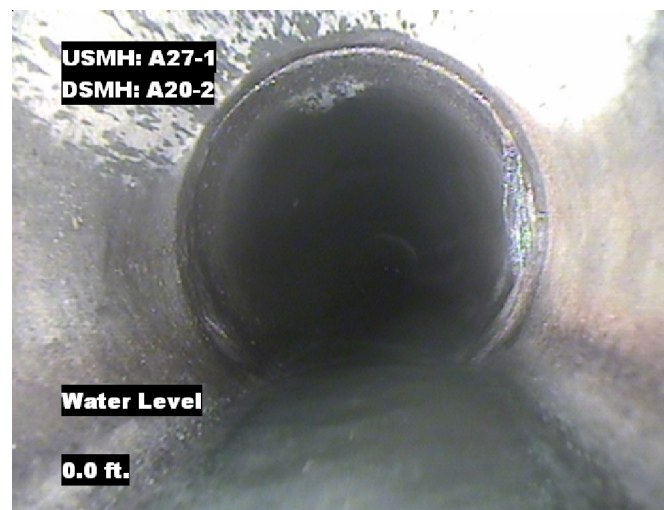
Distance: 0.0 ft. Grade: 0
Condition: Water Level
Remarks: N/A

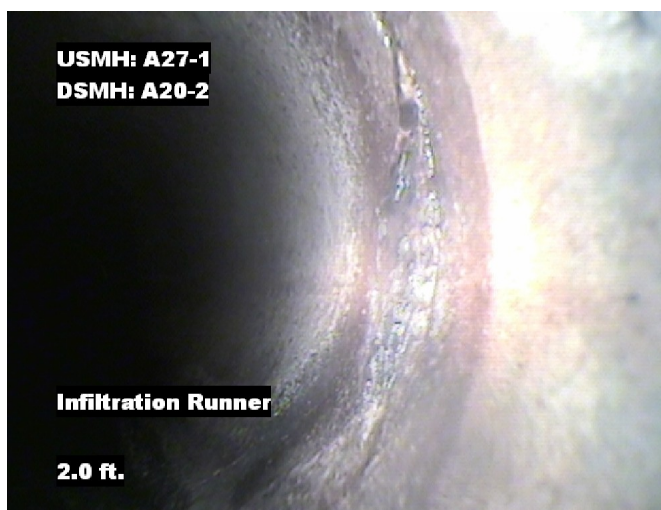
Distance: 2.0 ft. Grade: 4
Condition: Infiltration Runner
Remarks: N/A

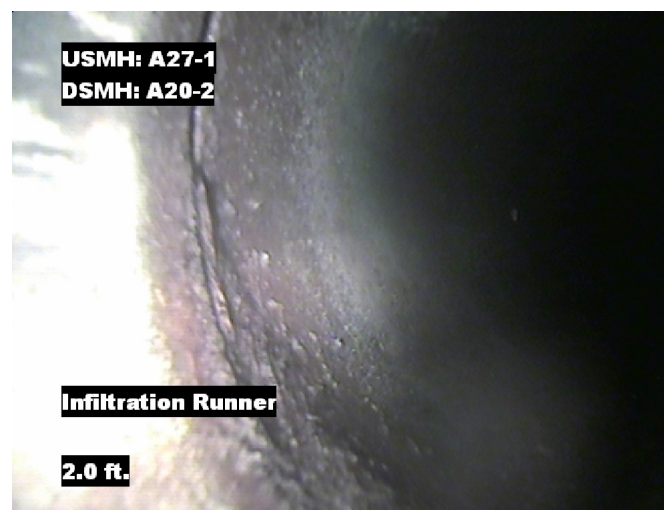
Distance: 2.0 ft. Grade: 4
Condition: Infiltration Runner
Remarks: N/A

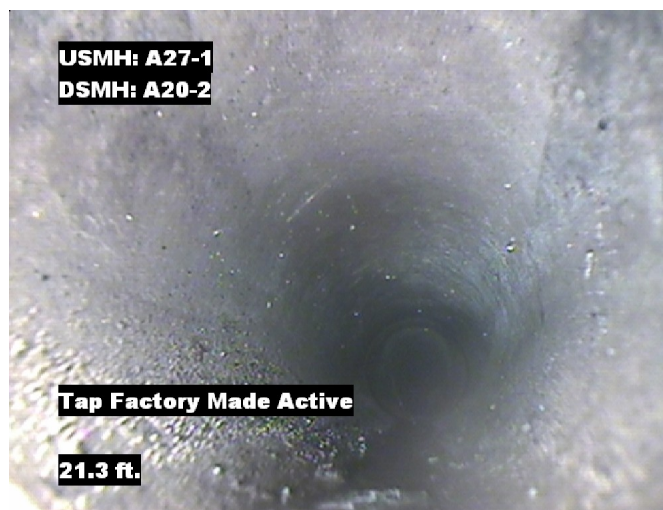
Distance: 21.3 ft. Grade: 0
Condition: Tap Factory Made Active
Remarks: N/A

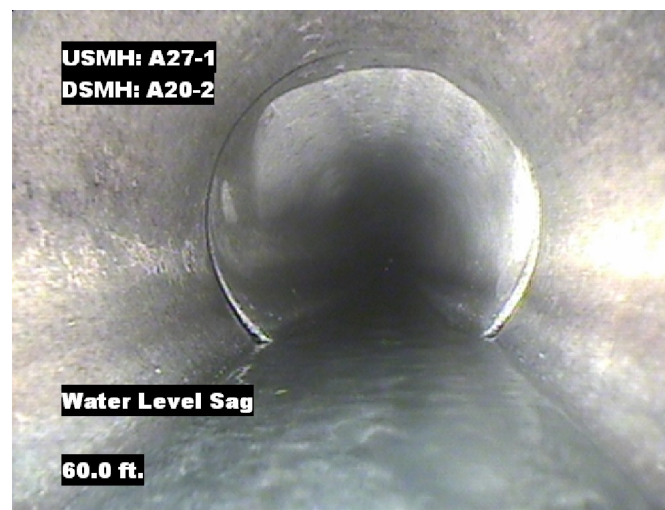
Distance: 60.0 ft. Grade: 2
Condition: Water Level Sag
Remarks: N/A

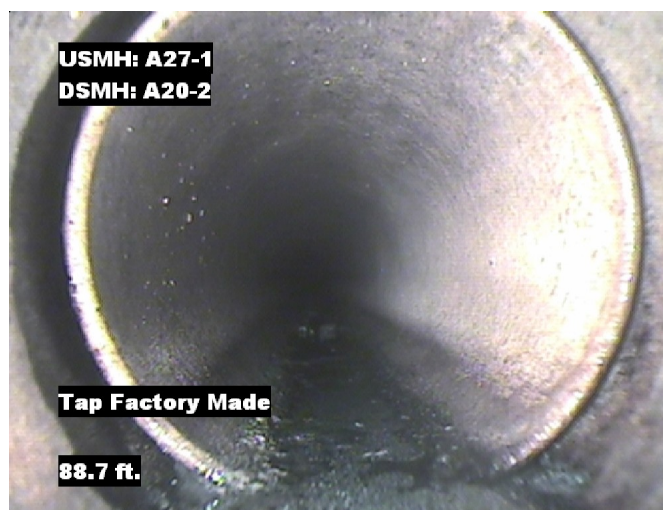
Distance: 88.7 ft. Grade: 0
Condition: Tap Factory Made
Remarks: N/A

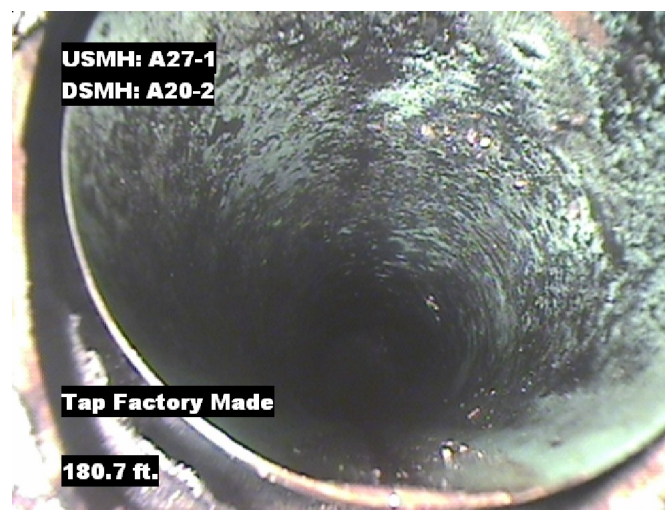
Distance: 180.7 ft. Grade: 0
Condition: Tap Factory Made
Remarks: N/A

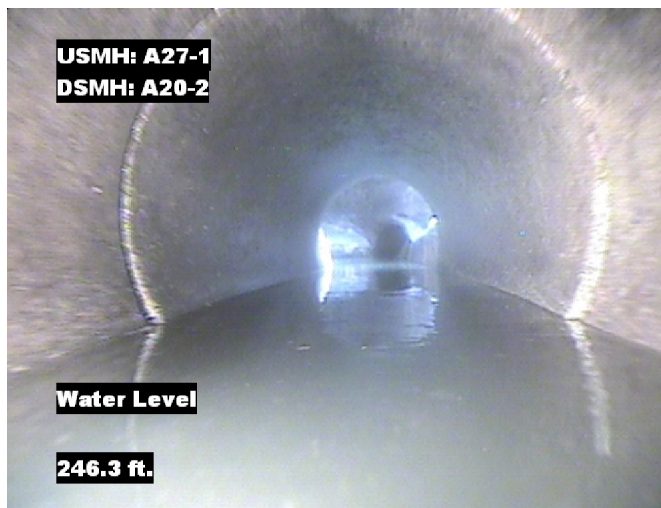
Distance: 246.2 ft. Grade: 0
Condition: Water Level
Remarks: N/A

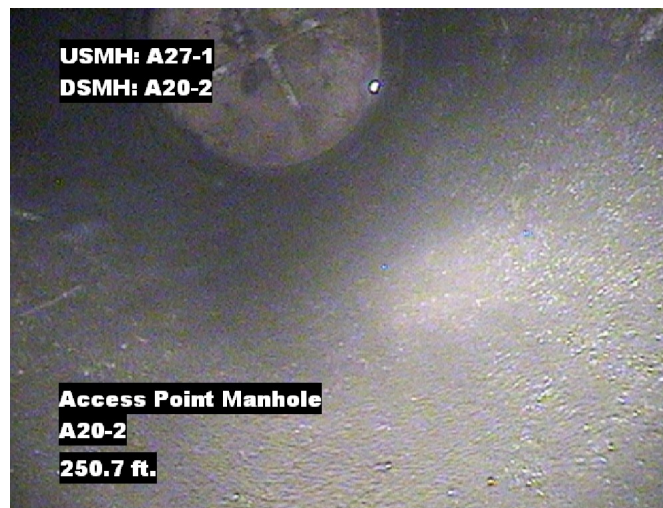
Distance: 250.7 ft. Grade: 0
Condition: Access Point Manhole
Remarks: A20-2
