## Defect Listing

| Pipe Segment Refere...<br>A27-10_A27-9 | City<br><b>Oliver Springs</b> | Street<br><b>Spring St.</b> | Material<br><b>Concrete Pipe (non-...</b> | Location C...<br><b>Light High...</b> | Sewer Use<br><b>Sanitary</b> |

| SPRI | N/A | MPRI | 2 | Work Order<br><b>4397-02</b> | Purpose<br><b>Pre-Rehabilitation Survey</b> |

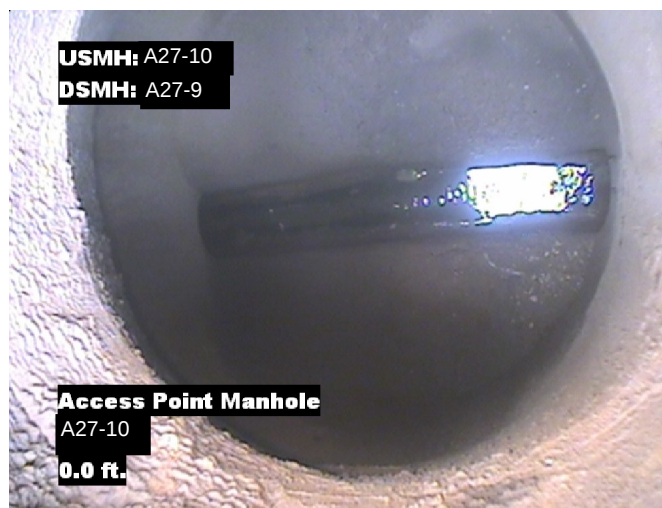
Distance: 0.0 ft. Grade: 0  
Condition: Access Point Manhole  
Remarks: A27-10

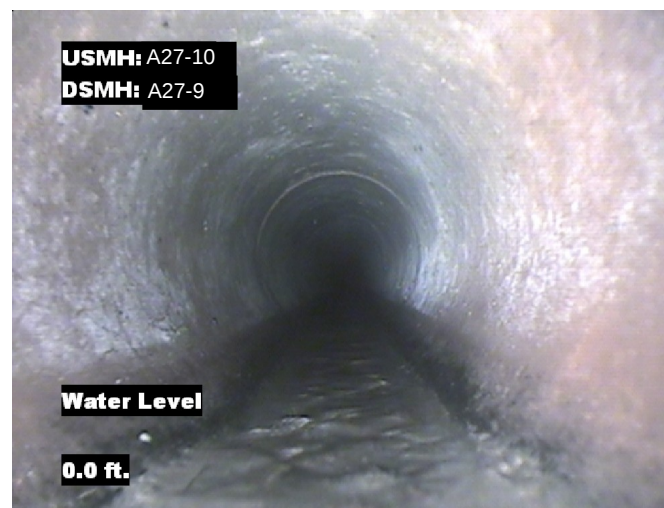
Distance: 0.0 ft. Grade: 0  
Condition: Water Level  
Remarks: N/A

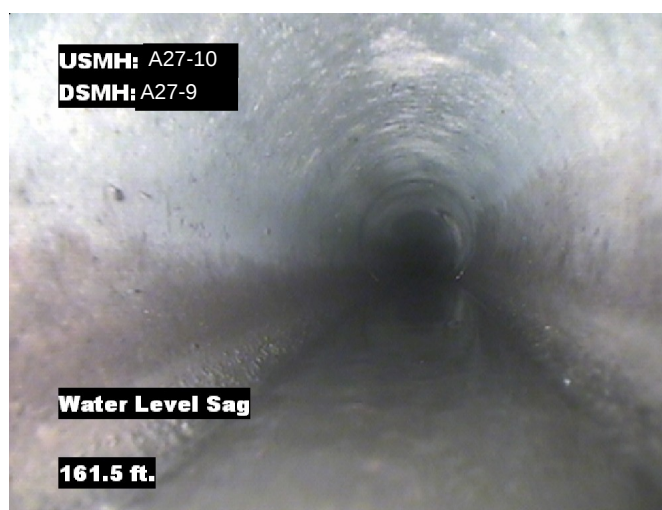
| Distance | Condition | Cont. Dfct. | Values | | | Joint | Clock Position | | Grade |
|---|---|---|---|---|---|---|---|---|---|
| 161.5 ft. | Water Level Sag | S01 | | | 10 | <input type="checkbox"/> | | | 2 |

Distance: 161.5 ft. Grade: 2  
Condition: Water Level Sag  
Remarks: N/A

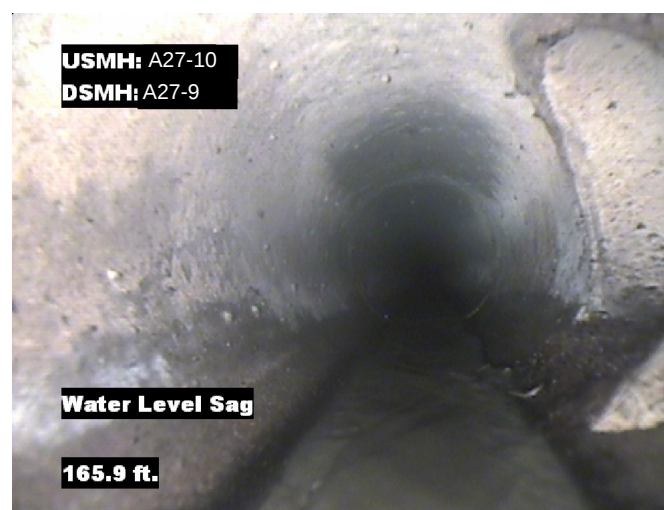
| Distance | Condition | Cont. Dfct. | Values | | | Joint | Clock Position | | Grade |
|---|---|---|---|---|---|---|---|---|---|
| 165.9 ft. | Water Level Sag | F01 | | | 10 | <input type="checkbox"/> | | | 2 |

Distance: 165.9 ft. Grade: 2  
Condition: Water Level Sag  
Remarks: N/A

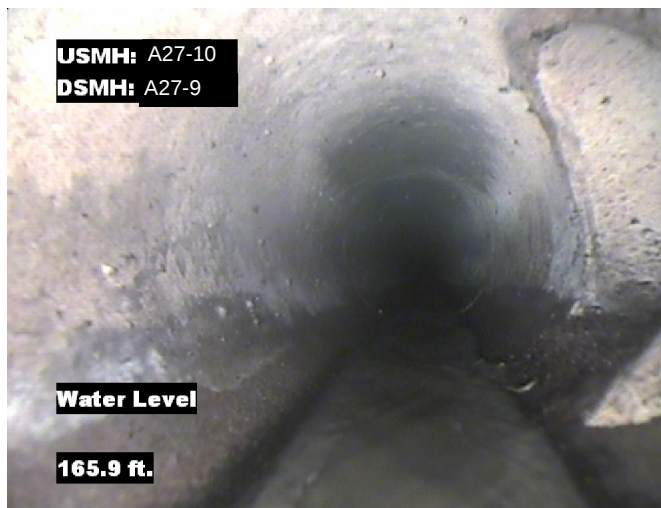
Distance: 165.9 ft. Grade: 0  
Condition: Water Level  
Remarks: N/A

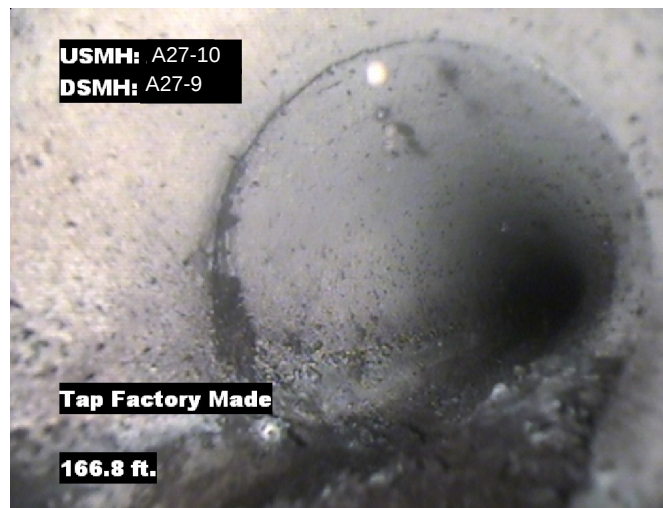
Distance: 166.8 ft. Grade: 0  
Condition: Tap Factory Made  
Remarks: N/A

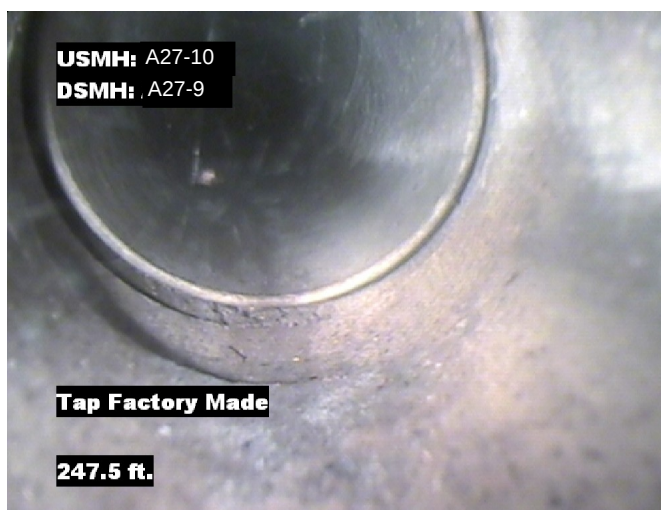
Distance: 247.5 ft. Grade: 0  
Condition: Tap Factory Made  
Remarks: N/A

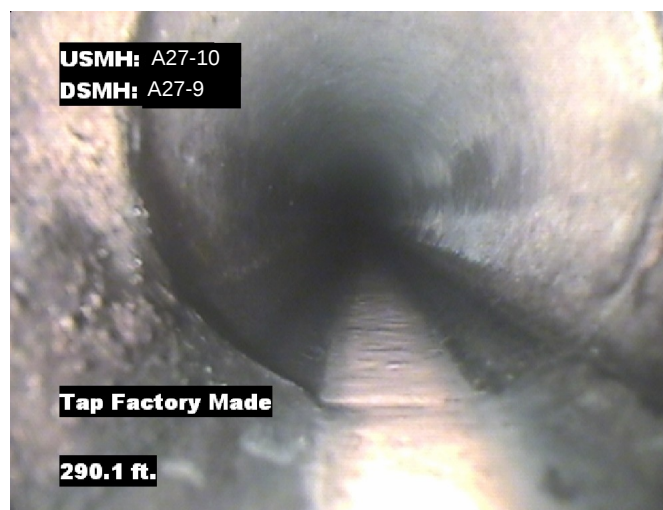
Distance: 290.1 ft. Grade: 0  
Condition: Tap Factory Made  
Remarks: N/A

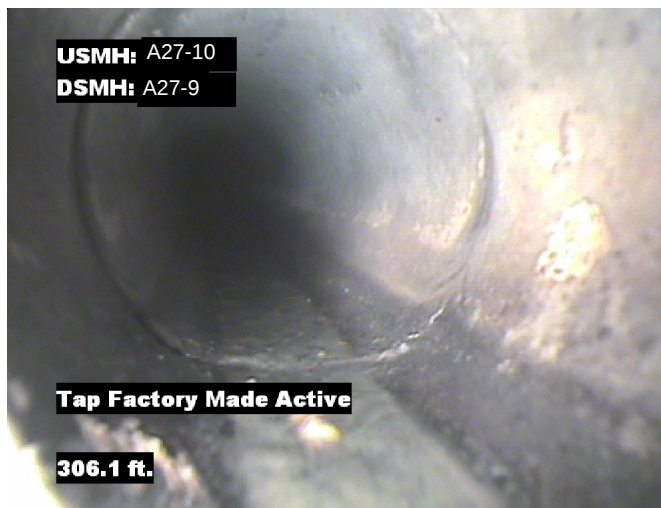
Distance: 306.1 ft. Grade: 0  
Condition: Tap Factory Made Active  
Remarks: N/A

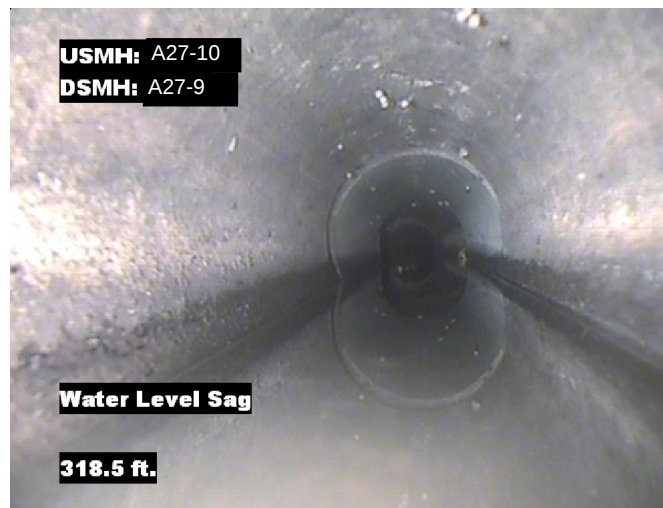
| Distance | Condition | Cont. Dfct. | Values | | | Joint | Clock Position | | Grade |
|---|---|---|---|---|---|---|---|---|---|
| 318.5 ft. | Water Level Sag | S02 | | | 20 | <input type="checkbox"/> | | | 2 |

Distance: 318.5 ft. Grade: 2  
Condition: Water Level Sag  
Remarks: N/A

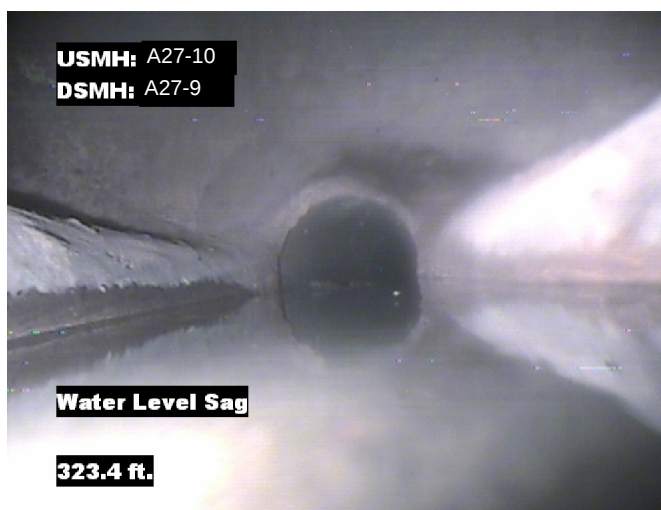
| Distance | Condition | Cont. Dfct. | Values | | | Joint | Clock Position | | Grade |
|---|---|---|---|---|---|---|---|---|---|
| 323.4 ft. | Water Level Sag | F02 | | | 20 | <input type="checkbox"/> | | | 2 |

Distance: 323.4 ft. Grade: 2  
Condition: Water Level Sag  
Remarks: N/A

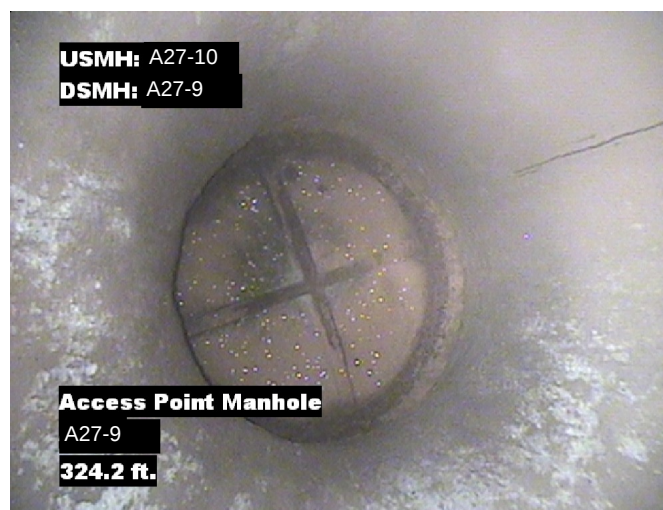
Distance: 324.2 ft. Grade: 0  
Condition: Access Point Manhole  
Remarks: A27-6
