Defect Listing

Pipe Segment Refere... A27-11_A27-10	City Oliver Springs	Street Spring St.	Material Concrete Pipe (non-...	Location C... Light High...	Sewer Use Sanitary
Upstream MH A27-11	Total Length 242.4	Year Laid	Shape Circular	Location Details	
DS Manhole A27-10	Length surveyed 242.4	Year Renewed	Height 8	Width 8	Pipe Joint... 4

SPR	N/A	MPR	6	PO Number 4397-03	Customer GRW
SPRI	N/A	MPRI	2	Work Order 4397-02	Purpose Pre-Rehabilitation Survey
QSR	N/A	QMR	2300		
OPR 6	Surveyed By Charlie Gordon	Direction Upstream	Date 20150902	Media label	
OPRI 2	Certificate Number U-615-07000491	Pre-Cleaning No Pre-Cleaning	Time 09:28	Weather Dry	
Date Cleaned			End Time 09:45	Additional Info UPSTREAM MANHOLE IS...

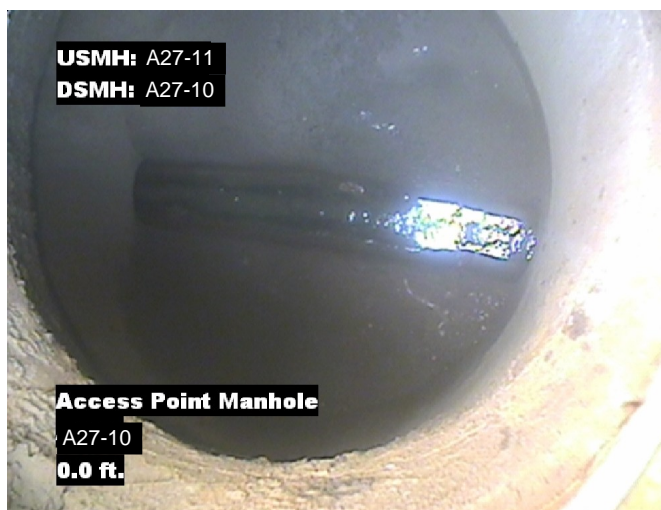
Distance: 0.0 ft. Grade: 0
Condition: Access Point Manhole
Remarks: A27-10

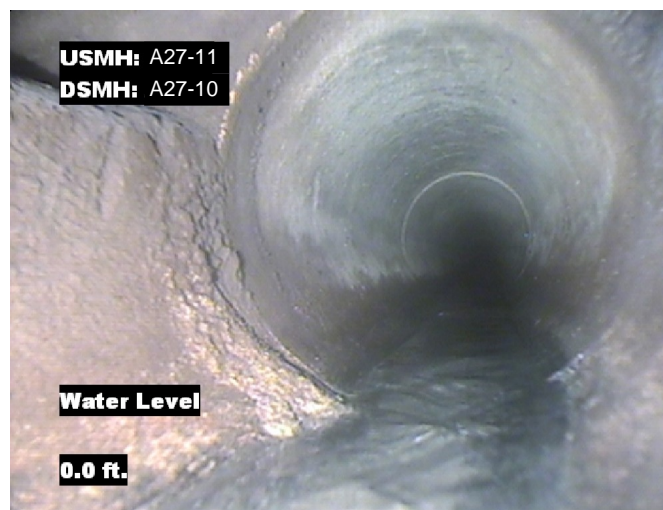
Distance: 0.0 ft. Grade: 0
Condition: Water Level
Remarks: N/A

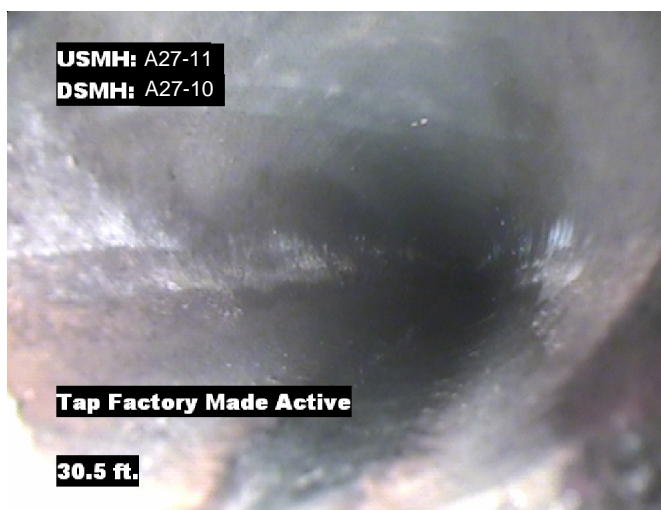
Distance: 30.5 ft. Grade: 0
Condition: Tap Factory Made Active
Remarks: N/A

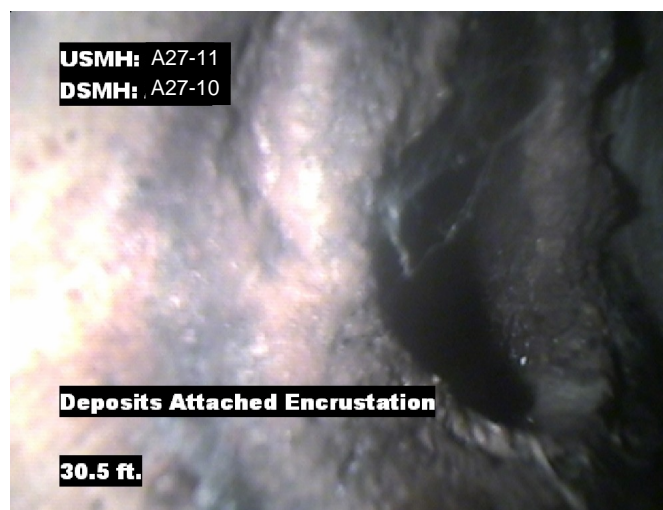
Distance: 30.5 ft. Grade: 2
Condition: Deposits Attached Encrustation
Remarks: N/A

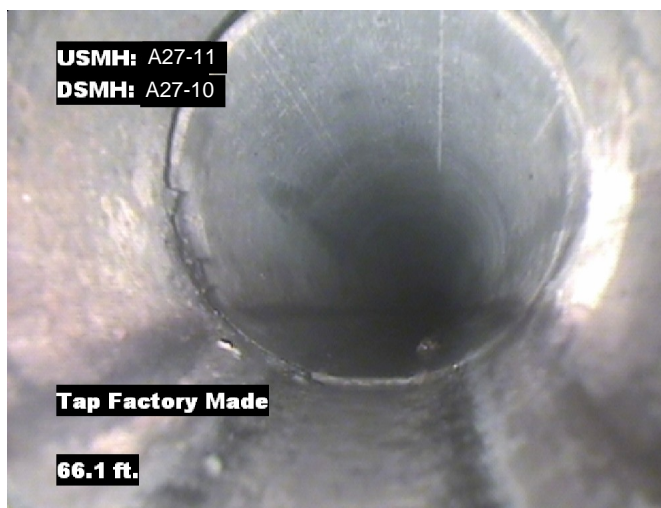
Distance: 66.1 ft. Grade: 0
Condition: Tap Factory Made
Remarks: N/A

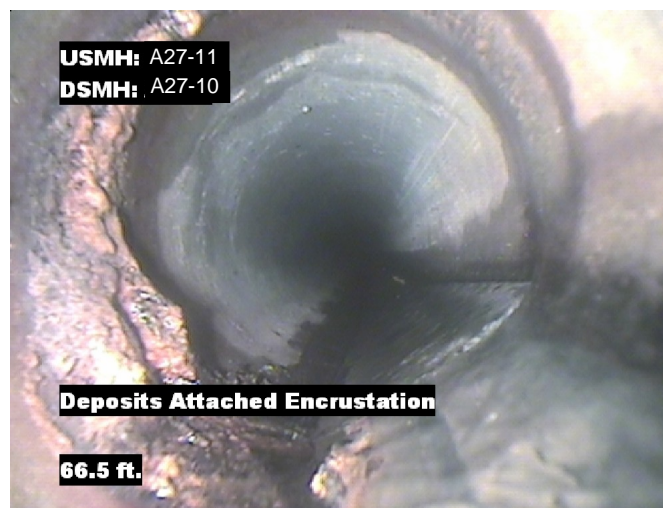
Distance: 66.5 ft. Grade: 2
Condition: Deposits Attached Encrustation
Remarks: N/A

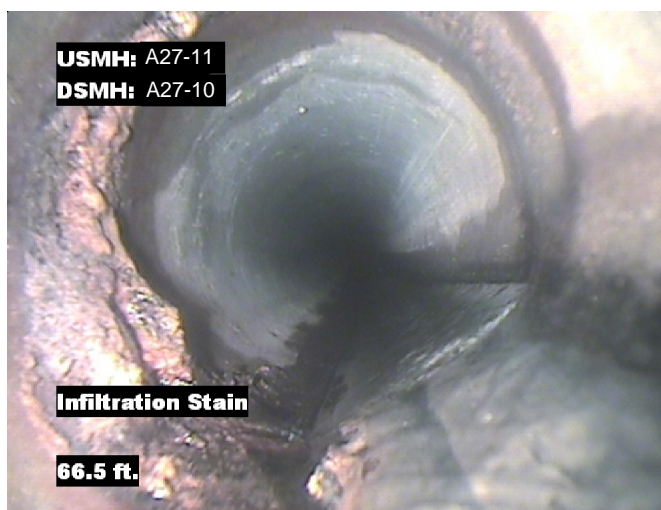
Distance: 66.5 ft. Grade: 0
Condition: Infiltration Stain
Remarks: N/A

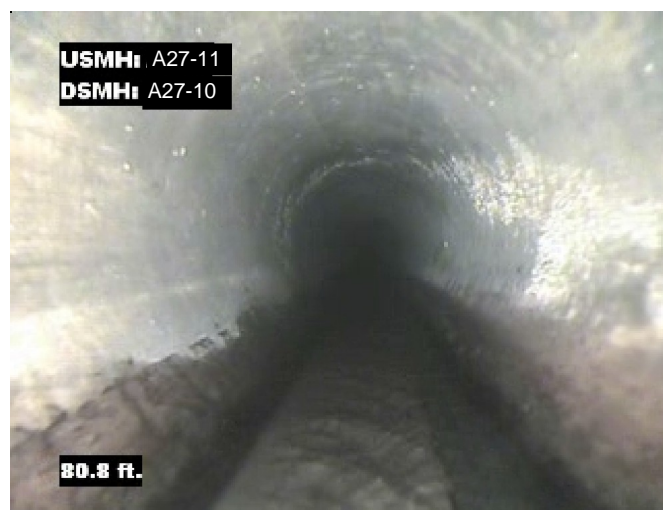
Distance: 80.7 ft. Grade: 2
Condition: Deposits Attached Grease
Remarks: N/A

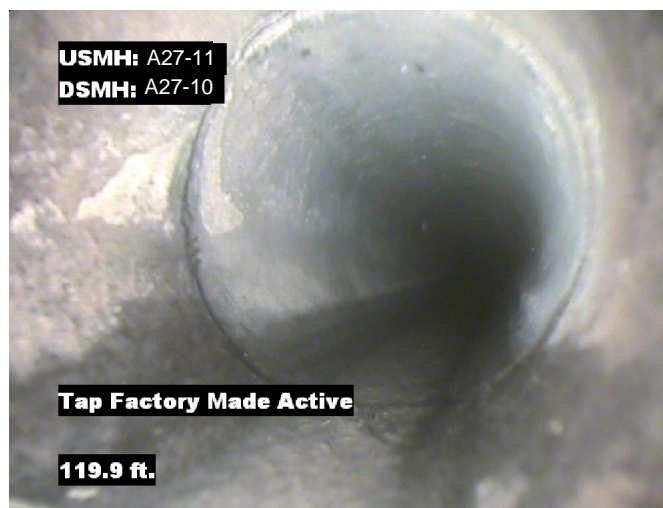
Distance: 119.9 ft. Grade: 0
Condition: Tap Factory Made Active
Remarks: N/A

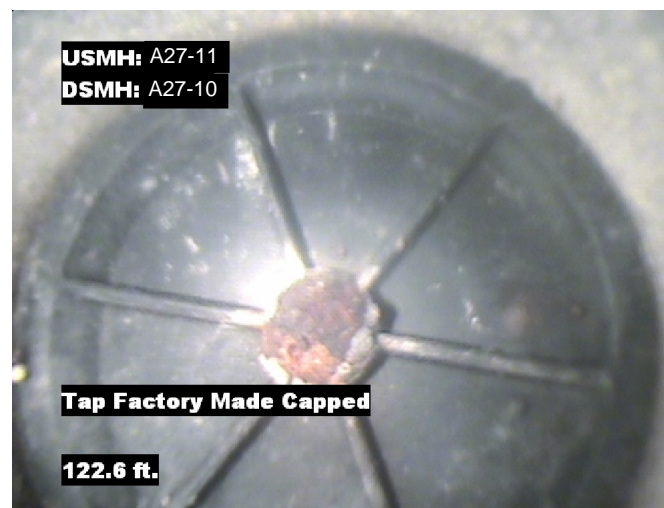
Distance: 122.6 ft. Grade: 0
Condition: Tap Factory Made Capped
Remarks: N/A

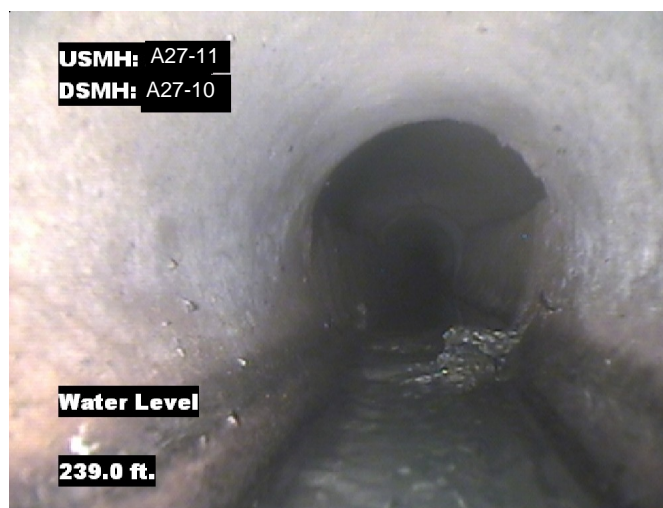
Distance: 239.0 ft. Grade: 0
Condition: Water Level
Remarks: N/A

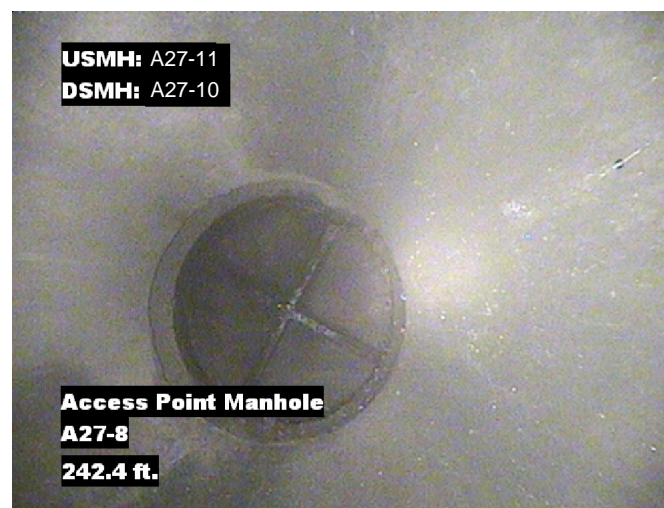
Distance: 242.4 ft. Grade: 0
Condition: Access Point Manhole
Remarks: A27-11
