## Defect Listing

| Pipe Segment Refere...<br>A27-12_A27-11 | City<br>Oliver Springs | Street<br>Spring St. | Material<br>Concrete Pipe (non-... | Location C...<br>Light High... | Sewer Use<br>Sanitary |

| SPRI | N/A | MPRI | 3.3 | Work Order<br>4397-02 | Purpose<br>Pre-Rehabilitation Survey |

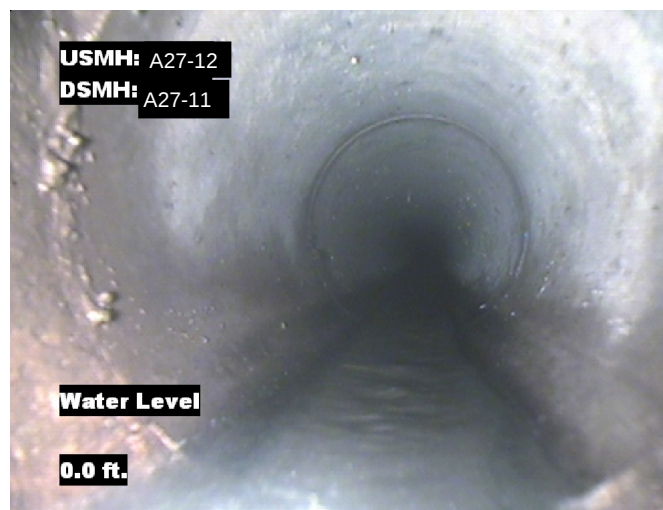
| Distance | Condition | Cont. Dfct. | Values | | | Joint | Clock Position | | Grade |
|---|---|---|---|---|---|---|---|---|---|
| 0.0 ft. | Water Level | | | | 5 | <input type="checkbox"/> | | | |

Distance: 0.0 ft. Grade: 0  
Condition: Water Level  
Remarks: N/A

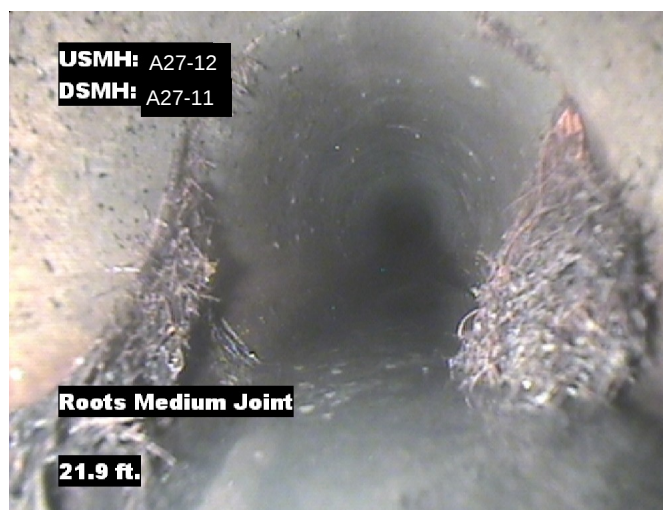
| Distance | Condition | Cont. Dfct. | Values | | | Joint | Clock Position | | Grade |
|---|---|---|---|---|---|---|---|---|---|
| 21.9 ft. | Roots Medium Joint | | | | 5 | <input checked="" type="checkbox"/> | 7 | 5 | 3 |

Distance: 21.9 ft. Grade: 3  
Condition: Roots Medium Joint  
Remarks: N/A

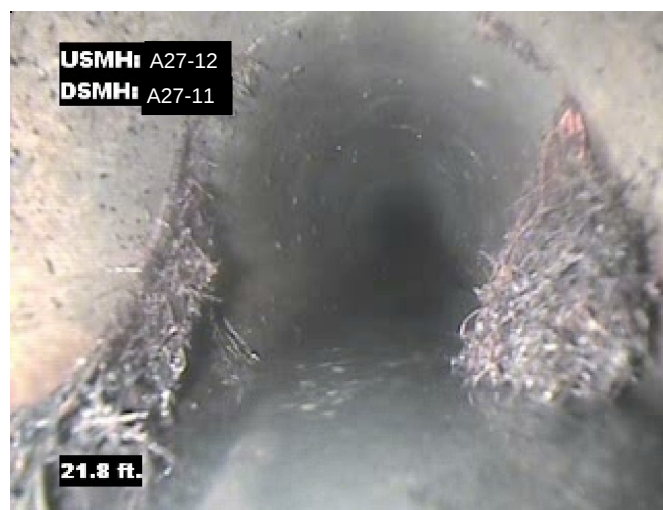
| Distance | Condition | Cont. Dfct. | Values | | | Joint | Clock Position | | Grade |
|---|---|---|---|---|---|---|---|---|---|
| 21.9 ft. | Roots Medium Barrel | | | | 5 | <input type="checkbox"/> | 7 | | 4 |

Distance: 21.9 ft. Grade: 4  
Condition: Roots Medium Barrel  
Remarks: N/A

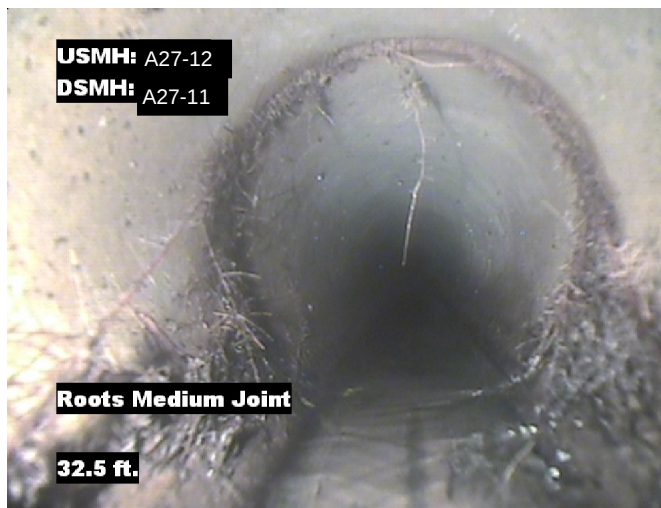
| Distance | Condition | Cont. Dfct. | Values | | | Joint | Clock Position | | Grade |
|---|---|---|---|---|---|---|---|---|---|
| 32.5 ft. | Roots Medium Joint | | | | 5 | <input checked="" type="checkbox"/> | 7 | 5 | 3 |

Distance: 32.5 ft. Grade: 3  
Condition: Roots Medium Joint  
Remarks: N/A

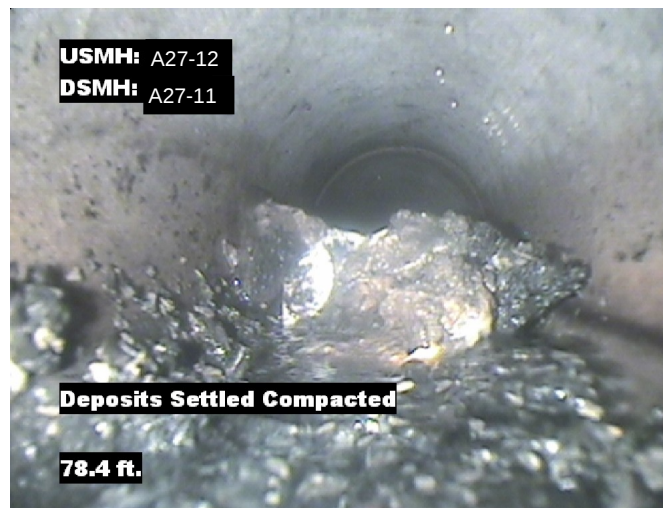
| Distance | Condition | Cont. Dfct. | Values | | | Joint | Clock Position | | Grade |
|---|---|---|---|---|---|---|---|---|---|
| 78.4 ft. | Deposits Settled Compacted | | | | 20 | <input type="checkbox"/> | 6 | | 3 |

Distance: 78.4 ft. Grade: 3  
Condition: Deposits Settled Compacted  
Remarks: N/A

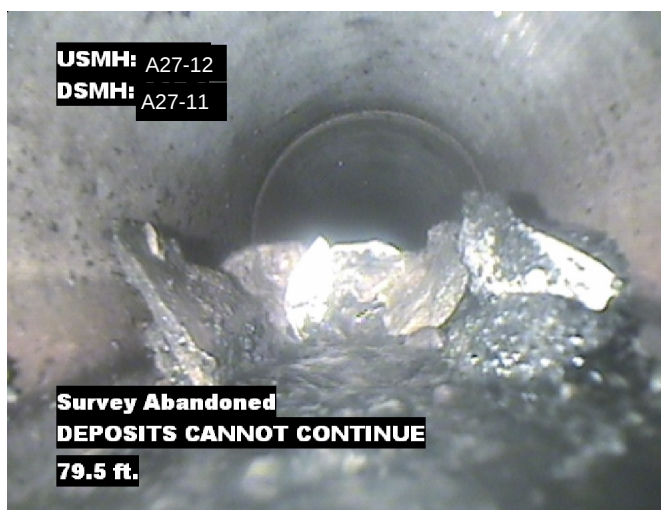
| Distance | Condition | Cont. Dfct. | Values | | | Joint | Clock Position | | Grade |
|---|---|---|---|---|---|---|---|---|---|
| 79.5 ft. | Survey Abandoned | | | | 0 | <input type="checkbox"/> | | | |
| Remarks: DEPOSITS CANNOT CONTINUE | | | | | | | | | |

Distance: 79.5 ft. Grade: 0  
Condition: Survey Abandoned  
Remarks: DEPOSITS CANNOT CONTINUE
