## Defect Listing

Pipe Segment Refere... <b>A27-2_A27-1</b>	City <b>Oliver Springs</b>	Street <b>Springs St</b>	Material <b>Fibreglass Reinf...</b>	Location C... <b>Light High...</b>	Sewer Use <b>Sanitary</b>
Upstream MH <b>A27-2</b>	Total Length <b>249.3</b>	Year Laid	Shape <b>Circular</b>	Location Details	
DS Manhole <b>A27-1</b>	Length surveyed <b>249.3</b>	Year Renewed	Height <b>8</b>	Width <b>8</b>	Pipe Joint... <b>N/A</b>

SPR <b>N/A</b>	MPR <b>15</b>	PO Number <b>4397-03</b>	Customer <b>GRW</b>
SPRI <b>N/A</b>	MPRI <b>2.1</b>	Work Order <b>4397-02</b>	Purpose <b>Pre-Rehabilitation Survey</b>
QSR <b>N/A</b>	QMR <b>3126</b>		
OPR <b>15</b>	Surveyed By <b>Charlie Gordon</b>	Direction <b>Downstream</b>	Date <b>20150821</b>
OPRI <b>2.1</b>	Certificate Number <b>U-615-07000491</b>	Pre-Cleaning <b>Jetting</b>	Time <b>14:49</b>
	Date Cleaned <b>20150821</b>	End Time <b>14:52</b>	Weather <b>Dry</b>
			Media label
			Additional Info

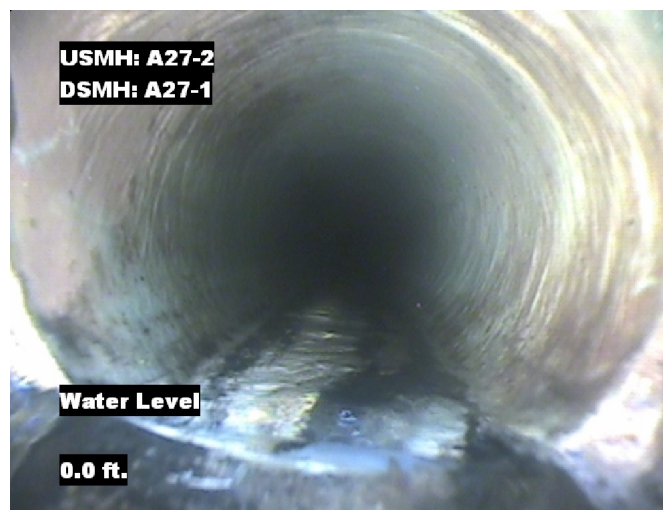
Distance: 0.0 ft. Grade: 0  
Condition: Water Level  
Remarks: N/A

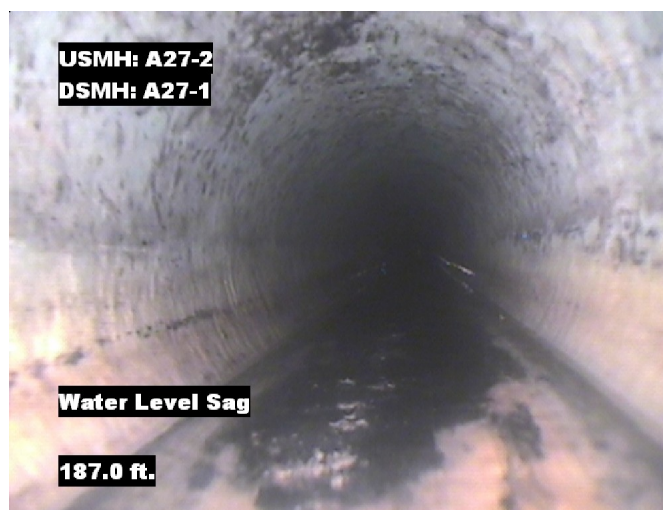
Distance: 187.0 ft. Grade: 2  
Condition: Water Level Sag  
Remarks: N/A

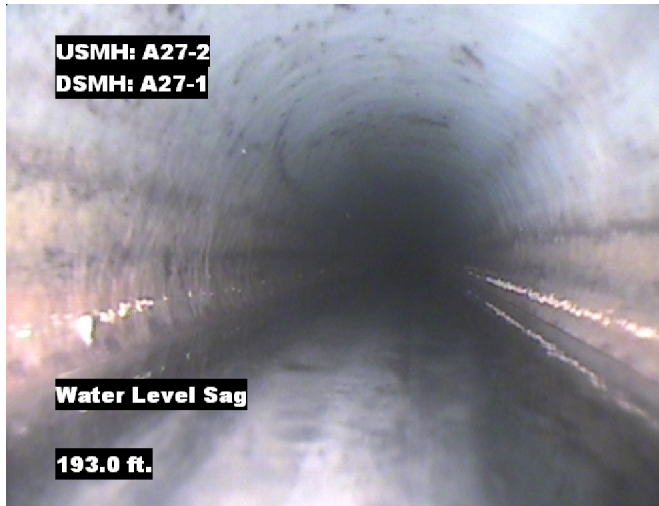
Distance: 193.0 ft. Grade: 2  
Condition: Water Level Sag  
Remarks: N/A

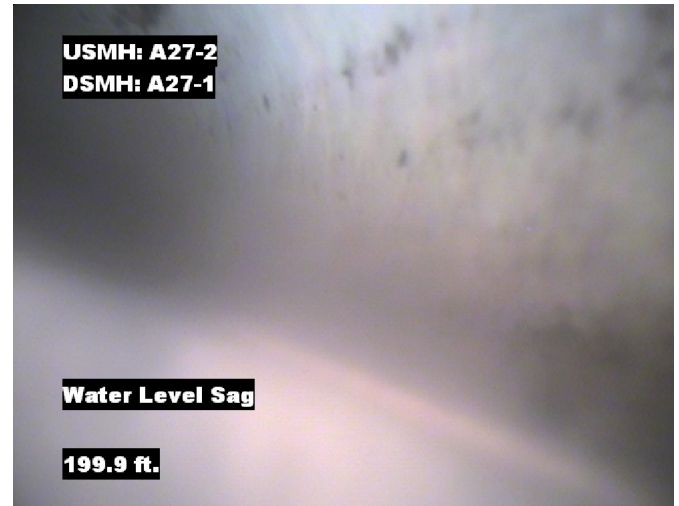
Distance: 199.9 ft. Grade: 2  
Condition: Water Level Sag  
Remarks: N/A

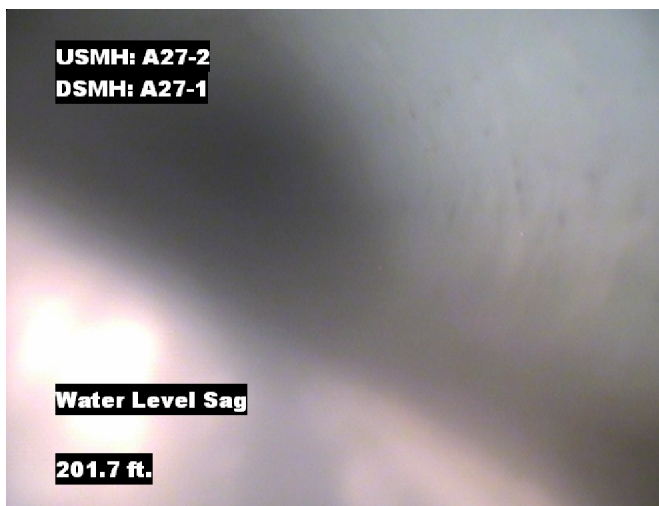
Distance: 201.7 ft. Grade: 3  
Condition: Water Level Sag  
Remarks: N/A

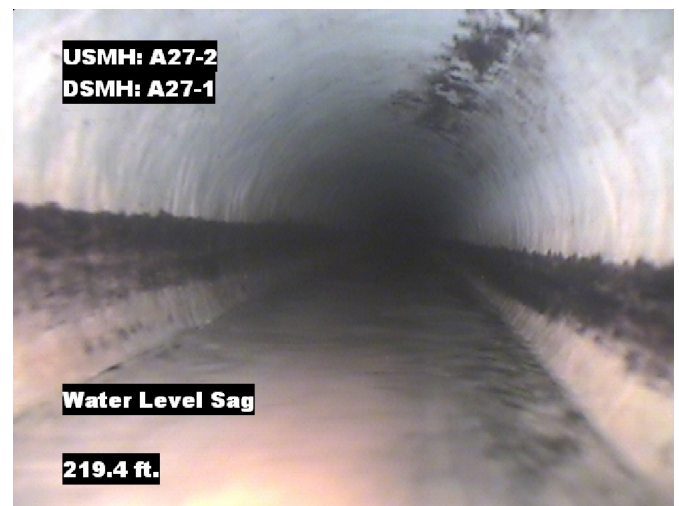
Distance: 219.4 ft. Grade: 2  
Condition: Water Level Sag  
Remarks: N/A

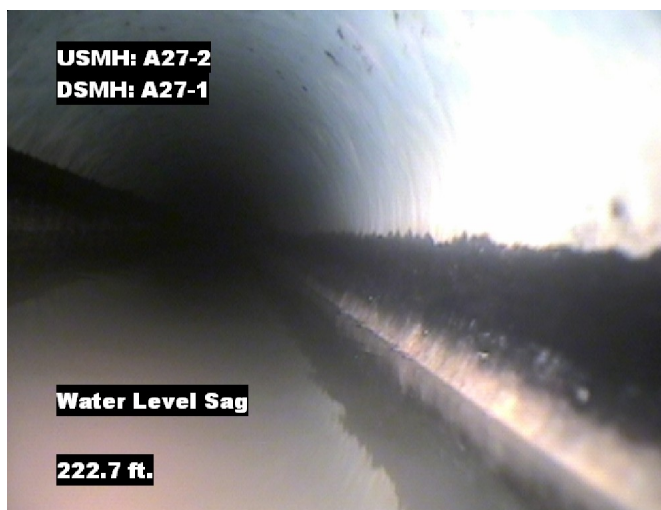
Distance: 222.7 ft. Grade: 2  
Condition: Water Level Sag  
Remarks: N/A

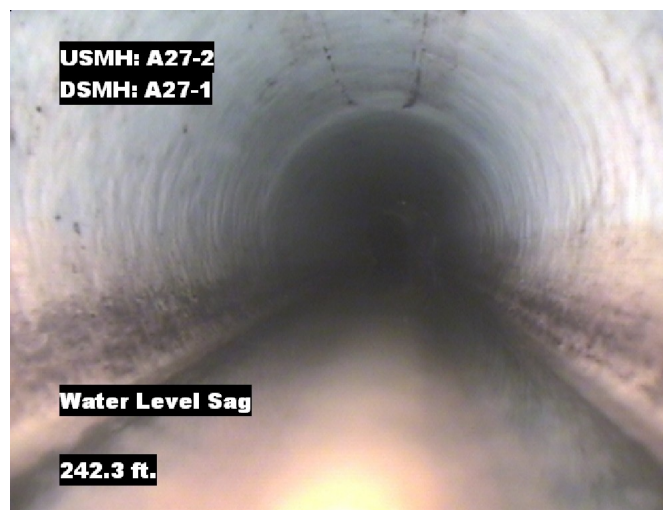
Distance: 242.3 ft. Grade: 2  
Condition: Water Level Sag  
Remarks: N/A

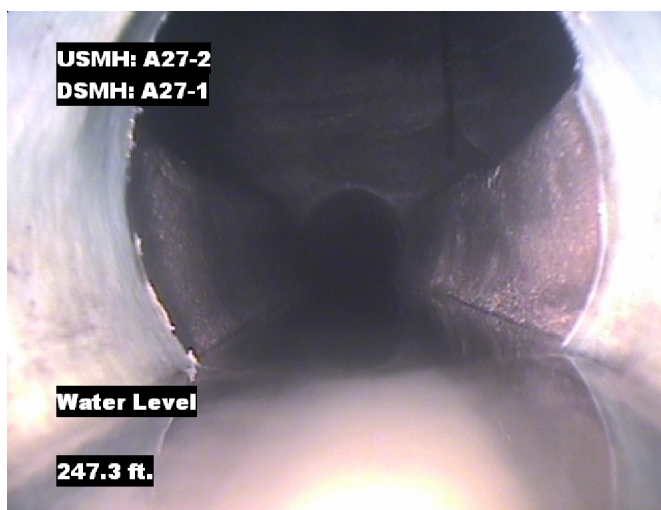
Distance: 247.3 ft. Grade: 0  
Condition: Water Level  
Remarks: N/A
