Defect Listing

| Pipe Segment Refere | | City | | Street | Mat | Material | | Sewer Use |
|---|---|---|---|---|---|---|---|---|
| A27-3_A27-2 | | Oliver Springs | | Springs St | Fibreglass | Fibreglass Reinforc | | Sanitary |
| QSR | N/A | QMR | 3122 | 4397-02 | | Pre-Rehabilitation Survey | | |

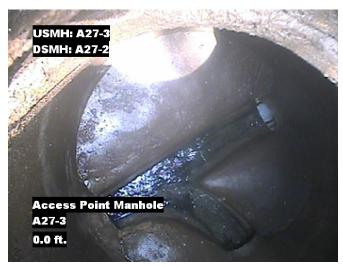
Distance: 0.0 ft. Grade: 0

Condition: Access Point Manhole

Remarks: A27-3

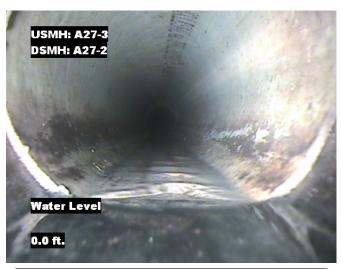
Distance: 0.0 ft. Grade: 0

Condition: Water Level

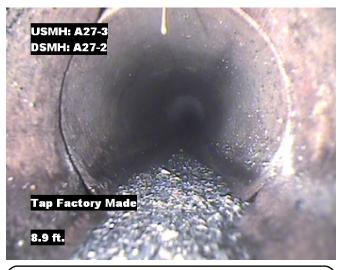
Distance: 8.9 ft. Grade: 0

Condition: Tap Factory Made

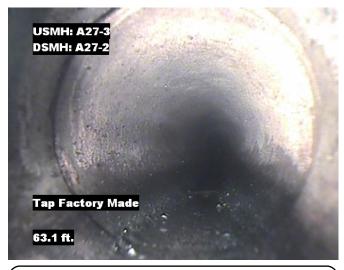
Distance: 63.1 ft. Grade: 0

Condition: Tap Factory Made

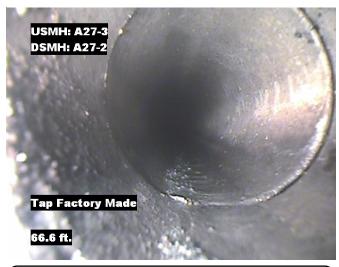
Distance: 66.6 ft. Grade: 0

Condition: Tap Factory Made

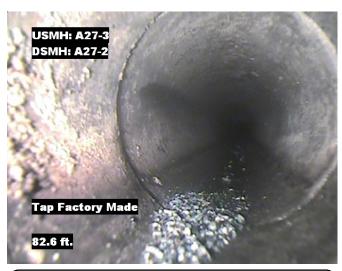
Distance: 82.6 ft. Grade: 0

Condition: Tap Factory Made

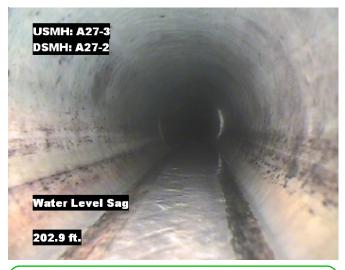
Distance: 202.9 ft. Grade: 2

| Distance | Condition | Court Diet | Values | | | | Clock Position | | Overde |
|---|---|---|---|---|---|---|---|---|---|
| 202.9 ft. | Water Level Sag | | | | 10 | | | | 2 |

Condition: Water Level Sag

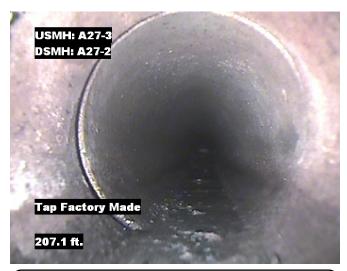
Distance: 207.1 ft. Grade: 0

Condition: Tap Factory Made

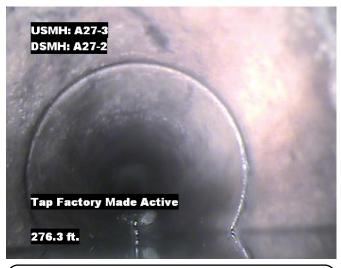
Distance: 276.3 ft. Grade: 0

Condition: Tap Factory Made Active

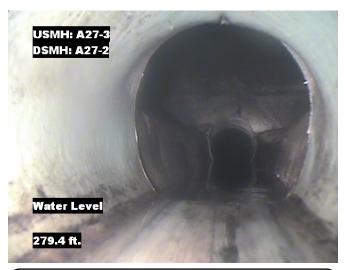
Distance: 279.4 ft. Grade: 0

Condition: Water Level

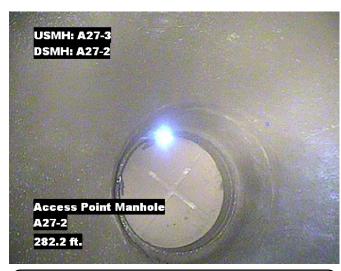
Distance: 282.2 ft. Grade: 0

Condition: Access Point Manhole

Remarks: A27-2
