## Defect Listing

Pipe Segment Refere... <b>A27-4_A27-3</b>	City <b>Oliver Springs</b>	Street <b>Springs ST</b>	Material <b>Fibreglass Reinforc...</b>	Location C... <b>Light High...</b>	Sewer Use <b>Sanitary</b>
Upstream MH <b>A27-4</b>	Total Length <b>339.4</b>	Year Laid	Shape <b>Circular</b>	Location Details	
DS Manhole <b>A27-3</b>	Length surveyed <b>339.4</b>	Year Renewed	Height <b>8</b>	Width <b>8</b>	Pipe Joint... <b>N/A</b>

SPR <b>N/A</b>	MPR <b>N/A</b>	PO Number <b>4397-03</b>	Customer <b>GRW</b>
SPRI <b>N/A</b>	MPRI <b>N/A</b>	Work Order <b>4397-02</b>	Purpose <b>Pre-Rehabilitation Survey</b>
QSR <b>N/A</b>	QMR <b>N/A</b>		
OPR <b>N/A</b>	Surveyed By <b>Charlie Gordon</b>	Direction <b>Downstream</b>	Date <b>20150821</b>
OPRI <b>N/A</b>	Certificate Number <b>U-615-07000491</b>	Pre-Cleaning <b>Jetting</b>	Time <b>12:50</b>
	Date Cleaned <b>20150821</b>	End Time <b>13:10</b>	Weather <b>Dry</b>
			Additional Info

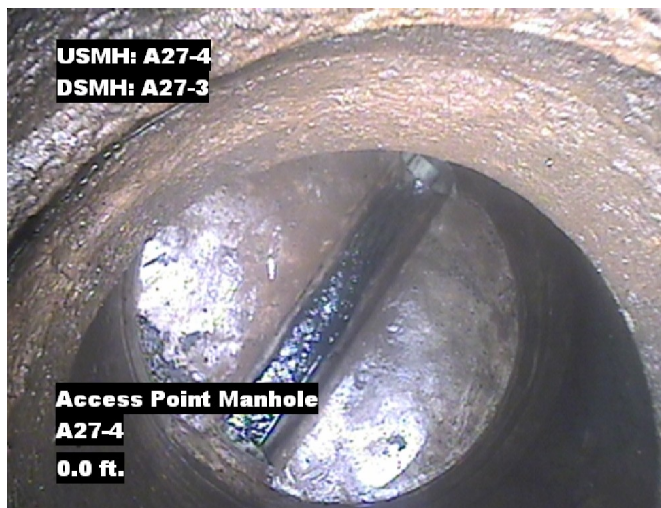
Distance: 0.0 ft. Grade: 0  
Condition: Access Point Manhole  
Remarks: A27-4

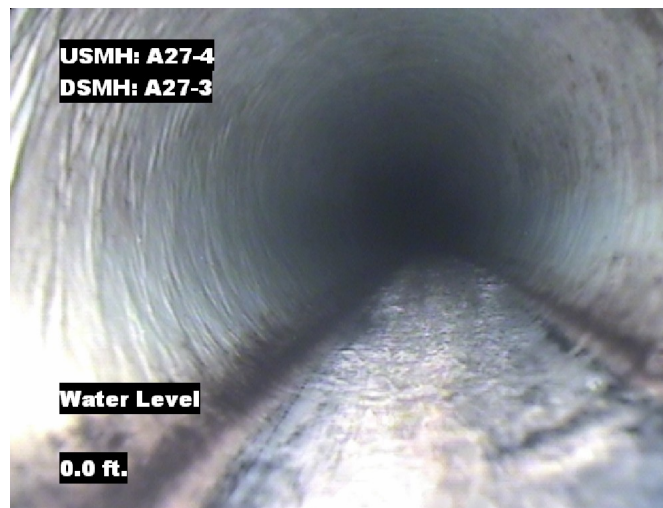
Distance: 0.0 ft. Grade: 0  
Condition: Water Level  
Remarks: N/A

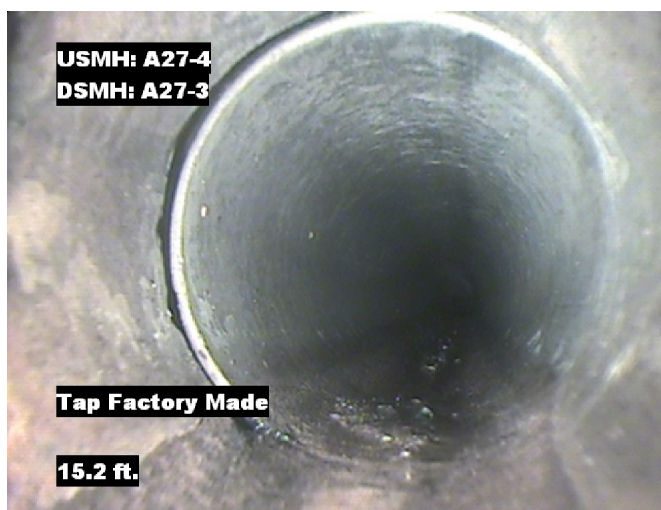
Distance: 15.2 ft. Grade: 0  
Condition: Tap Factory Made  
Remarks: N/A

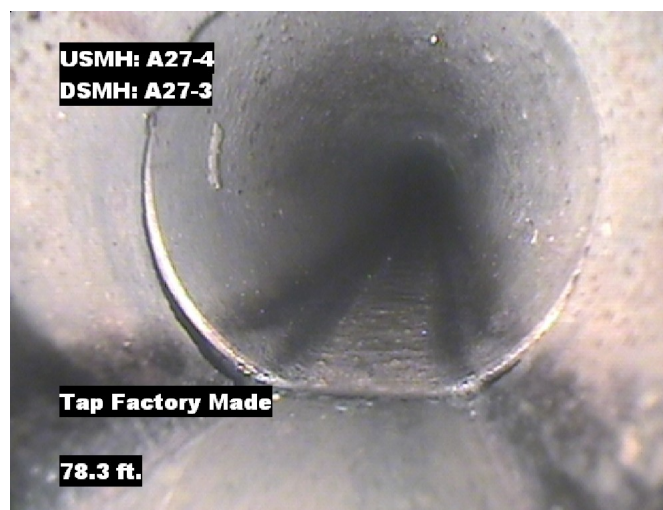
Distance: 78.3 ft. Grade: 0  
Condition: Tap Factory Made  
Remarks: N/A

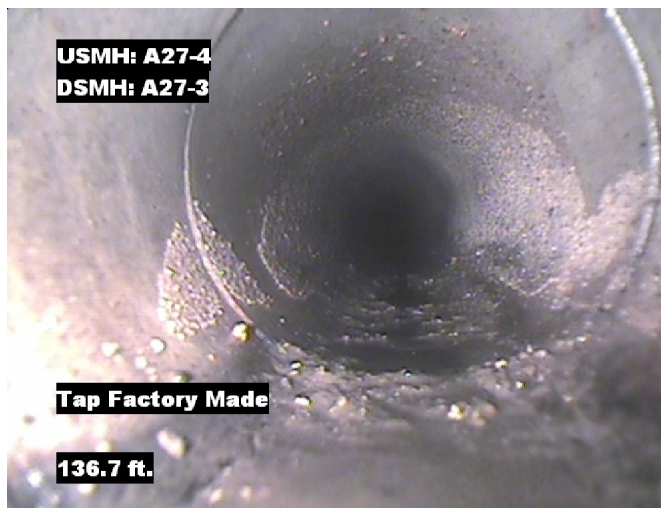
Distance: 136.7 ft. Grade: 0  
Condition: Tap Factory Made  
Remarks: N/A

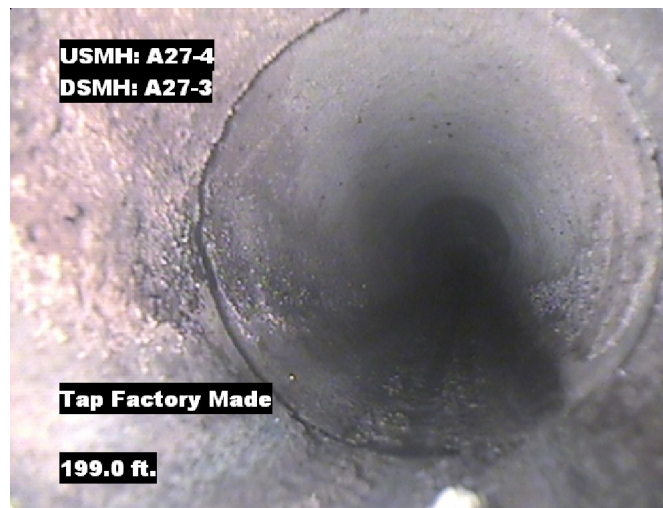
Distance: 199.0 ft. Grade: 0  
Condition: Tap Factory Made  
Remarks: N/A

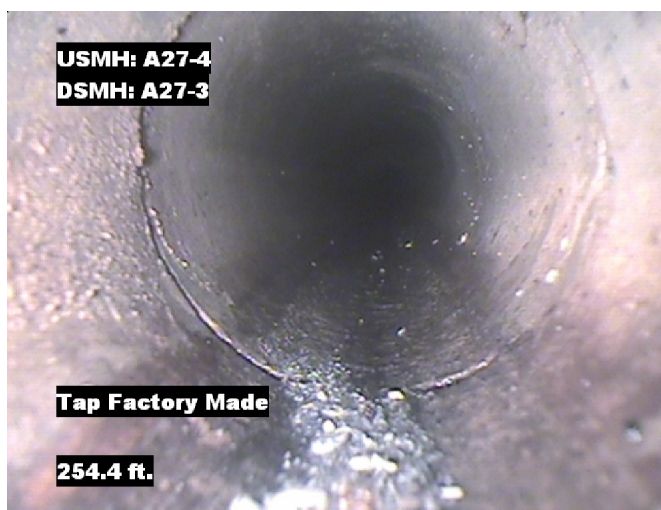
Distance: 254.4 ft. Grade: 0  
Condition: Tap Factory Made  
Remarks: N/A

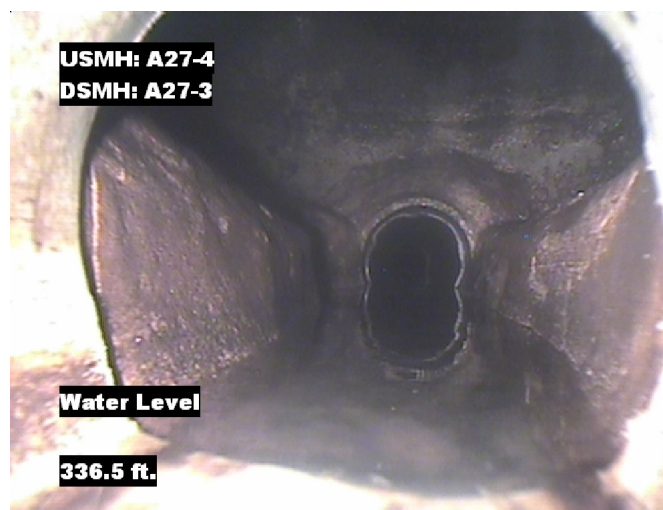
Distance: 336.5 ft. Grade: 0  
Condition: Water Level  
Remarks: N/A

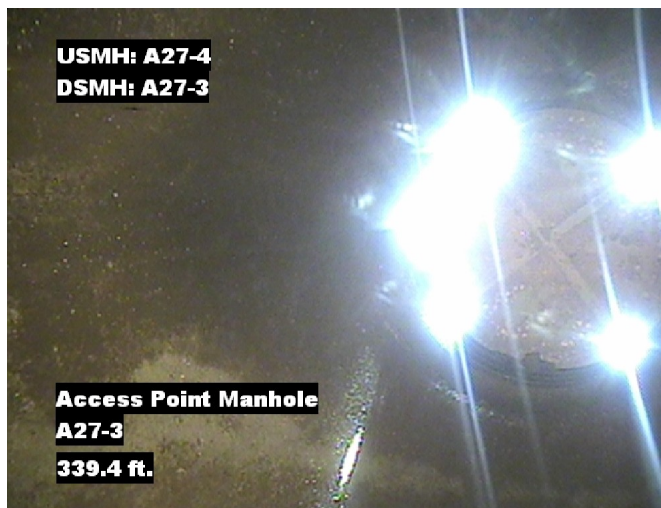
Distance: 339.4 ft.      Grade: 0  
Condition: Access Point Manhole  
Remarks: A27-3
