Defect Listing

Pipe Segment Refere... A27-5_A27-4	City Oliver Springs	Street Springs St	Material Fibreglass Reinforc...	Location C... Light High...	Sewer Use Sanitary
Upstream MH A27-5	Total Length 348.4	Year Laid	Shape Circular	Location Details	
DS Manhole A27-4	Length surveyed 348.4	Year Renewed	Height 8	Width 8	Pipe Joint... N/A

SPR N/A	MPR 2	PO Number 4397-03	Customer GRW
SPRI N/A	MPRI 2	Work Order 4397-02	Purpose Pre-Rehabilitation Survey
QSR N/A	QMR 2100		
OPR 2	Surveyed By Charlie Gordon	Direction Downstream	Date 20150821
OPRI 2	Certificate Number U-615-07000491	Pre-Cleaning Jetting	Time 12:14
	Date Cleaned 20150821	End Time 12:31	Weather Damp
			Media label
			Additional Info

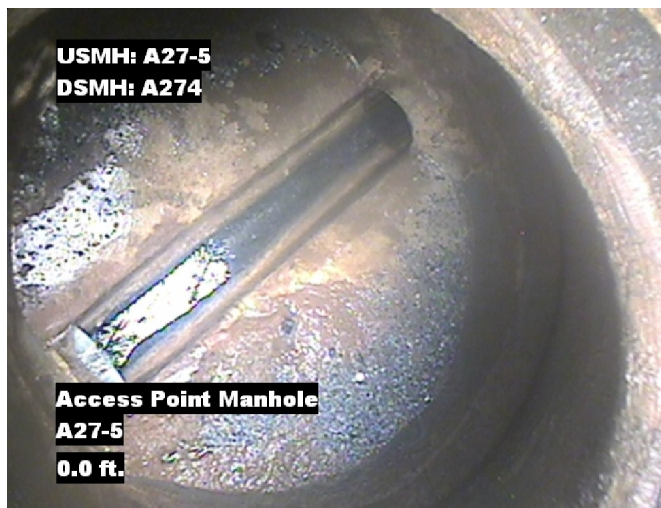
Distance: 0.0 ft. Grade: 0
Condition: Access Point Manhole
Remarks: A27-5

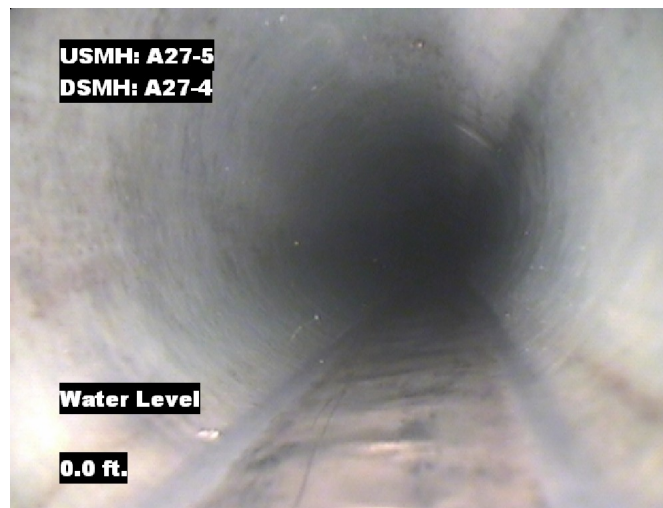
Distance: 0.0 ft. Grade: 0
Condition: Water Level
Remarks: N/A

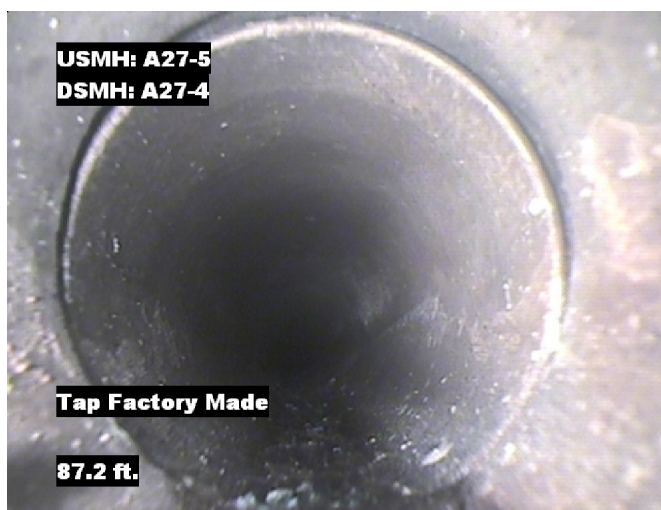
Distance: 87.2 ft. Grade: 0
Condition: Tap Factory Made
Remarks: N/A

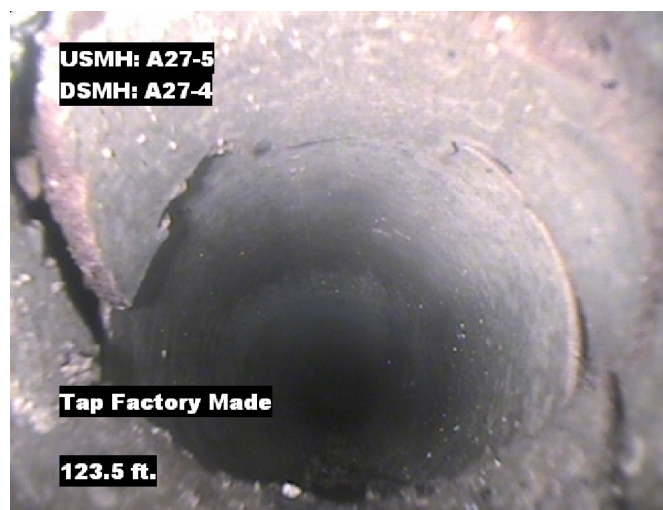
Distance: 123.5 ft. Grade: 0
Condition: Tap Factory Made
Remarks: N/A

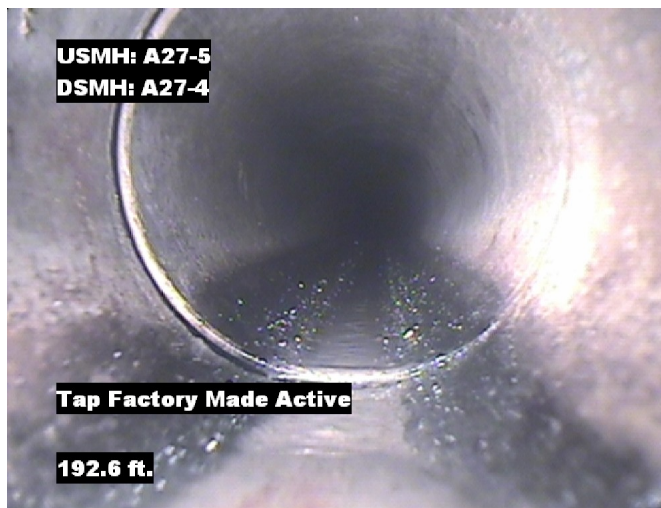
Distance: 192.6 ft. Grade: 0
Condition: Tap Factory Made Active
Remarks: N/A

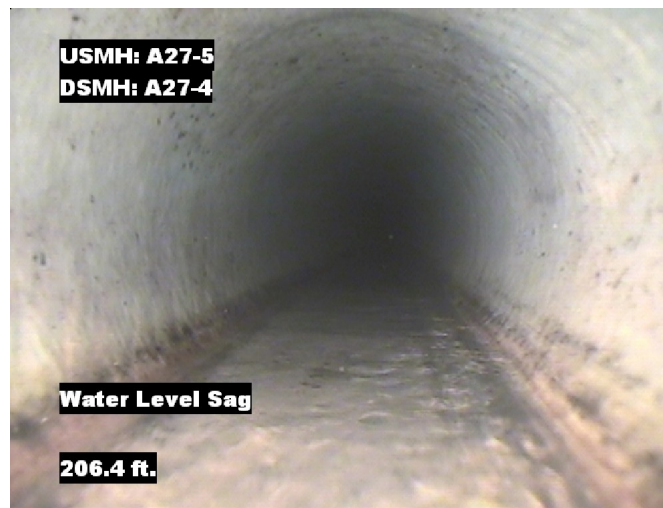
Distance: 206.4 ft. Grade: 2
Condition: Water Level Sag
Remarks: N/A

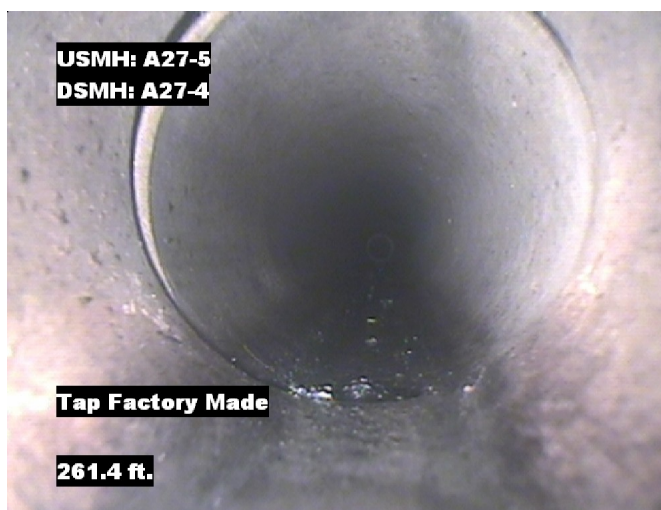
Distance: 261.4 ft. Grade: 0
Condition: Tap Factory Made
Remarks: N/A

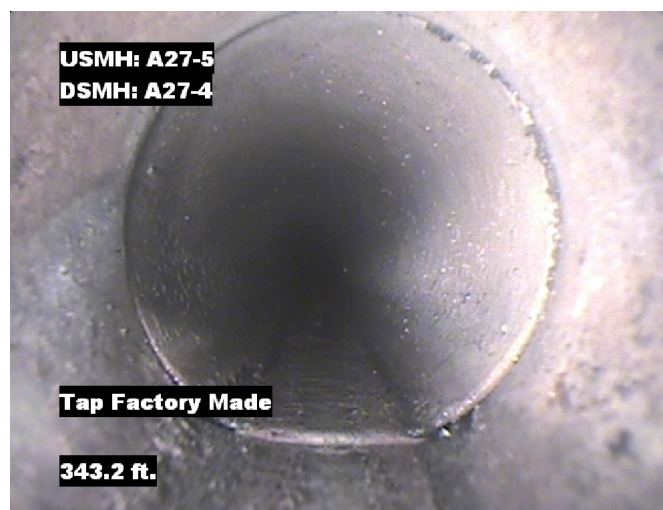
Distance: 343.2 ft. Grade: 0
Condition: Tap Factory Made
Remarks: N/A

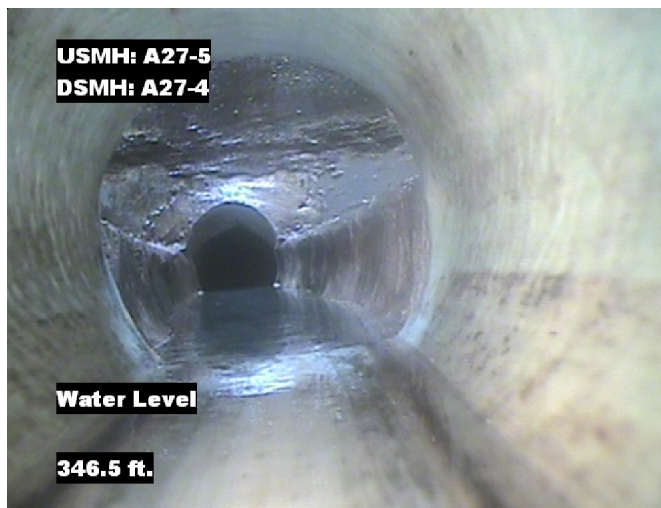
Distance: 346.4 ft. Grade: 0
Condition: Water Level
Remarks: N/A

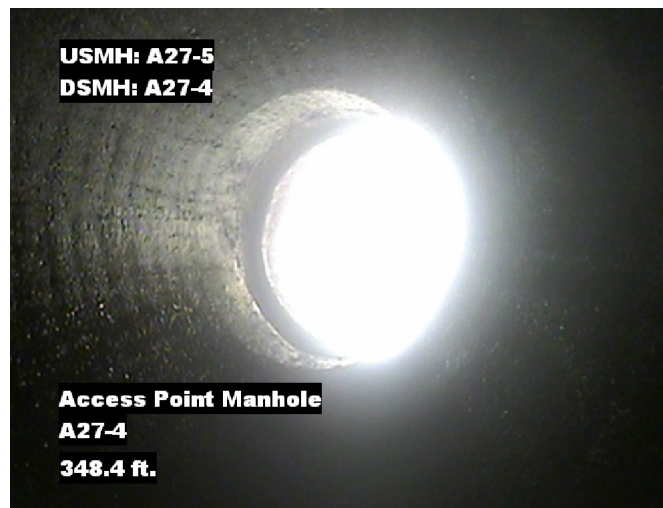
Distance: 348.4 ft. Grade: 0
Condition: Access Point Manhole
Remarks: A27-4
