Defect Listing

Pipe Segment Refere... A27-6_A27-5	City Oliver Springs	Street Springs St	Material Concrete Pipe (non-...	Location C... Light High...	Sewer Use Sanitary
Upstream MH A27-6	Total Length 308.3	Year Laid	Shape Circular	Location Details	
DS Manhole A27-5	Length surveyed 308.3	Year Renewed	Height 8	Width 8	Pipe Joint... 4

SPR 3	MPR 14	PO Number 4397-03	Customer GRW
SPRI 1.5	MPRI 2.3	Work Order 4397-02	Purpose Pre-Rehabilitation Survey
QSR 2111	QMR 4125		
OPR 17	Surveyed By Charlie Gordon	Direction Upstream	Date 20150821
OPRI 2.1	Certificate Number U-615-07000491	Pre-Cleaning Heavy Cleaning	Time 10:19
	Date Cleaned 20150821	End Time 10:42	Weather Damp
			Media label
			Additional Info

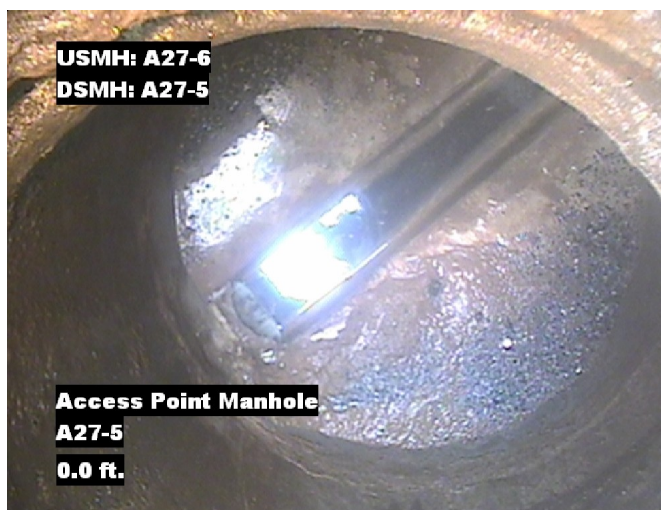
Distance: 0.0 ft. Grade: 0
Condition: Access Point Manhole
Remarks: A27-5

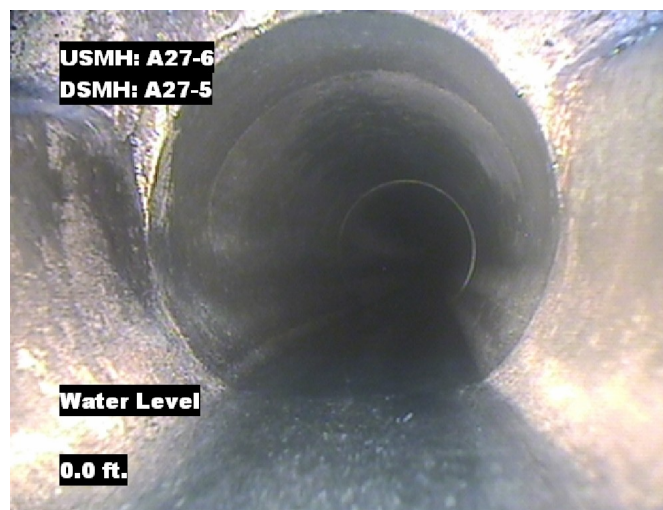
Distance: 0.0 ft. Grade: 0
Condition: Water Level
Remarks: N/A

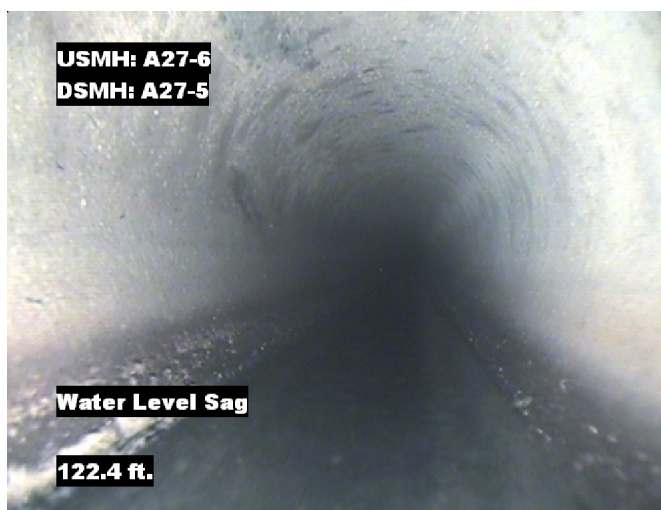
Distance: 122.4 ft. Grade: 2
Condition: Water Level Sag
Remarks: N/A

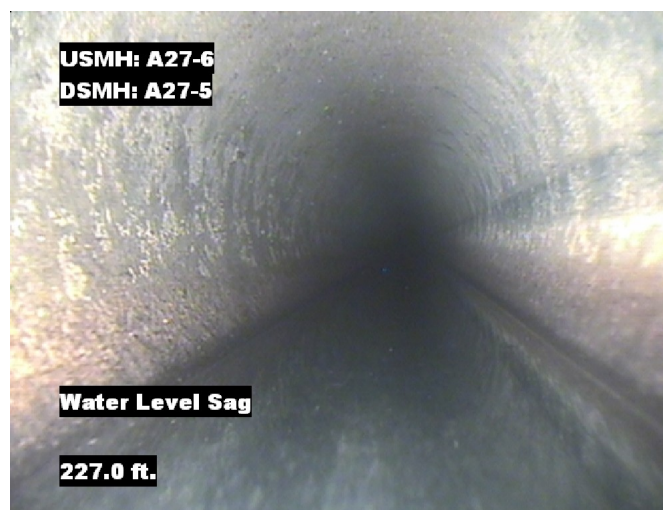
Distance: 227.0 ft. Grade: 2
Condition: Water Level Sag
Remarks: N/A

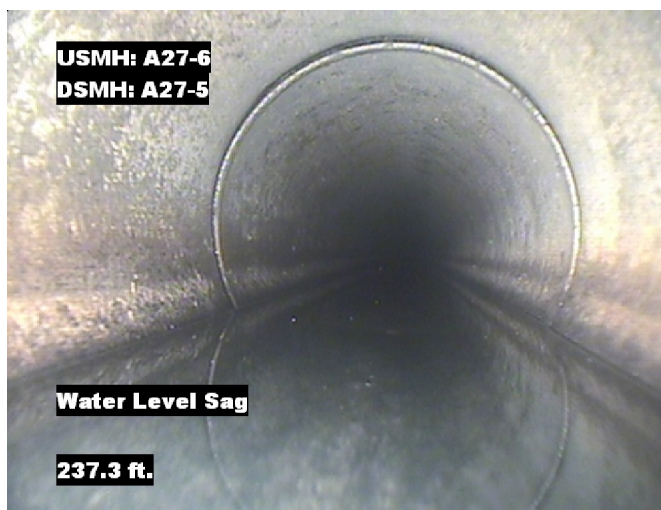
Distance: 237.3 ft. Grade: 2
Condition: Water Level Sag
Remarks: N/A

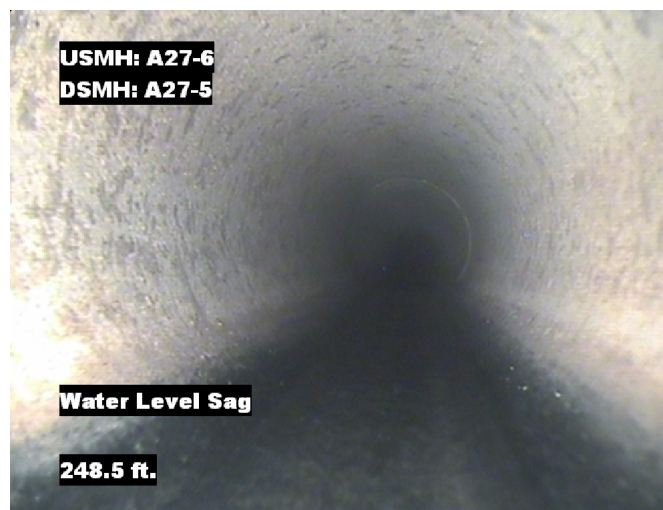
Distance: 248.5 ft. Grade: 2
Condition: Water Level Sag
Remarks: N/A

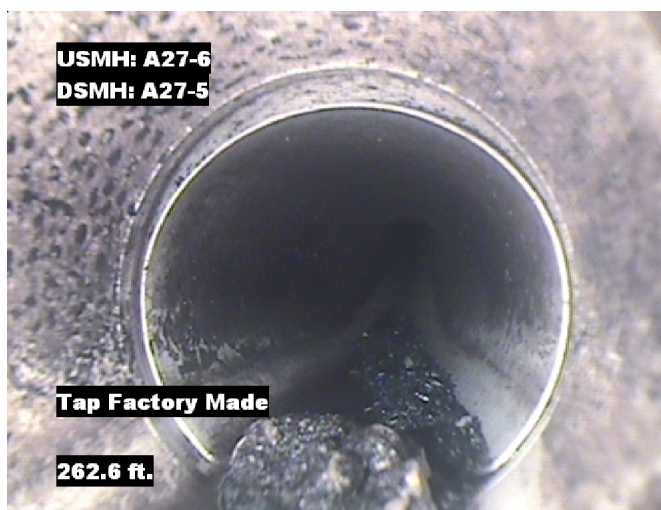
Distance: 262.6 ft. Grade: 0
Condition: Tap Factory Made
Remarks: N/A

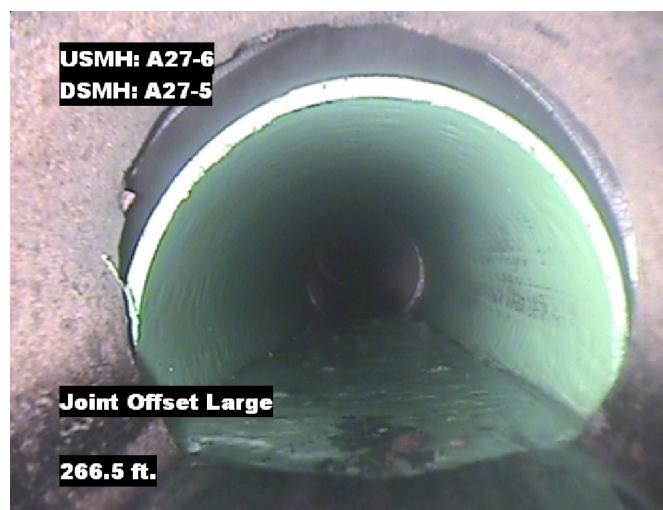
Distance: 266.5 ft. Grade: 2
Condition: Joint Offset Large
Remarks: N/A

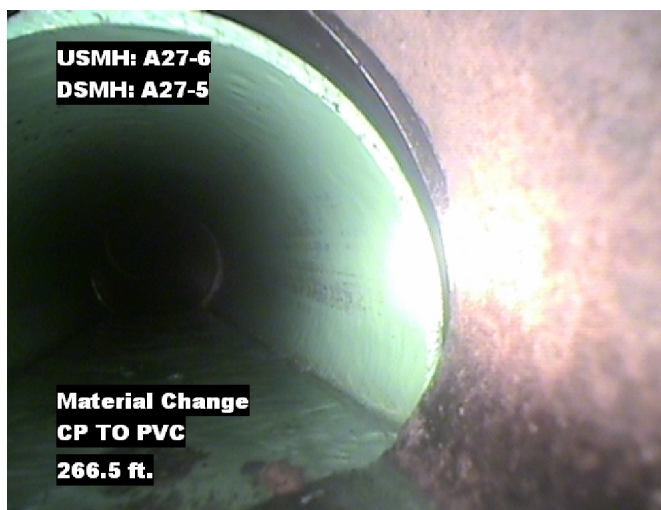
Distance: 266.5 ft. Grade: 0
Condition: Material Change
Remarks: CP TO PVC

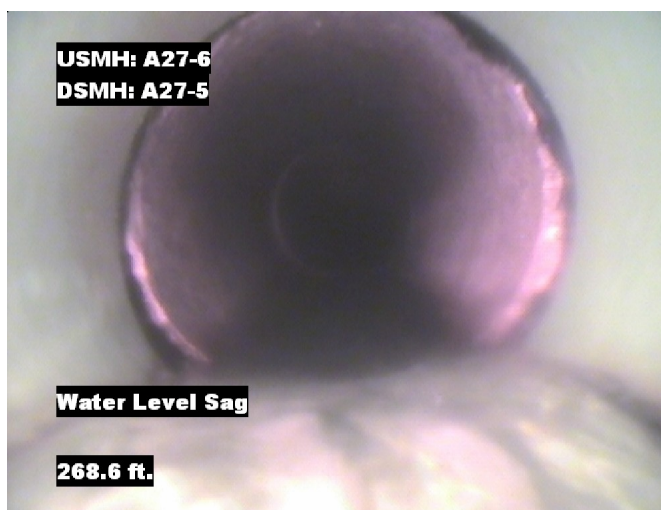
Distance: 268.6 ft. Grade: 2
Condition: Water Level Sag
Remarks: N/A

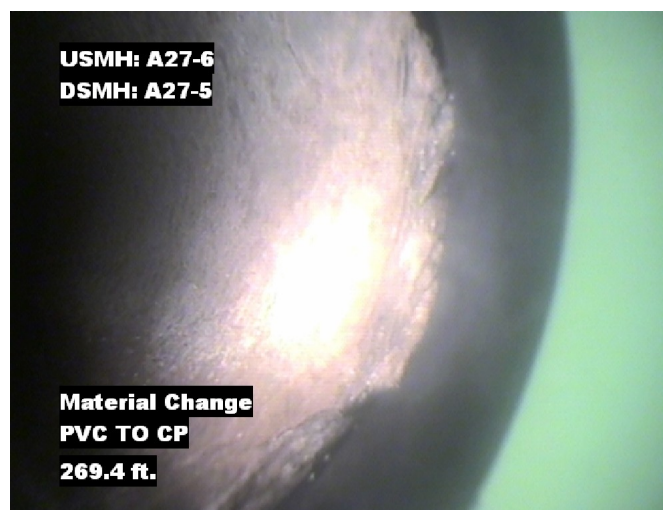
Distance: 269.4 ft. Grade: 0
Condition: Material Change
Remarks: PVC TO CP

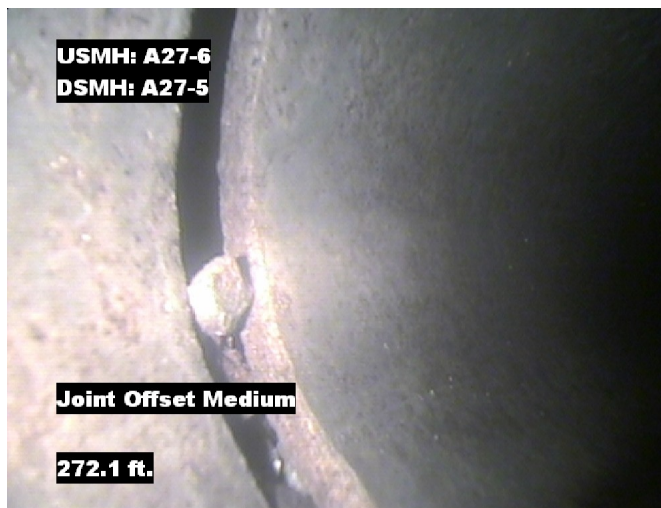
Distance: 272.1 ft. Grade: 1
Condition: Joint Offset Medium
Remarks: N/A

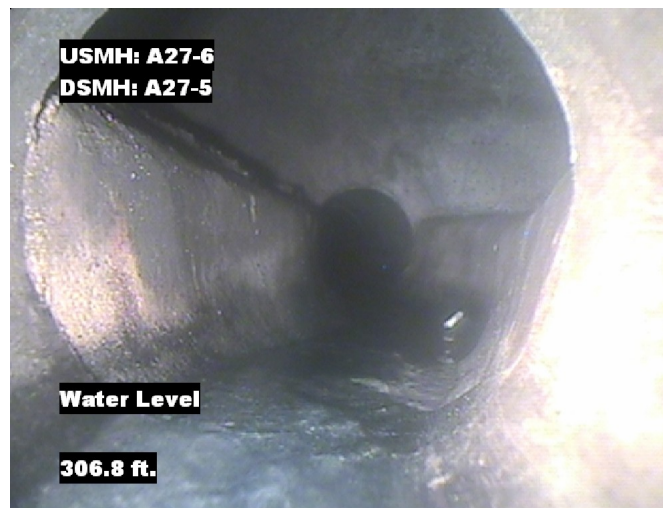
Distance: 306.8 ft. Grade: 0
Condition: Water Level
Remarks: N/A

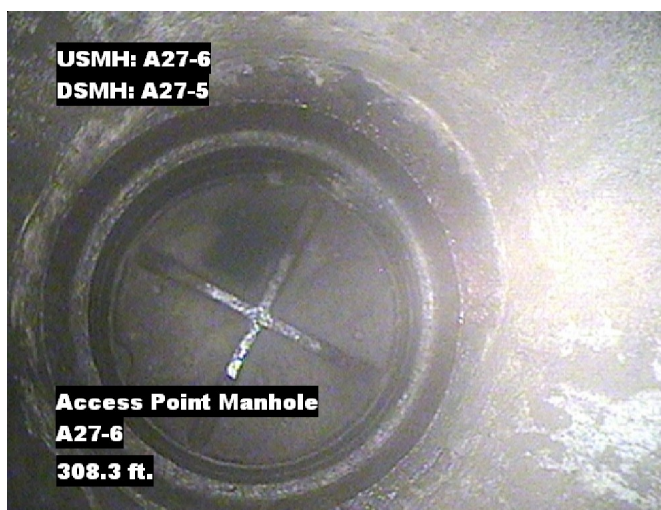
Distance: 308.3 ft. Grade: 0
Condition: Access Point Manhole
Remarks: A27-6
