Defect Listing

Pipe Segment Refere		City		Street	Mat	Material		Sewer Use	
A28-1_A27-3		Oliver Springs		Union Dr	Concrete F	ipe (non	Light High	Sanitary	
Upstream MH Total L		_ength	Year Laid	Shape		Location Details			
A2	8-1	99	0.6		Circular				
DS Manhole		Length surveyed		Year Renewed	Height Width		Pipe Joint		
A2	7-3	99	0.6		8 8 4				
SPR	5	MPR	8	PO Number	PO Number		Customer		
				4397-03		GRW			
SPRI	5	MPRI	2.7	Work Order	Work Order		Purpose		
QSR	5100	QMR	4131	4397-02		Pre-	e-Rehabilitation Survey		
0	PR	Surve	yed By	Direction	Date		Media label		
1	3	Charlie Gordon		Downstream	20150821				
Ol	PRI	Certificate Number		Pre-Cleaning	Time		Weather		
3.3		U-615-07000491		Jetting	08:15		Damp		
		Date C	leaned		End Time Add		Addition	nal Info	
		2015	0821		08:23

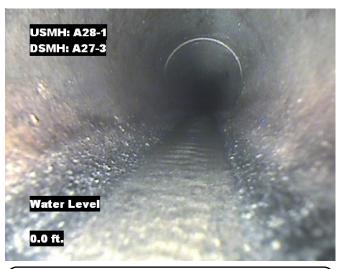
Distance: 0.0 ft. Grade: 0

Condition: Access Point Manhole

Remarks: A28-1

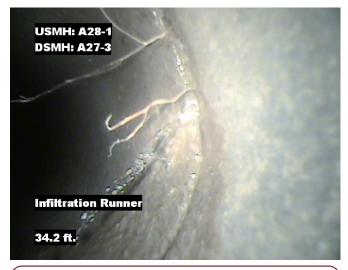
Distance: 34.2 ft. Grade: 1

Condition: Roots Fine Joint

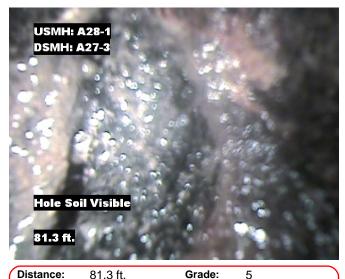
Distance: 81.3 ft. Condition:

Hole Soil Visible

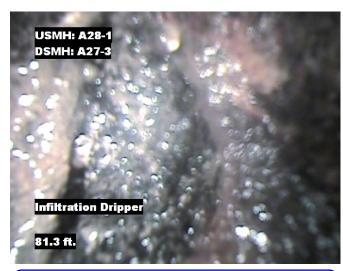
Distance: 81.3 ft. Grade: 3

Condition: Infiltration Dripper

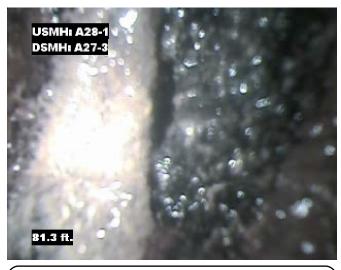
Distance: 81.3 ft. Grade: 0

Condition: Infiltration Stain

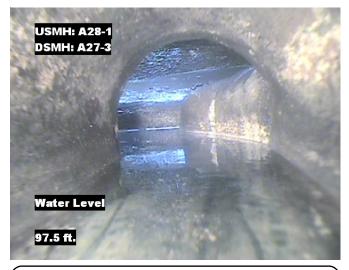
Distance: 97.5 ft. Grade: 0

Condition: Water Level

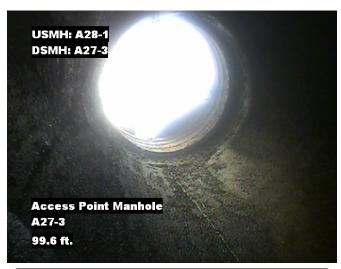
Distance: 99.6 ft. Grade: 0

Condition: Access Point Manhole

Remarks: A27-3
