Defect Listing

Pipe Segment Refere... A28-2_A28-1	City Oliver Springs	Street Highland Dr	Material Concrete Pipe (non-...	Location C... Light High...	Sewer Use Sanitary
Upstream MH A28-2	Total Length 112.8	Year Laid	Shape Circular	Location Details	
DS Manhole A28-1	Length surveyed 112.8	Year Renewed	Height 8	Width 8	Pipe Joint... 4

SPR 1	MPR N/A	PO Number 4397-03	Customer GRW
SPRI 1	MPRI N/A	Work Order 4397-02	Purpose Pre-Rehabilitation Survey
QSR 1100	QMR N/A		
OPR 1	Surveyed By Charlie Gordon	Direction Downstream	Date 20150820
OPRI 1	Certificate Number U-615-07000491	Pre-Cleaning Jetting	Time 14:27
	Date Cleaned 20150820	End Time 14:37	Weather Damp
			Media label
			Additional Info

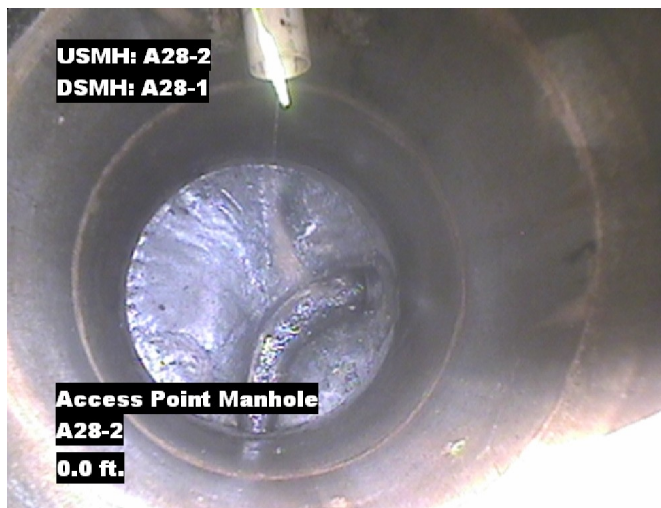
Distance: 0.0 ft. Grade: 0
Condition: Access Point Manhole
Remarks: A28-2

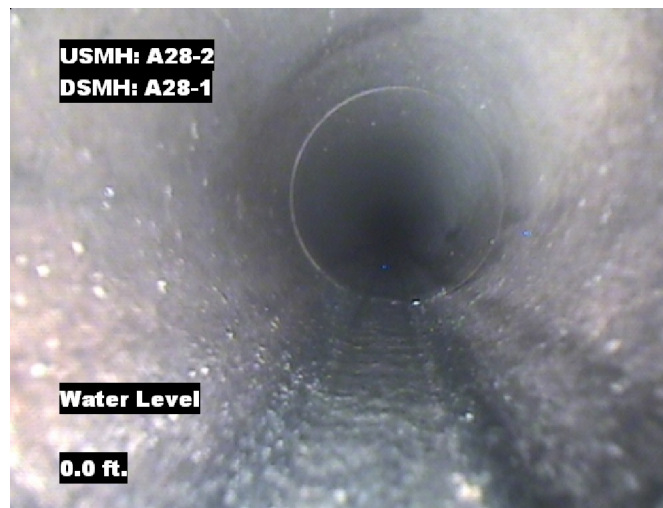
Distance: 0.0 ft. Grade: 0
Condition: Water Level
Remarks: N/A

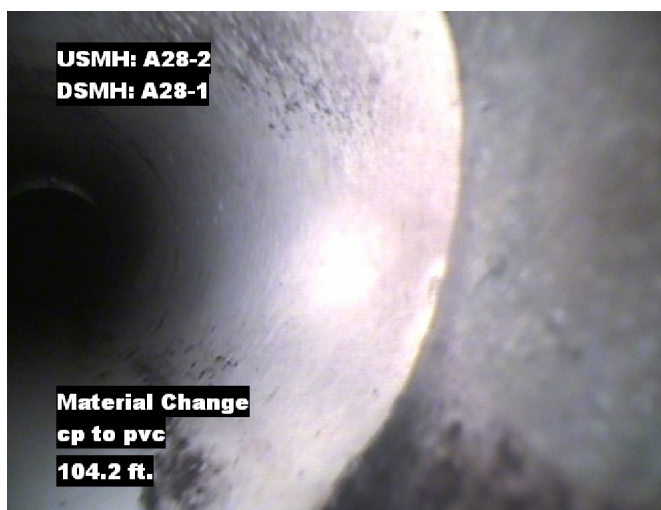
Distance: 104.2 ft. Grade: 0
Condition: Material Change
Remarks: cp to pvc

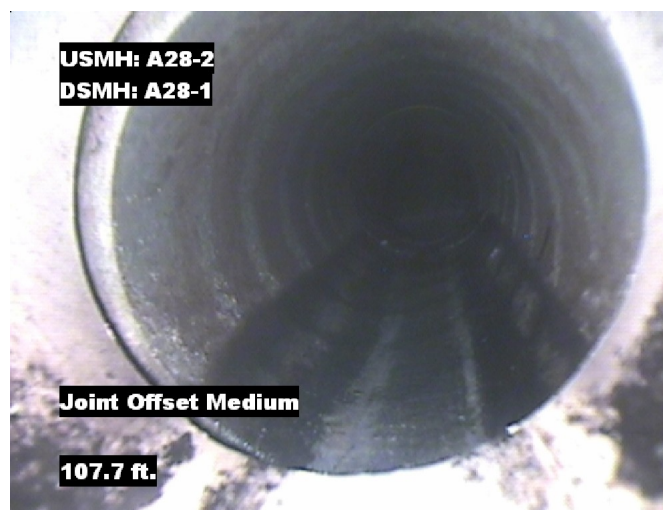
Distance: 107.7 ft. Grade: 1
Condition: Joint Offset Medium
Remarks: N/A

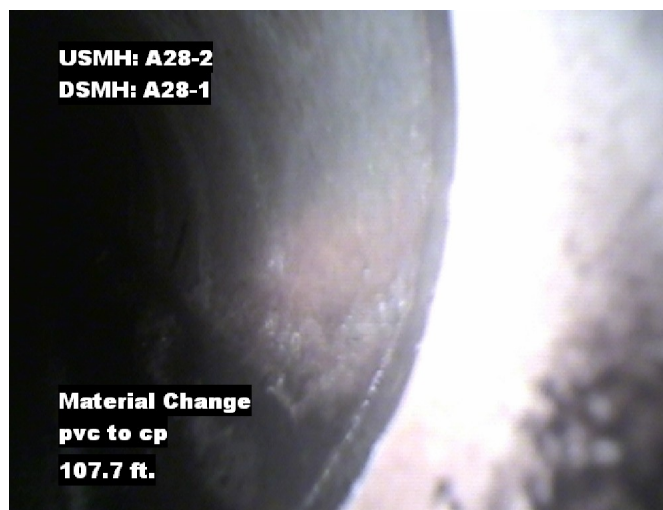
Distance: 107.7 ft. Grade: 0
Condition: Material Change
Remarks: pvc to cp

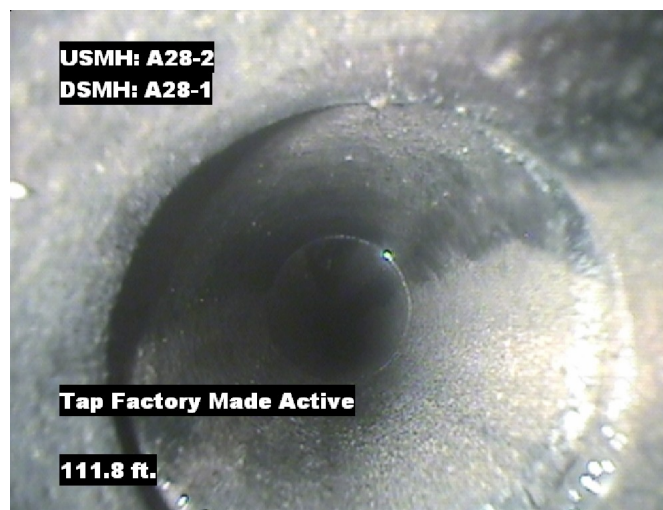
Distance: 111.8 ft. Grade: 0
Condition: Tap Factory Made Active
Remarks: N/A

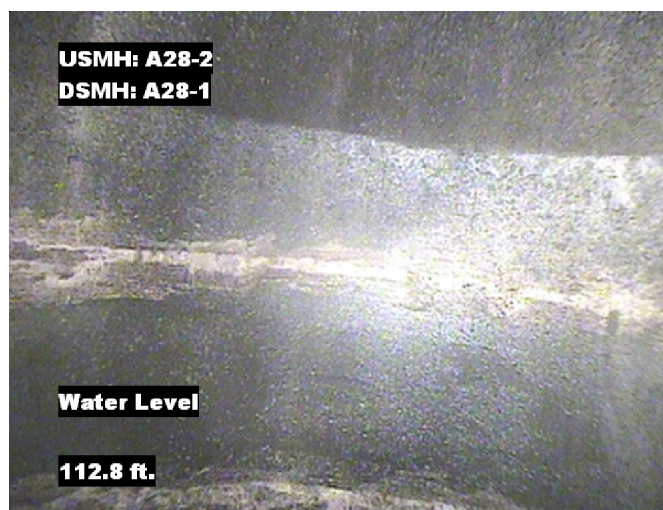
Distance: 112.8 ft. Grade: 0
Condition: Water Level
Remarks: N/A

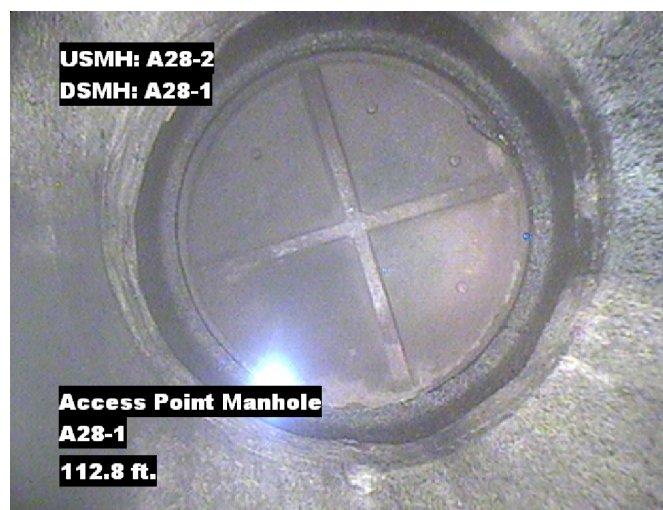
Distance: 112.8 ft. Grade: 0
Condition: Access Point Manhole
Remarks: A28-1
