Defect Listing

Pipe Segment Refere... A28-3_A28-2	City Oliver Springs	Street Highland Dr	Material Concrete Pipe (non-...	Location C... Light High...	Sewer Use Sanitary
Upstream MH A28-3	Total Length 278.5	Year Laid	Shape Circular	Location Details	
DS Manhole A28-2	Length surveyed 278.5	Year Renewed	Height 8	Width 8	Pipe Joint... 4

SPR 3	MPR N/A	PO Number 4397-03	Customer GRW
SPRI 3	MPRI N/A	Work Order 4397-02	Purpose Pre-Rehabilitation Survey
QSR 3100	QMR N/A		
OPR 3	Surveyed By Charlie Gordon	Direction Downstream	Date 20150820
OPRI 3	Certificate Number U-615-07000491	Pre-Cleaning Jetting	Time 14:12
	Date Cleaned 20150820	End Time 14:12	Weather Damp
			Media label
			Additional Info

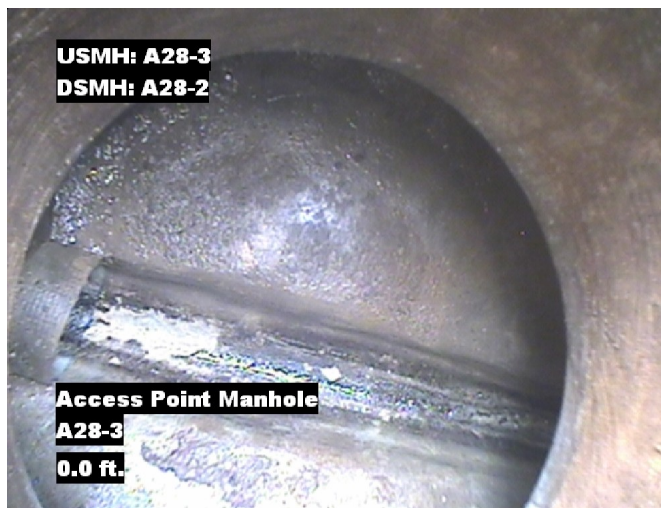
Distance: 0.0 ft. Grade: 0
Condition: Access Point Manhole
Remarks: A28-3

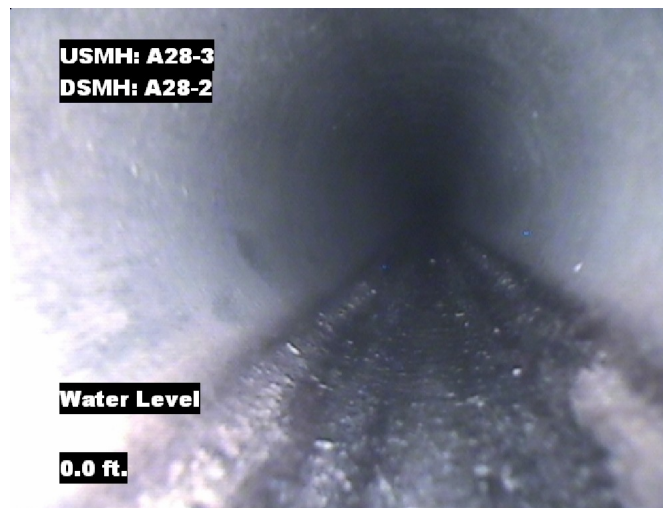
Distance: 0.0 ft. Grade: 0
Condition: Water Level
Remarks: N/A

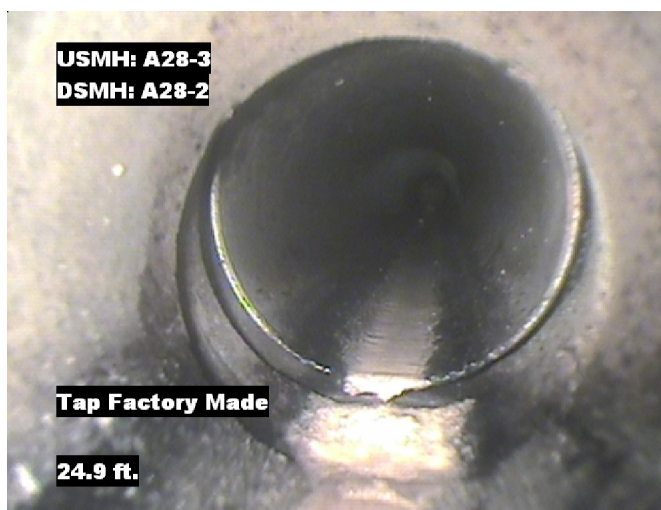
Distance: 24.9 ft. Grade: 0
Condition: Tap Factory Made
Remarks: N/A

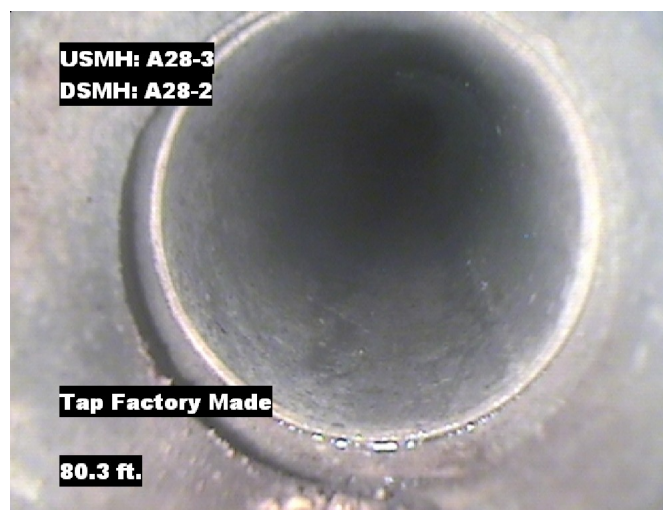
Distance: 80.3 ft. Grade: 0
Condition: Tap Factory Made
Remarks: N/A

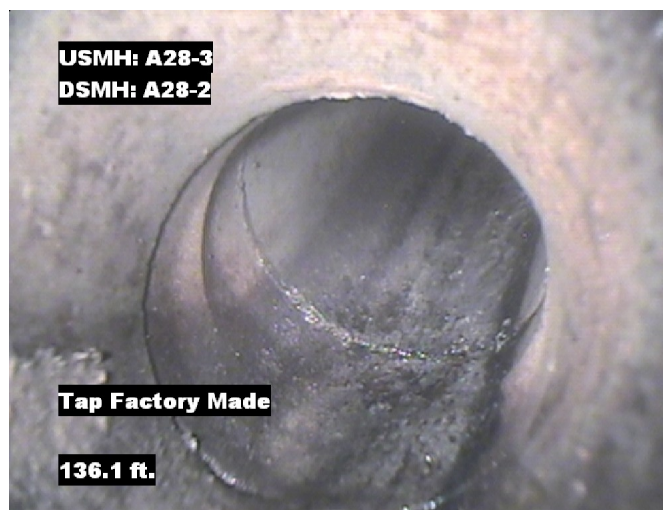
Distance: 136.1 ft. Grade: 0
Condition: Tap Factory Made
Remarks: N/A

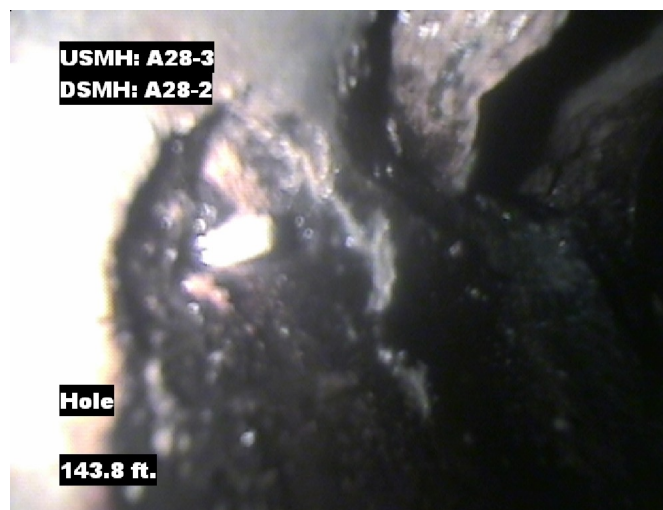
Distance: 143.8 ft. Grade: 3
Condition: Hole
Remarks: N/A

Structural Ratings			O & M Ratings			Combined Ratings		
			Grade Rating	No. Occur.	Rating	Grade Rating	No. Occur.	Rating	Grade Rating	No. Occur.	Rating
Normal Defects											
Continuous Defects			1	0	0	1	0	0	1	0	0
			2	0	0	2	0	0	2	0	0
			3	1	3	3	0	0	3	1	3
			4	0	0	4	0	0	4	0	0
			5	0	0	5	0	0	5	0	0
Code	ID	Length

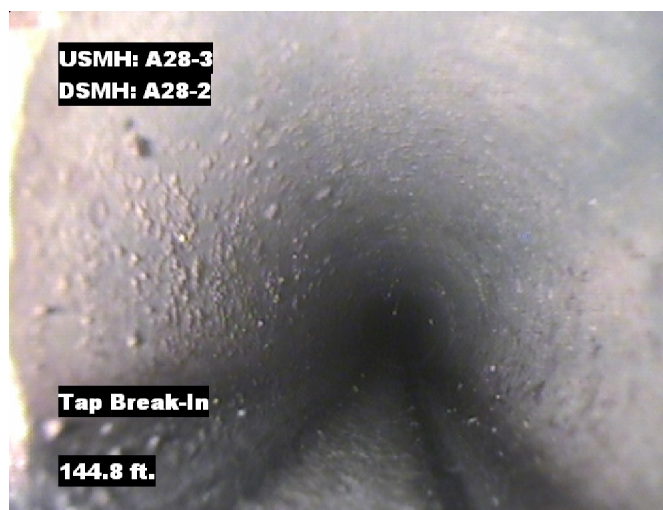
Distance: 144.8 ft. Grade: 0
Condition: Tap Break-In
Remarks: N/A

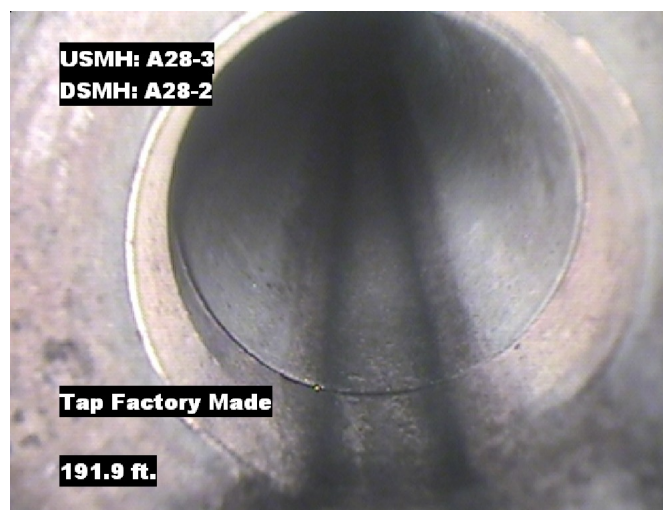
Distance: 191.9 ft. Grade: 0
Condition: Tap Factory Made
Remarks: N/A

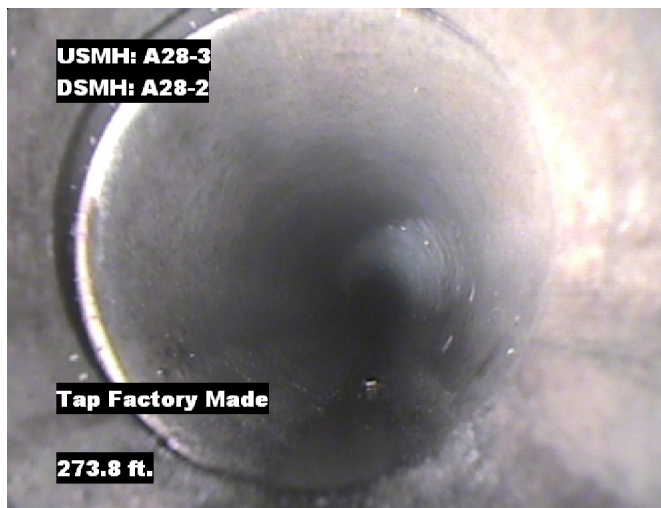
Distance: 273.8 ft. Grade: 0
Condition: Tap Factory Made
Remarks: N/A

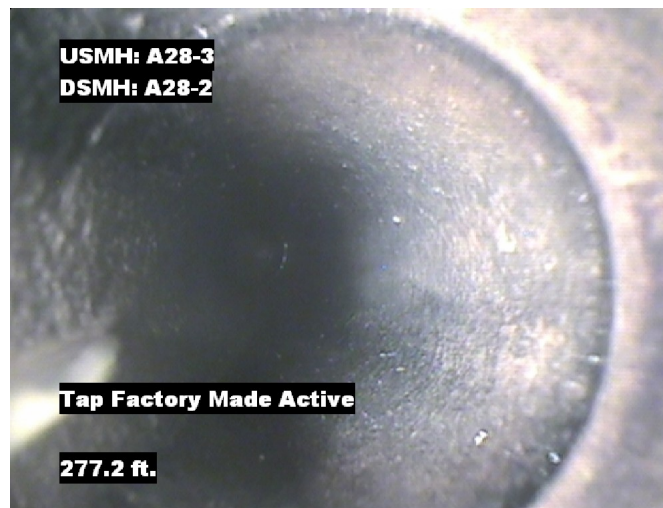
Distance: 277.2 ft. Grade: 0
Condition: Tap Factory Made Active
Remarks: N/A

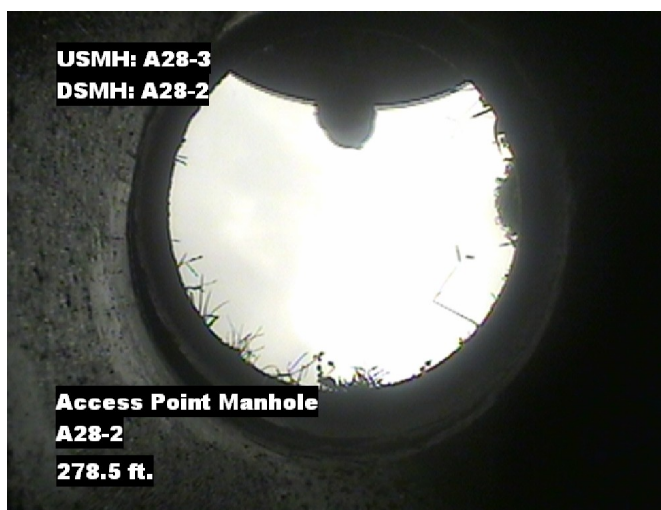
Distance: 278.5 ft. Grade: 0
Condition: Access Point Manhole
Remarks: A28-2
