Defect Listing

Pipe Segment Refere... A29-1_A28-1	City Oliver Springs	Street Union St	Material Concrete Pipe (non-...	Location C... Light High...	Sewer Use Sanitary
Upstream MH A29-1	Total Length 256.3	Year Laid	Shape Circular	Location Details	
DS Manhole A28-1	Length surveyed 256.3	Year Renewed	Height 8	Width 8	Pipe Joint... 4

SPR 2	MPR N/A	PO Number 4397-03	Customer GRW
SPRI 2	MPRI N/A	Work Order 4397-02	Purpose Pre-Rehabilitation Survey
QSR 2100	QMR N/A		
OPR 2	Surveyed By Charlie Gordon	Direction Downstream	Date 20150821
OPRI 2	Certificate Number U-615-07000491	Pre-Cleaning Jetting	Time 07:43
	Date Cleaned 20150821	End Time 07:59	Weather Damp
			Additional Info

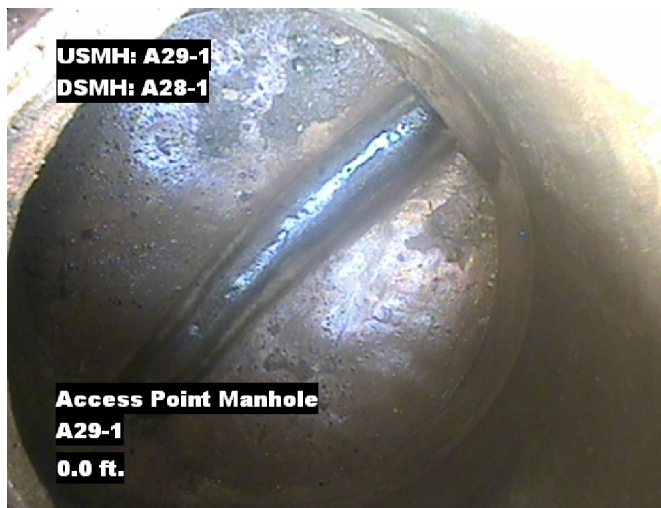
Distance: 0.0 ft. Grade: 0
Condition: Access Point Manhole
Remarks: A29-1

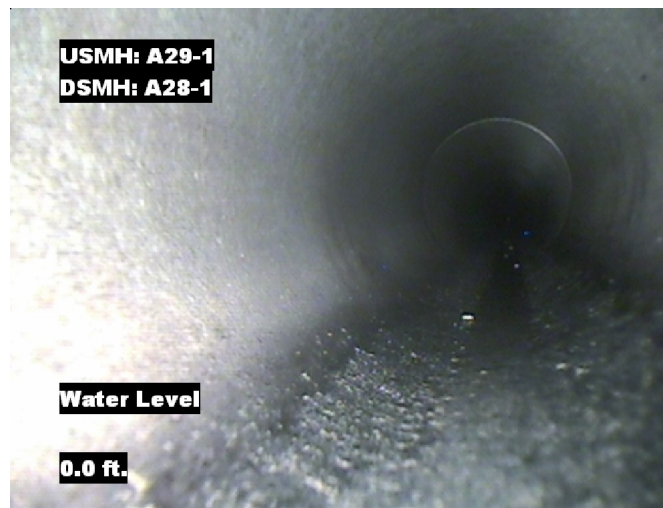
Distance: 0.0 ft. Grade: 0
Condition: Water Level
Remarks: N/A

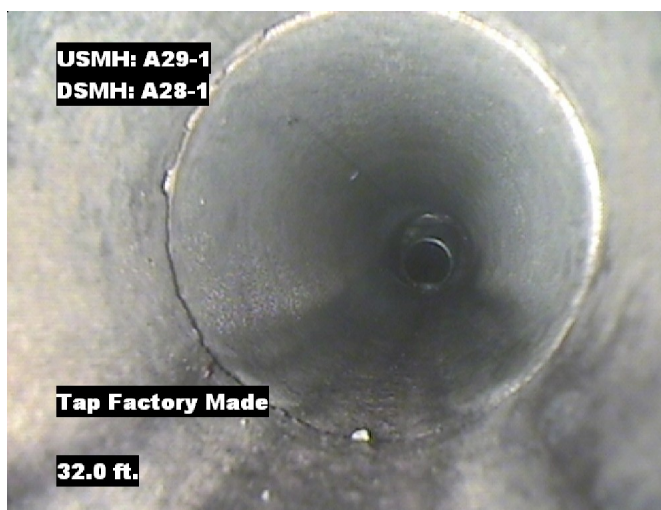
Distance: 32.0 ft. Grade: 0
Condition: Tap Factory Made
Remarks: N/A

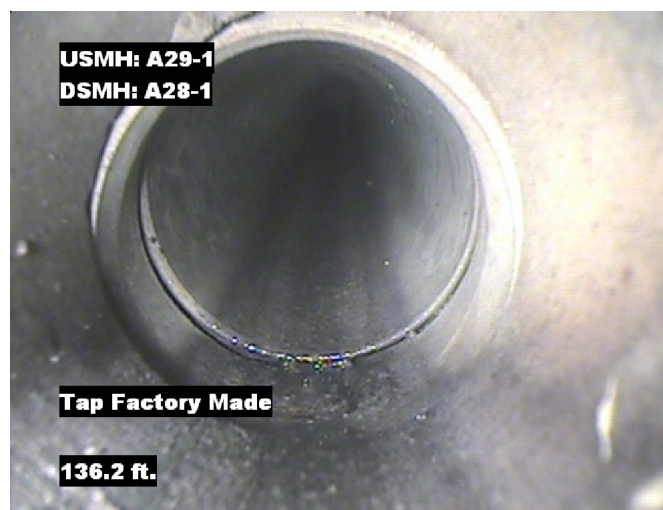
Distance: 136.2 ft. Grade: 0
Condition: Tap Factory Made
Remarks: N/A

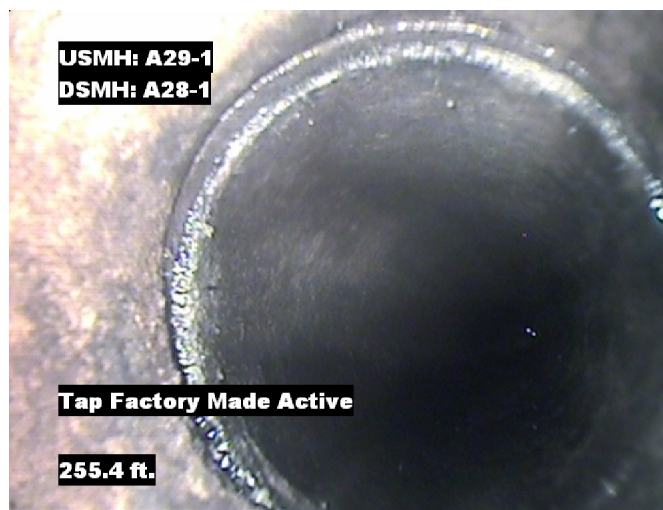
Distance: 255.4 ft. Grade: 0
Condition: Tap Factory Made Active
Remarks: N/A

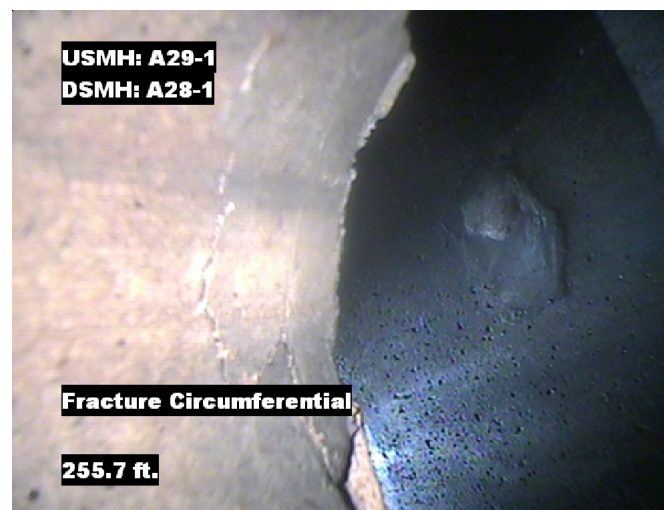
Distance: 255.7 ft. Grade: 2
Condition: Fracture Circumferential
Remarks: N/A

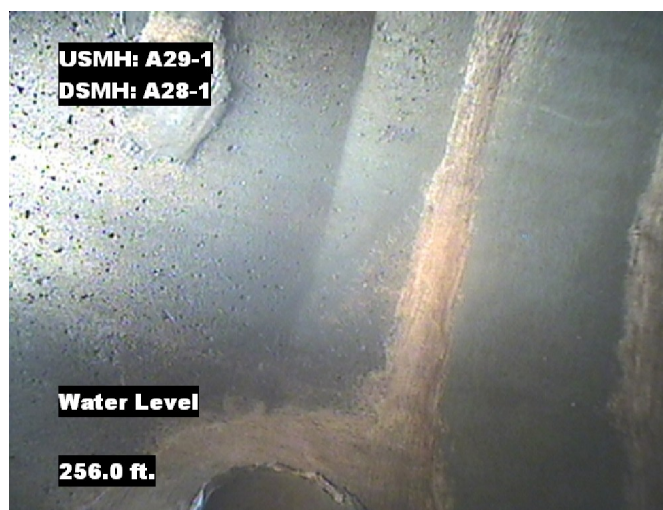
Distance: 256.0 ft. Grade: 0
Condition: Water Level
Remarks: N/A

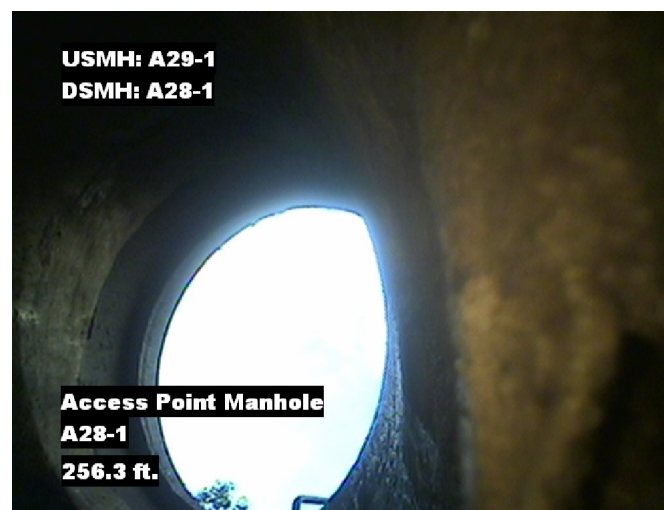
Distance: 256.3 ft. Grade: 0
Condition: Access Point Manhole
Remarks: A28-1
