Defect Listing

Pipe Segment Refere... A3-3_A3-2	City Oliver Springs	Street Burney Dr	Material Concrete Pipe (non-...	Location C... Yard	Sewer Use Sanitary
Upstream MH A3-3	Total Length 242.1	Year Laid	Shape Circular	Location Details	
DS Manhole A3-2	Length surveyed 242.1	Year Renewed	Height 8	Width 8	Pipe Joint... 4

SPR 8	MPR 18	PO Number 4397-03	Customer GRW
SPRI 2.7	MPRI 1.5	Work Order 4397-02	Purpose Pre-Rehabilitation Survey
QSR 4131	QMR 2616		
OPR 26	Surveyed By Charlie Gordon	Direction Upstream	Date 20150831
OPRI 1.7	Certificate Number U-615-07000491	Pre-Cleaning Heavy Cleaning	Time 13:55
	Date Cleaned 20150831	End Time 14:17	Weather Dry
		Additional Info BOTTOM 30 FT HAD RO...

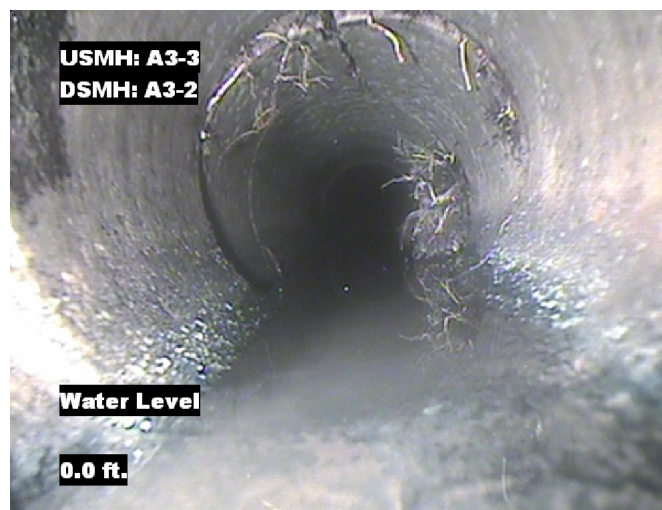
Distance: 0.0 ft. Grade: 0
Condition: Water Level
Remarks: N/A

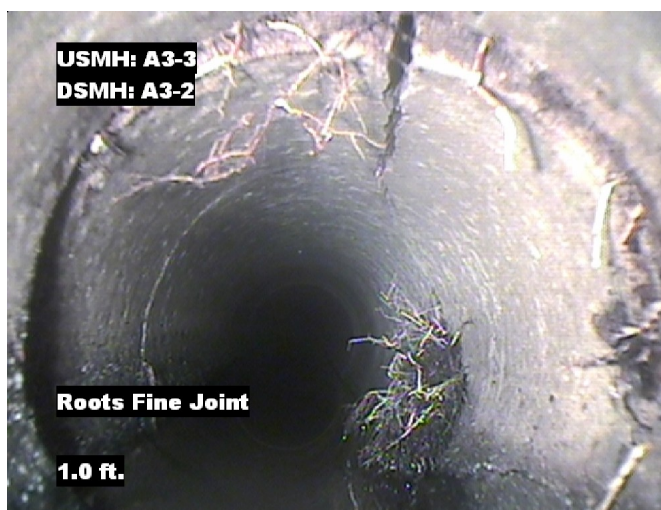
Distance: 1.0 ft. Grade: 1
Condition: Roots Fine Joint
Remarks: N/A

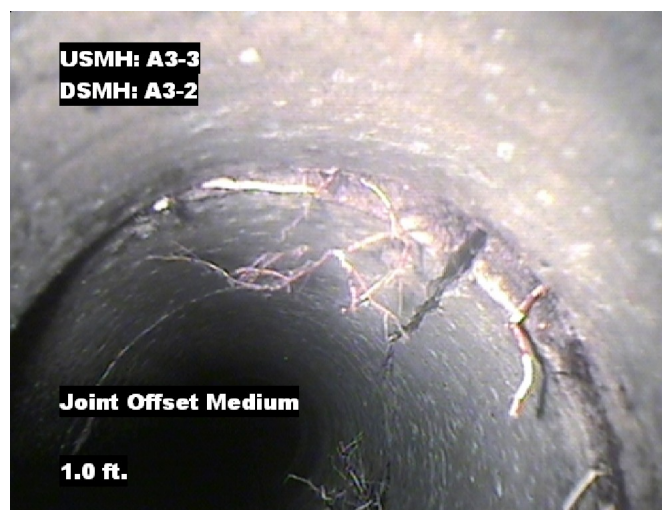
Distance: 1.0 ft. Grade: 1
Condition: Joint Offset Medium
Remarks: N/A

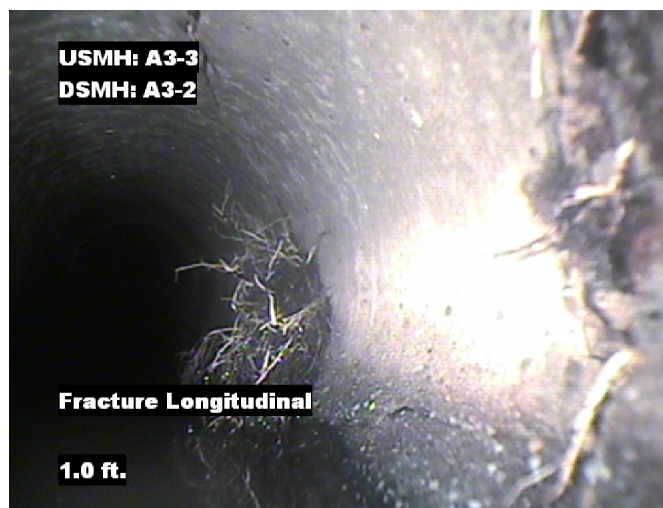
Distance: 1.0 ft. Grade: 3
Condition: Fracture Longitudinal
Remarks: N/A

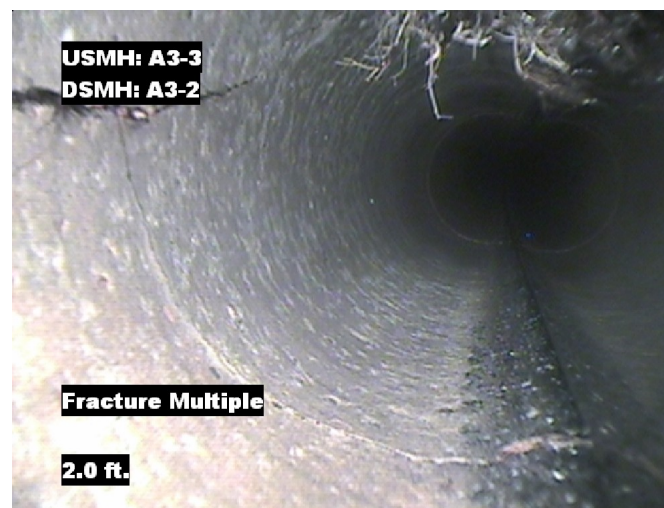
Distance: 2.0 ft. Grade: 4
Condition: Fracture Multiple
Remarks: N/A

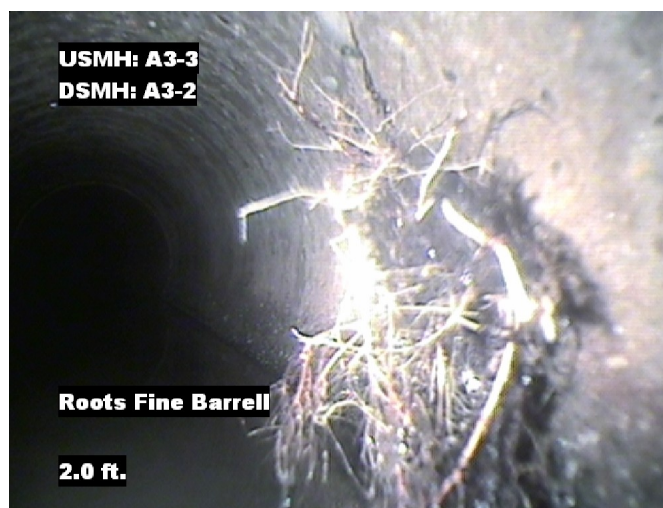
Distance: 2.0 ft. Grade: 2
Condition: Roots Fine Barrell
Remarks: N/A

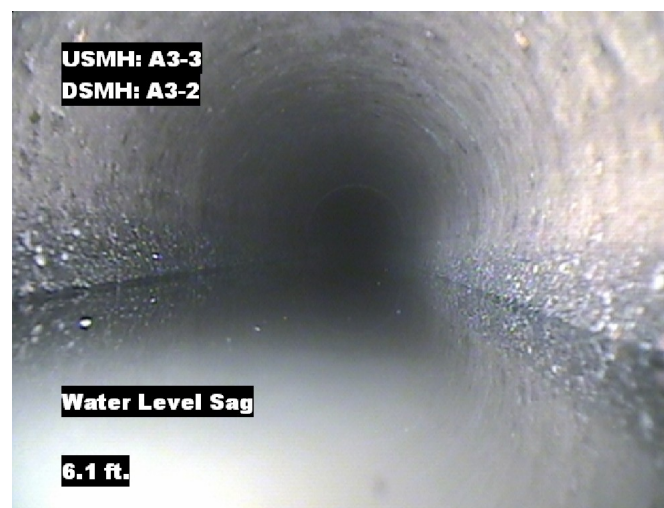
Distance: 6.1 ft. Grade: 2
Condition: Water Level Sag
Remarks: N/A

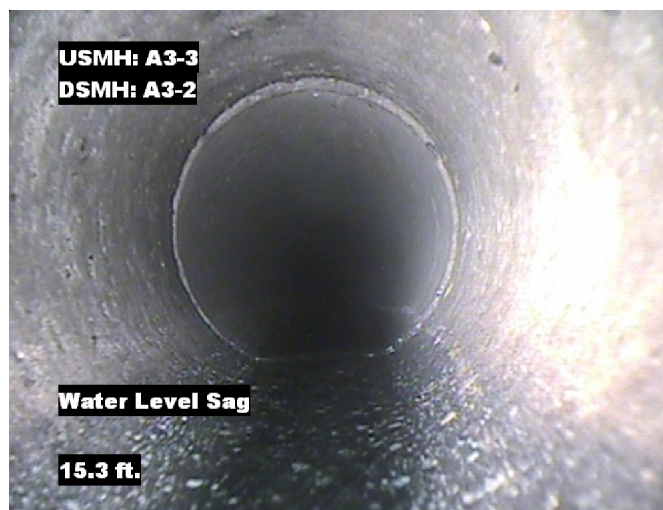
Distance: 15.3 ft. Grade: 2
Condition: Water Level Sag
Remarks: N/A

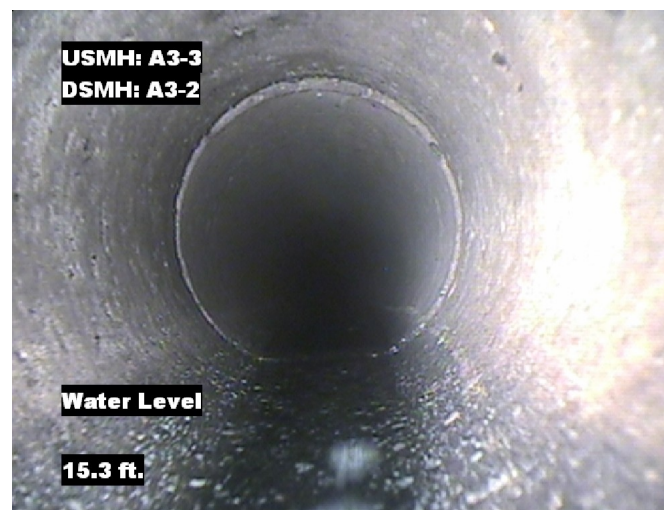
Distance: 15.3 ft. Grade: 0
Condition: Water Level
Remarks: N/A

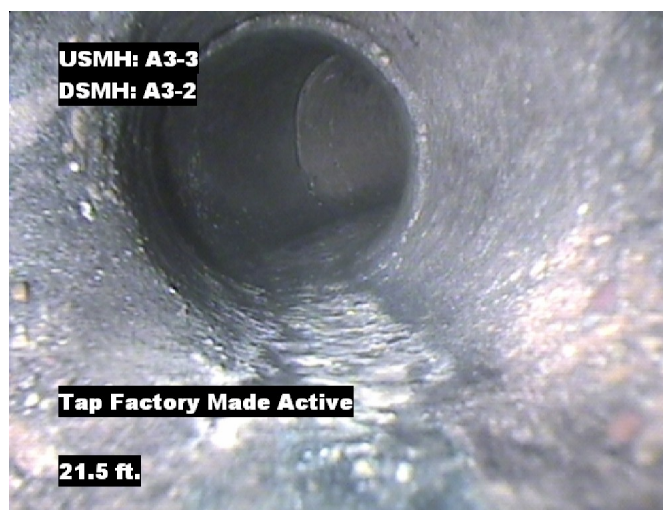
Distance: 21.5 ft. Grade: 0
Condition: Tap Factory Made Active
Remarks: N/A

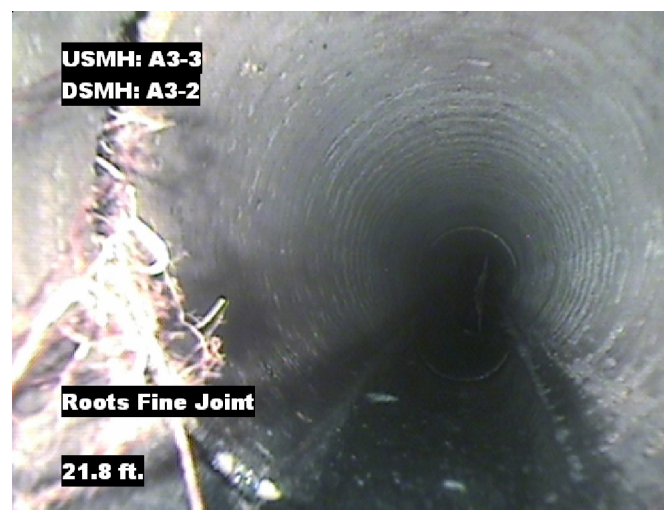
Distance: 21.8 ft. Grade: 1
Condition: Roots Fine Joint
Remarks: N/A

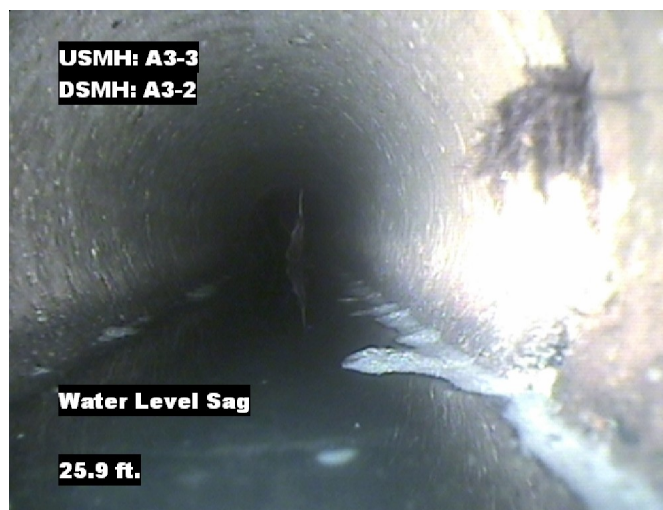
Distance: 25.9 ft. Grade: 2
Condition: Water Level Sag
Remarks: N/A

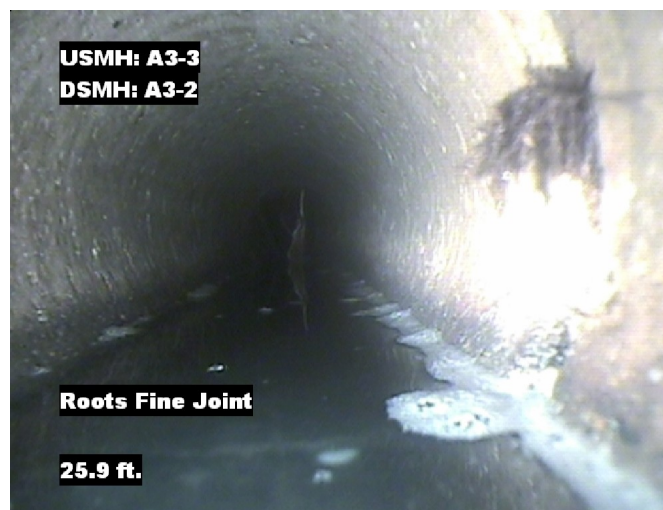
Distance: 25.9 ft. Grade: 1
Condition: Roots Fine Joint
Remarks: N/A

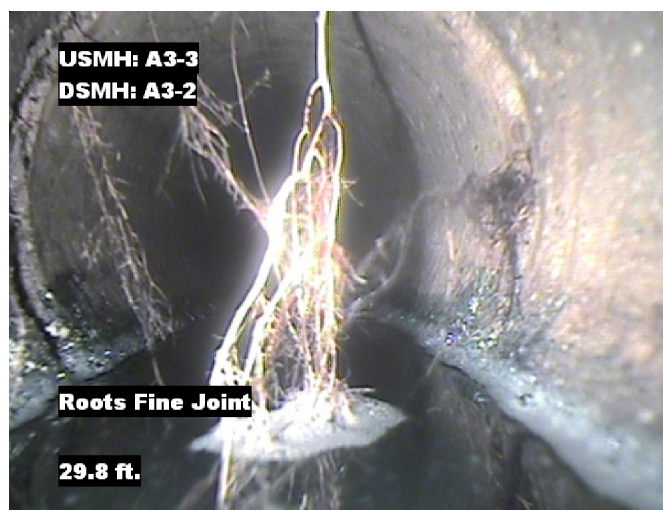
Distance: 29.8 ft. Grade: 1
Condition: Roots Fine Joint
Remarks: N/A

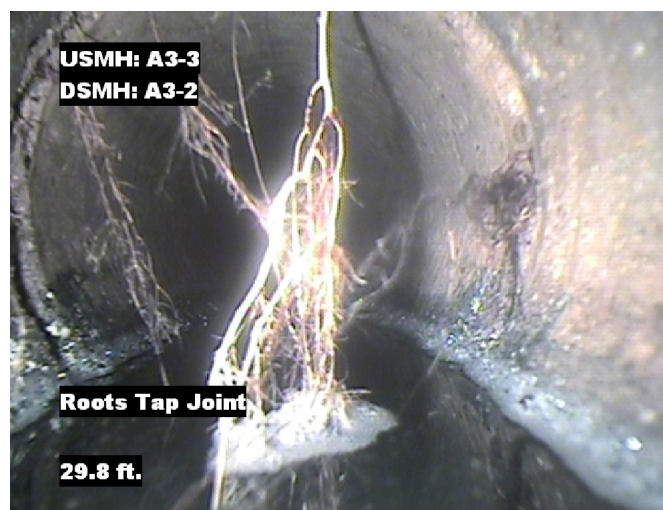
Distance: 29.8 ft. Grade: 2
Condition: Roots Tap Joint
Remarks: N/A

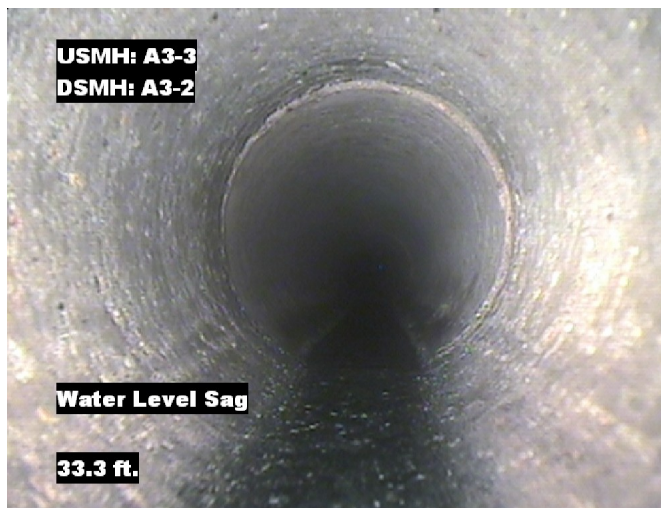
Distance: 33.3 ft. Grade: 2
Condition: Water Level Sag
Remarks: N/A

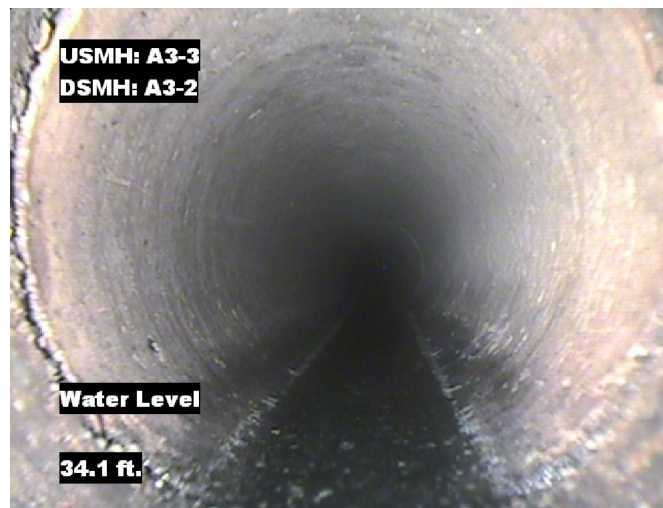
Distance: 34.1 ft. Grade: 0
Condition: Water Level
Remarks: N/A

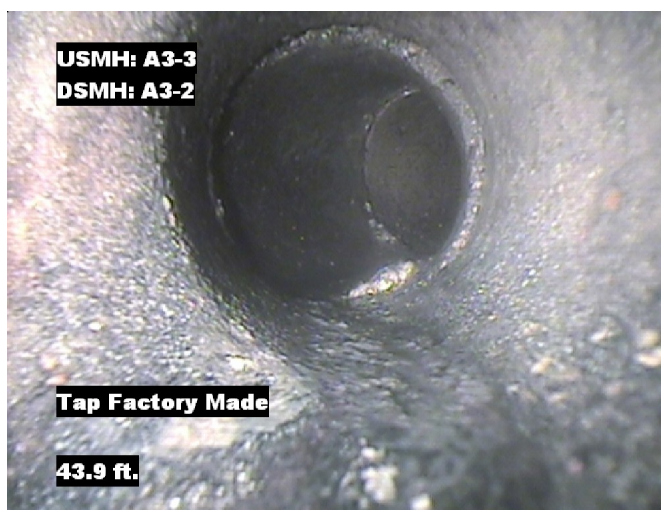
Distance: 43.9 ft. Grade: 0
Condition: Tap Factory Made
Remarks: N/A

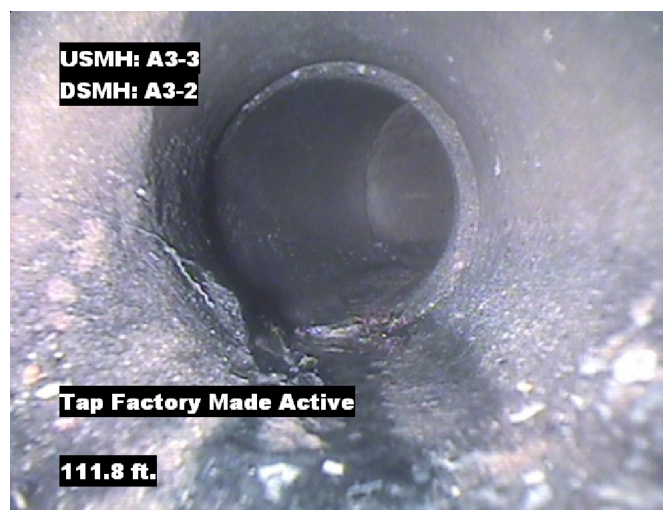
Distance: 111.8 ft. Grade: 0
Condition: Tap Factory Made Active
Remarks: N/A

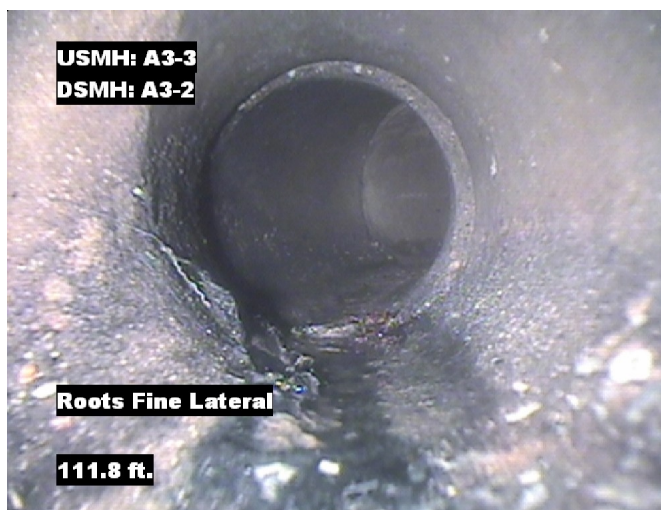
Distance: 111.8 ft. Grade: 1
Condition: Roots Fine Lateral
Remarks: N/A

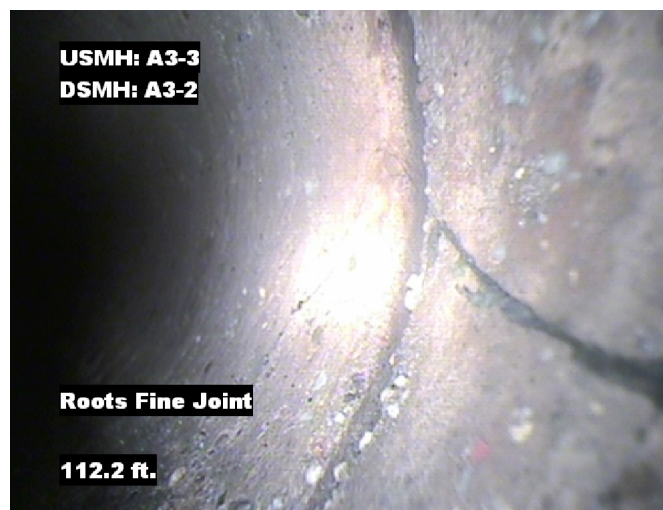
Distance: 112.2 ft. Grade: 1
Condition: Roots Fine Joint
Remarks: N/A

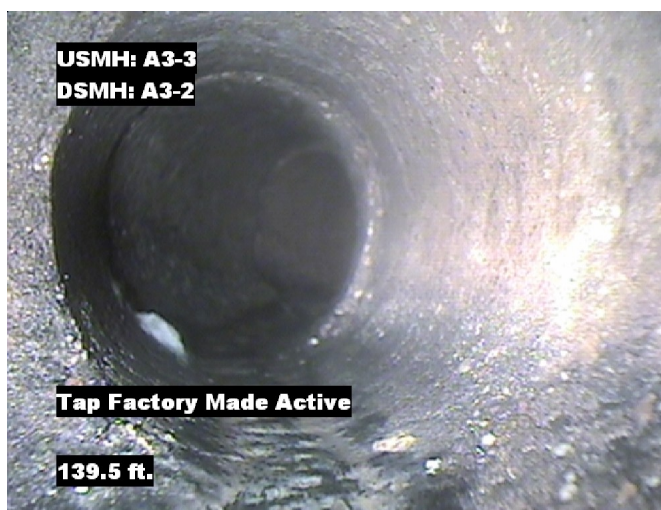
Distance: 139.5 ft. Grade: 0
Condition: Tap Factory Made Active
Remarks: N/A

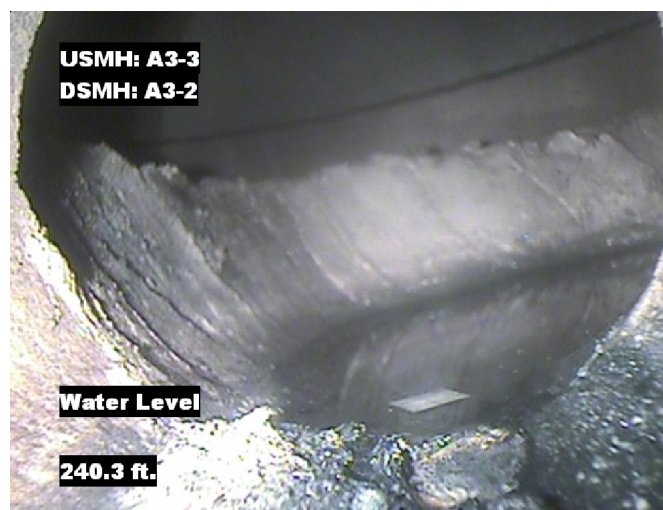
Distance: 240.3 ft. Grade: 0
Condition: Water Level
Remarks: N/A

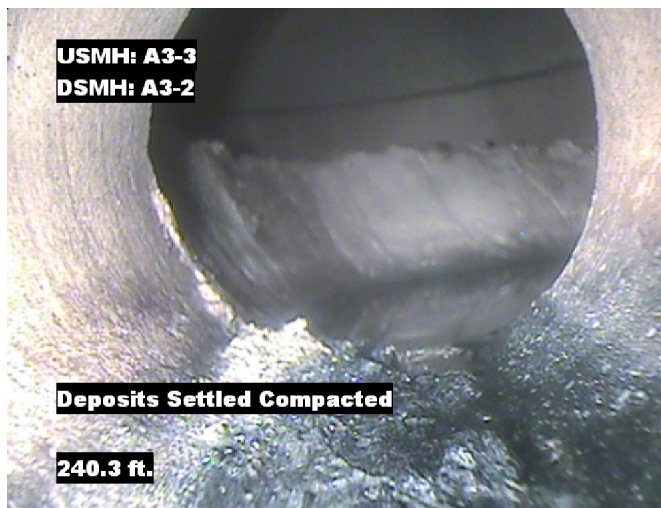
Distance: 240.3 ft. Grade: 2
Condition: Deposits Settled Compacted
Remarks: N/A
