Defect Listing

Pipe Segment Refere... A30-1_A20-4	City Oliver Springs	Street Ann St	Material Concrete Pipe (non-...	Location C... Yard	Sewer Use Sanitary
Upstream MH A30-1	Total Length 364.5	Year Laid	Shape Circular	Location Details	
DS Manhole A20-4	Length surveyed 364.5	Year Renewed	Height 8	Width 8	Pipe Joint... 4

SPR 8	MPR 23	PO Number 4397-03	Customer GRW
SPRI 2.7	MPRI 2.9	Work Order 4397-02	Purpose Pre-Rehabilitation Survey
QSR 5121	QMR 5141		
OPR 31	Surveyed By Charlie Gordon	Direction Downstream	Date 20150902
OPRI 2.8	Certificate Number U-615-07000491	Pre-Cleaning No Pre-Cleaning	Time 10:23
	Date Cleaned	End Time 11:05	Weather Dry
		Additional Info

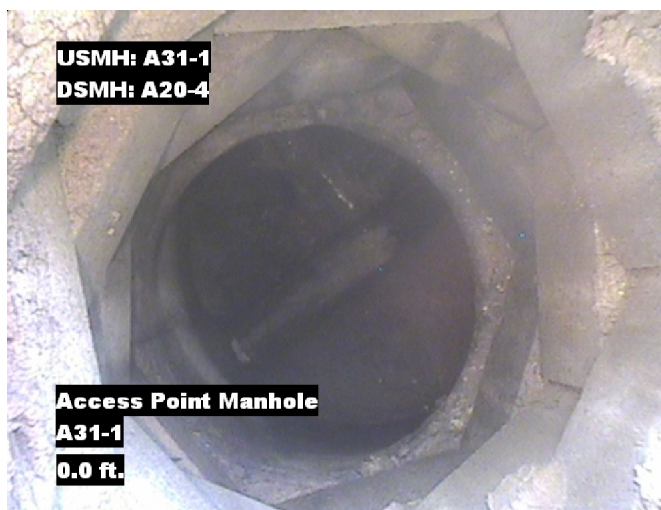
Distance: 0.0 ft. Grade: 0
Condition: Access Point Manhole
Remarks: A30-1

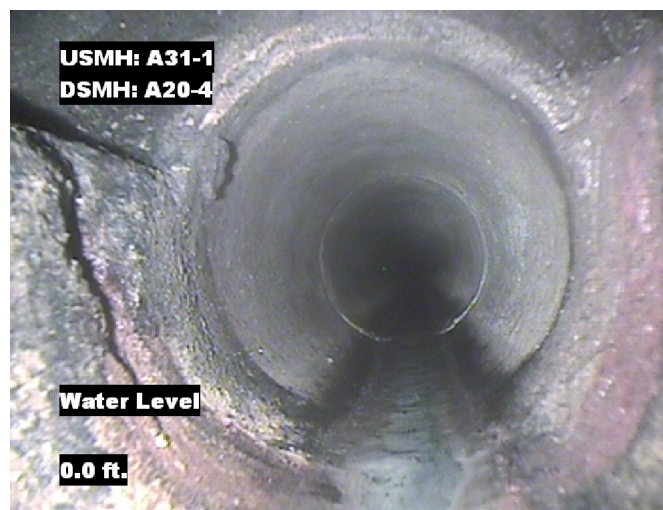
Distance: 0.0 ft. Grade: 0
Condition: Water Level
Remarks: N/A

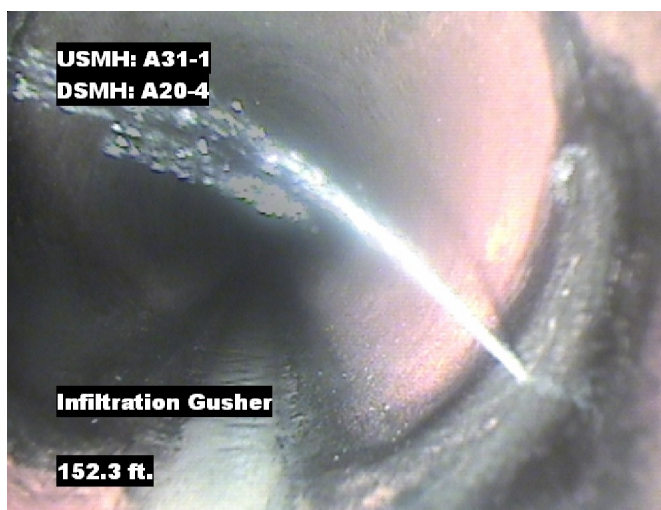
Distance: 152.3 ft. Grade: 5
Condition: Infiltration Gusher
Remarks: N/A

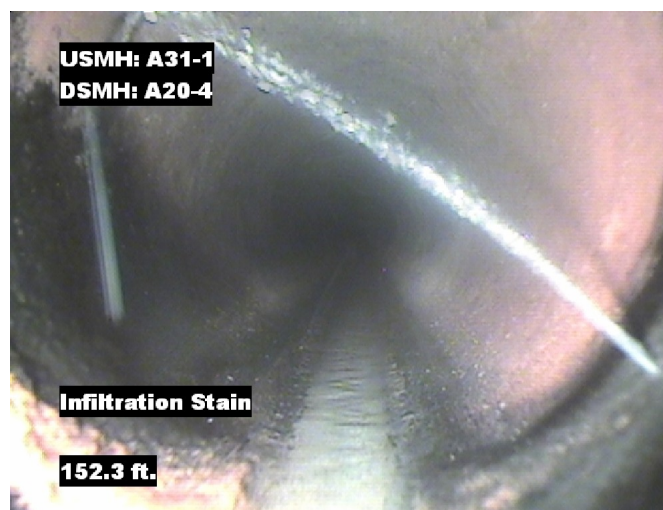
Distance: 152.3 ft. Grade: 0
Condition: Infiltration Stain
Remarks: N/A

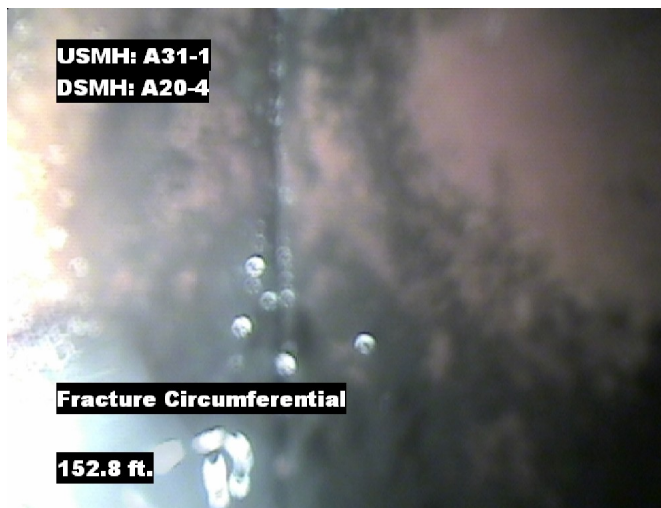
Distance: 152.8 ft. Grade: 2
Condition: Fracture Circumferential
Remarks: N/A

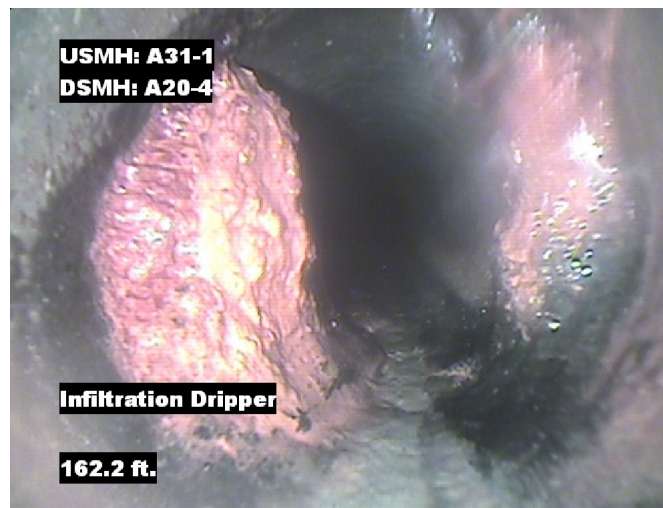
Distance: 162.2 ft. Grade: 3
Condition: Infiltration Dripper
Remarks: N/A

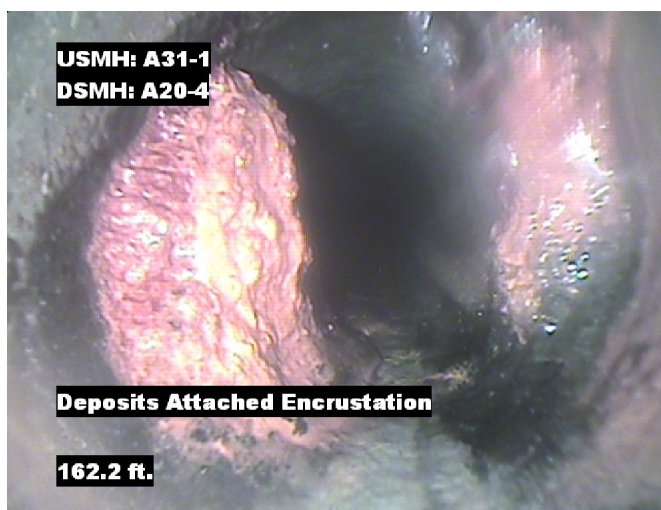
Distance: 162.2 ft. Grade: 3
Condition: Deposits Attached Encrustation
Remarks: N/A

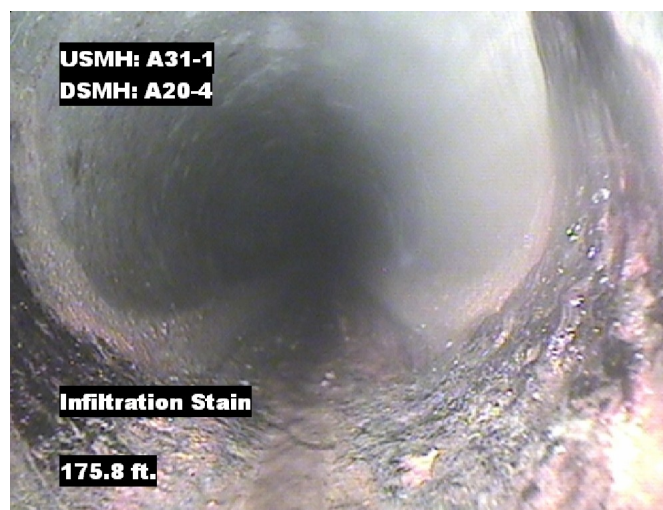
Distance: 175.8 ft. Grade: 0
Condition: Infiltration Stain
Remarks: N/A

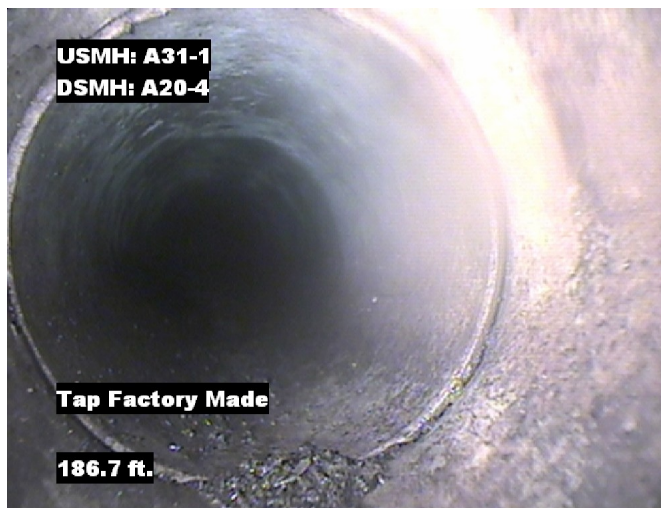
Distance: 186.7 ft. Grade: 0
Condition: Tap Factory Made
Remarks: N/A

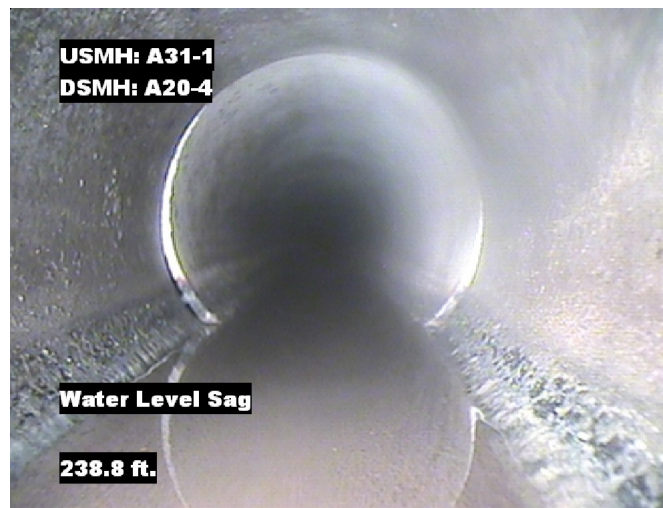
Distance: 238.8 ft. Grade: 2
Condition: Water Level Sag
Remarks: N/A

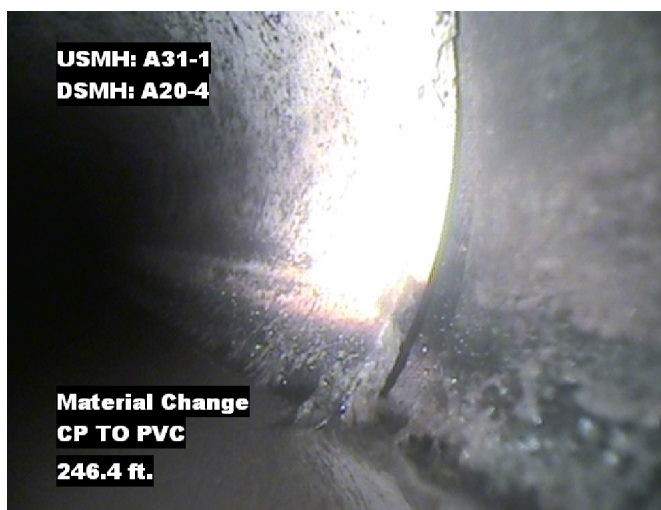
Distance: 246.4 ft. Grade: 0
Condition: Material Change
Remarks: CP TO PVC

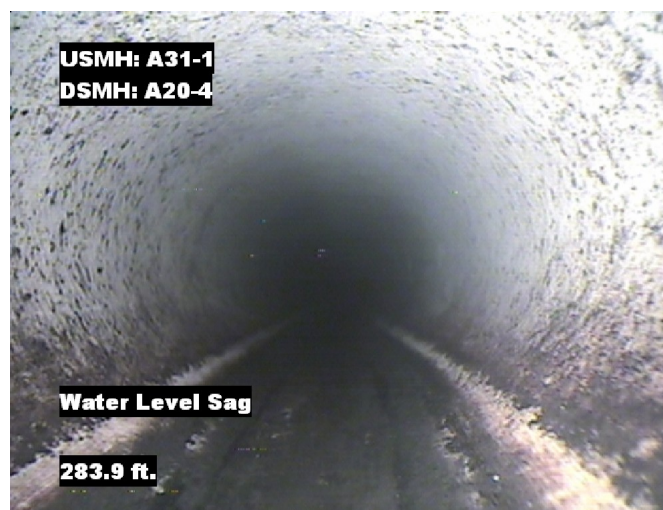
Distance: 283.9 ft. Grade: 2
Condition: Water Level Sag
Remarks: N/A

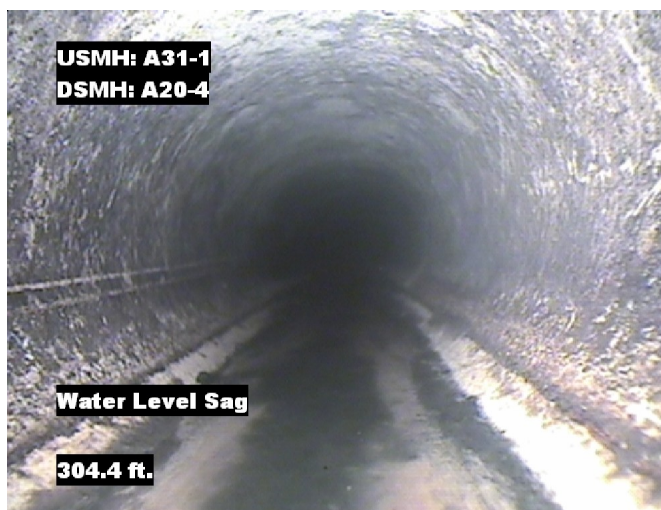
Distance: 304.4 ft. Grade: 2
Condition: Water Level Sag
Remarks: N/A

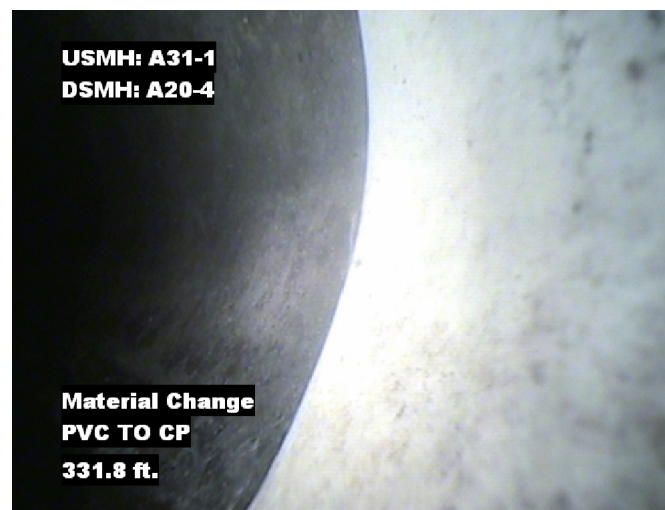
Distance: 331.8 ft. Grade: 0
Condition: Material Change
Remarks: PVC TO CP

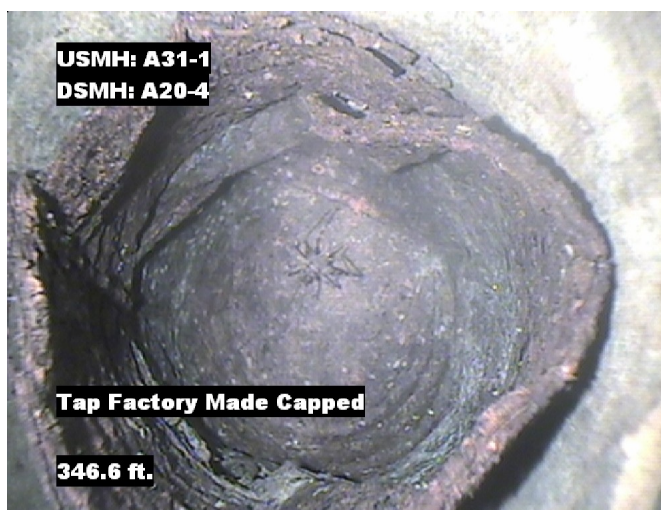
Distance: 346.6 ft. Grade: 0
Condition: Tap Factory Made Capped
Remarks: N/A

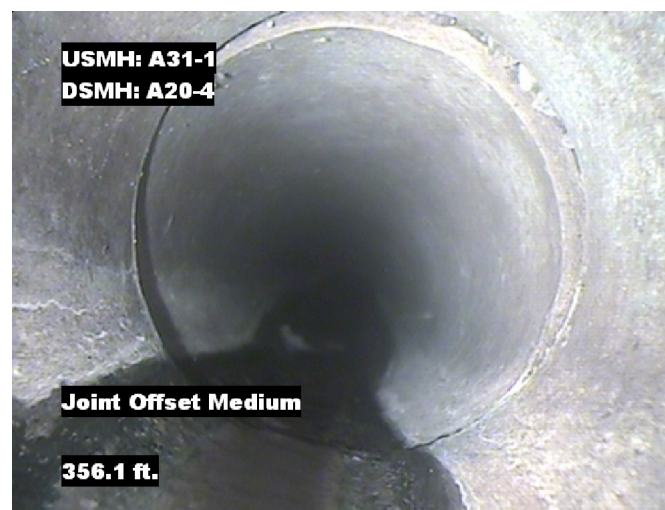
Distance: 356.1 ft. Grade: 1
Condition: Joint Offset Medium
Remarks: N/A

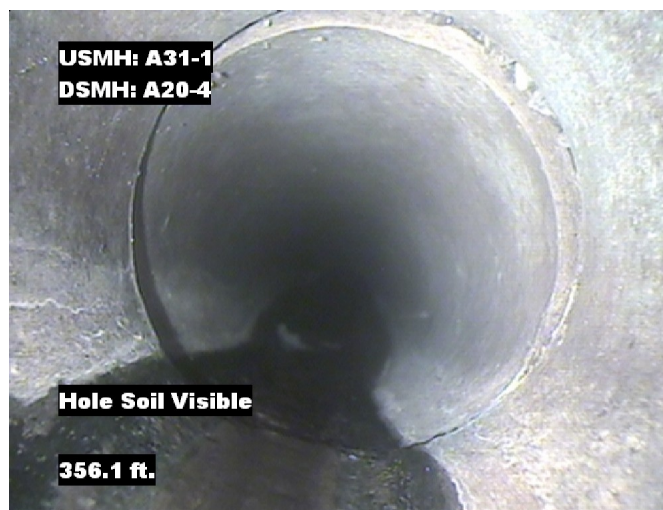
Distance: 356.1 ft. Grade: 5
Condition: Hole Soil Visible
Remarks: N/A

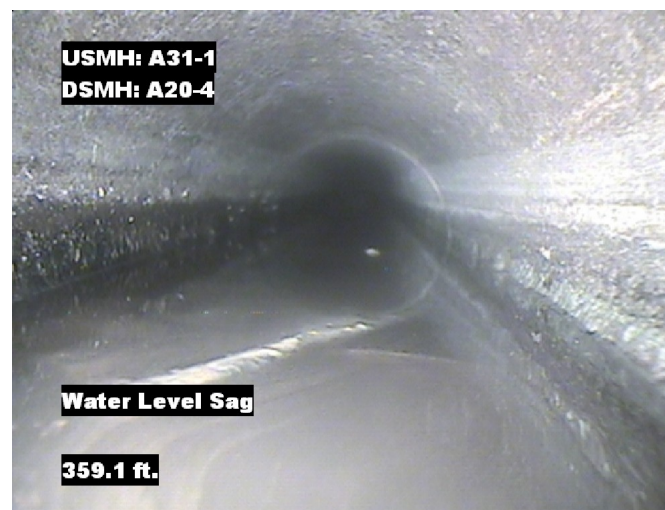
Distance: 359.1 ft. Grade: 2
Condition: Water Level Sag
Remarks: N/A

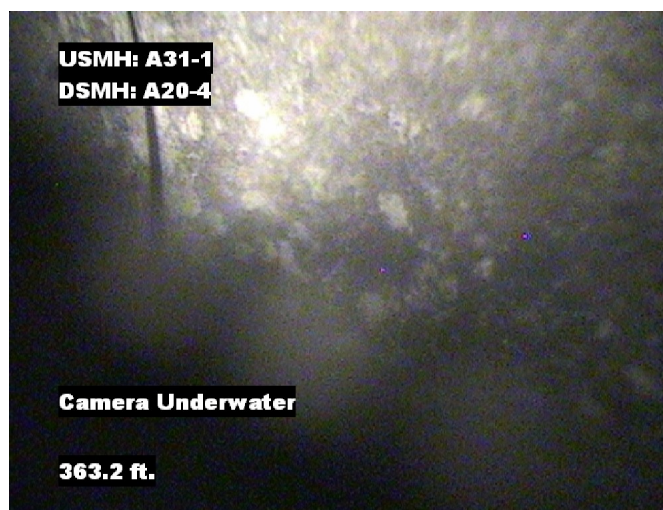
Distance: 363.2 ft. Grade: 4
Condition: Camera Underwater
Remarks: N/A

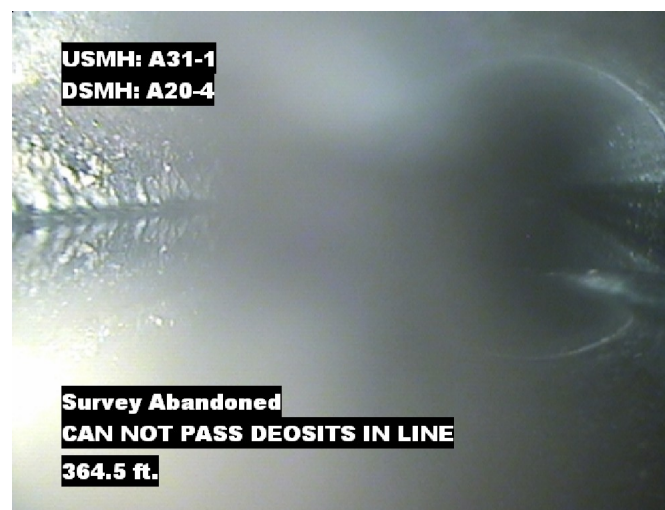
Distance: 364.5 ft. Grade: 0
Condition: Survey Abandoned
Remarks: CAN NOT PASS DEOSITS IN LINE

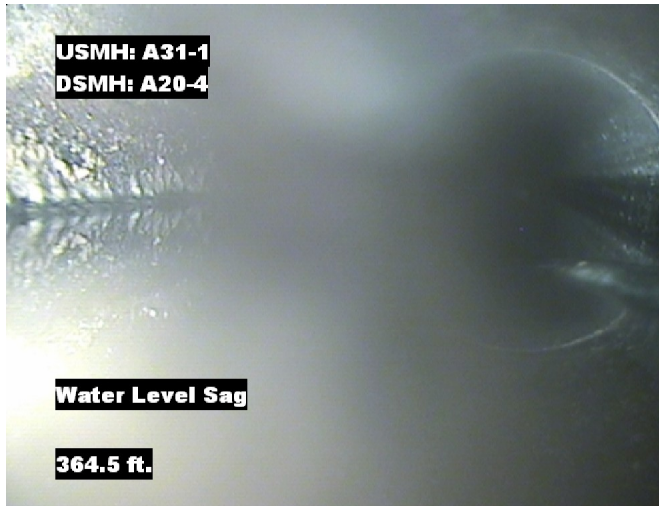
Distance: 364.5 ft. Grade: 2
Condition: Water Level Sag
Remarks: N/A
