## Defect Listing

Pipe Segment Refere... <b>A30-2_A30-1</b>	City <b>Oliver Springs</b>	Street <b>Ann St.</b>	Material <b>Concrete Pipe (non-...</b>	Location C... <b>Yard</b>	Sewer Use <b>Sanitary</b>
Upstream MH <b>A30-2</b>	Total Length <b>283.7</b>	Year Laid	Shape <b>Circular</b>	Location Details	
DS Manhole <b>A30-1</b>	Length surveyed <b>283.7</b>	Year Renewed	Height <b>8</b>	Width <b>8</b>	Pipe Joint... <b>4</b>

SPR <b>N/A</b>	MPR <b>5</b>	PO Number <b>4397-03</b>	Customer <b>GRW</b>
SPRI <b>N/A</b>	MPRI <b>5</b>	Work Order <b>4397-02</b>	Purpose <b>Pre-Rehabilitation Survey</b>
QSR <b>N/A</b>	QMR <b>5100</b>		
OPR <b>5</b>	Surveyed By <b>Barry Rogers</b>	Direction <b>Downstream</b>	Date <b>20150731</b>
OPRI <b>5</b>	Certificate Number <b>U-1012-16405</b>	Pre-Cleaning <b>Jetting</b>	Time <b>14:36</b>
	Date Cleaned <b>20150731</b>	End Time <b>14:50</b>	Weather <b>Dry</b>
			Media label
			Additional Info

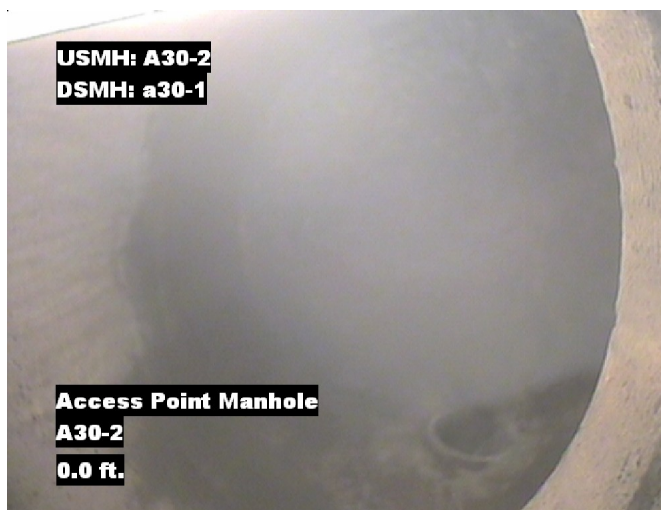
Distance: 0.0 ft. Grade: 0  
Condition: Access Point Manhole  
Remarks: A30-2

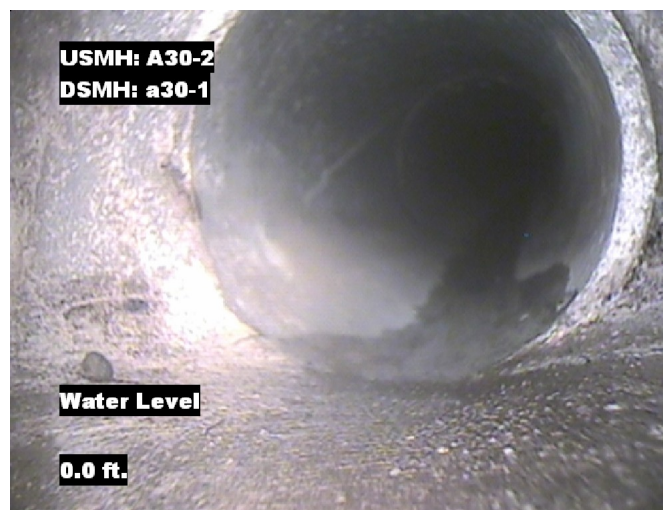
Distance: 0.0 ft. Grade: 0  
Condition: Water Level  
Remarks: N/A

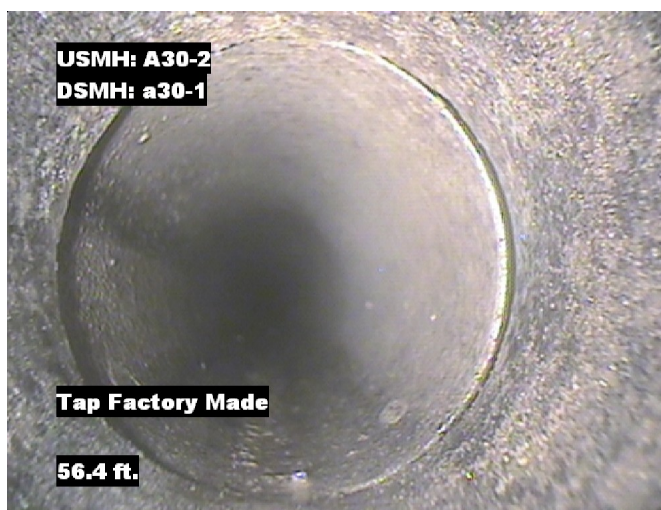
Distance: 56.4 ft. Grade: 0  
Condition: Tap Factory Made  
Remarks: N/A

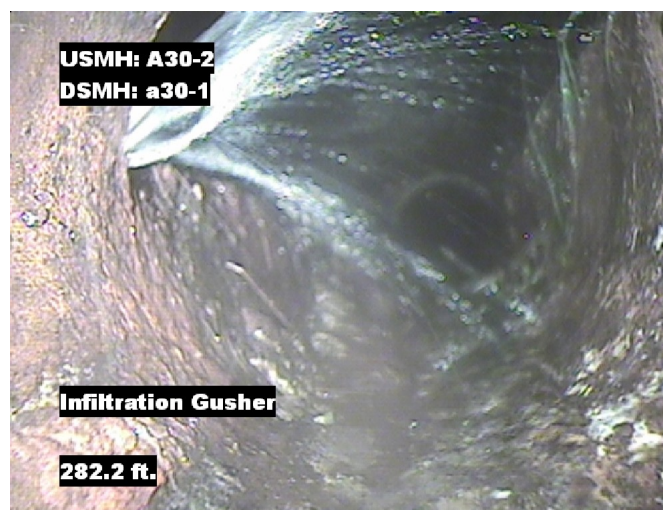
Distance: 282.2 ft. Grade: 5  
Condition: Infiltration Gusher  
Remarks: N/A

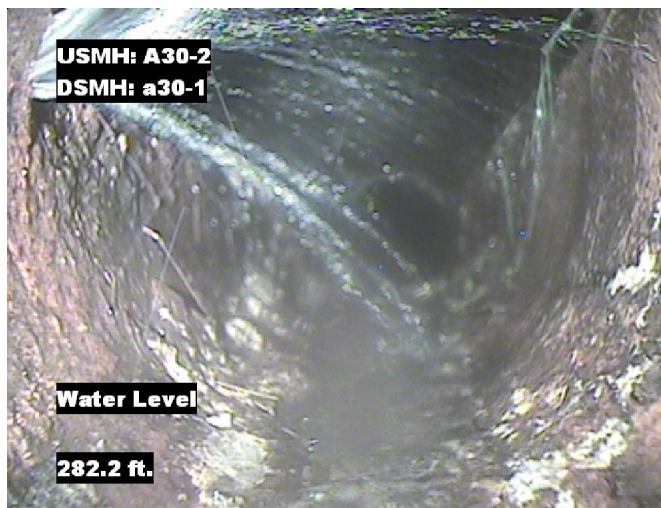
Distance: 282.2 ft.      Grade: 0  
Condition: Water Level  
Remarks: N/A

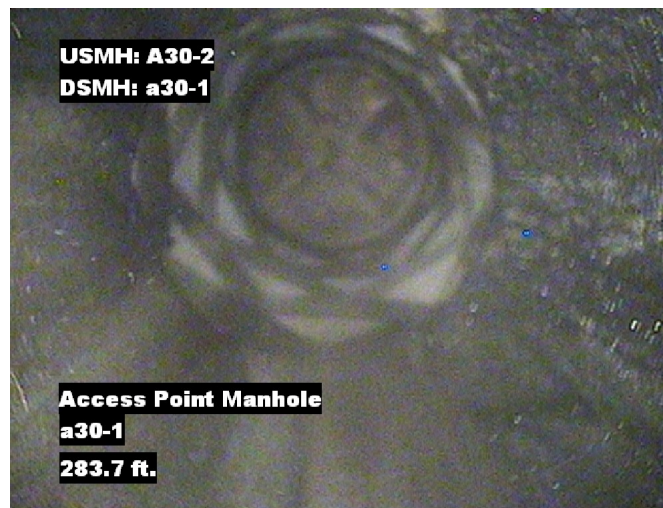
Distance: 283.7 ft.      Grade: 0  
Condition: Access Point Manhole  
Remarks: a30-1
