Defect Listing

Pipe Segment Refere... A31-1_A-48	City Oliver Springs	Street Vanhook Ct.	Material Concrete Pipe (non-...	Location C... Yard	Sewer Use Sanitary
Upstream MH A31-1	Total Length 118.2	Year Laid	Shape Circular	Location Details	
DS Manhole A-48	Length surveyed 118.2	Year Renewed	Height 8	Width 8	Pipe Joint... 4

SPR 2	MPR 9	PO Number 4397-03	Customer GRW
SPRI 2	MPRI 2.3	Work Order 4397-02	Purpose Pre-Rehabilitation Survey
QSR 2100	QMR 3123		
OPR 11	Surveyed By Charlie Gordon	Direction Downstream	Date 20150901
OPRI 2.2	Certificate Number U-615-07000491	Pre-Cleaning No Pre-Cleaning	Time 12:47
	Date Cleaned	End Time 13:00	Weather Dry
		Additional Info

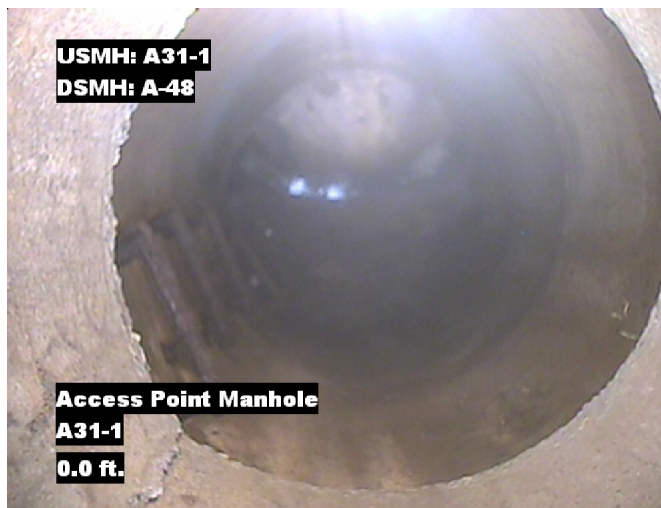
Distance: 0.0 ft. Grade: 0
Condition: Access Point Manhole
Remarks: A31-1

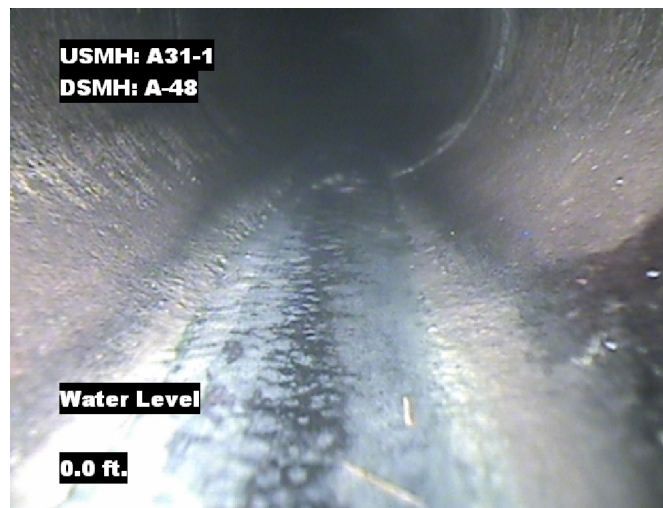
Distance: 0.0 ft. Grade: 0
Condition: Water Level
Remarks: N/A

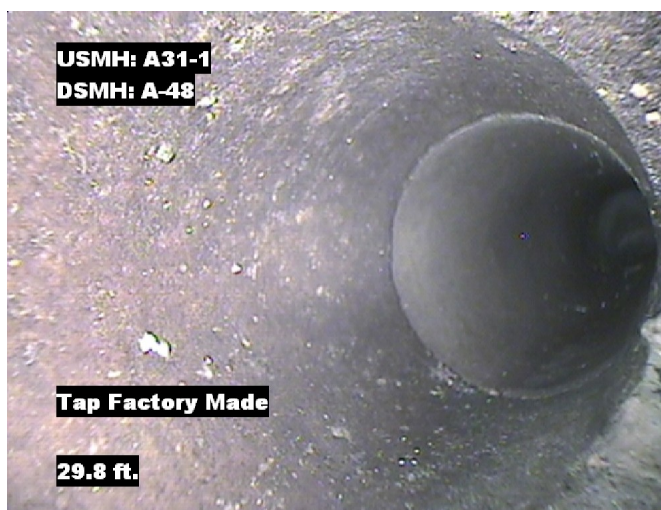
Distance: 29.8 ft. Grade: 0
Condition: Tap Factory Made
Remarks: N/A

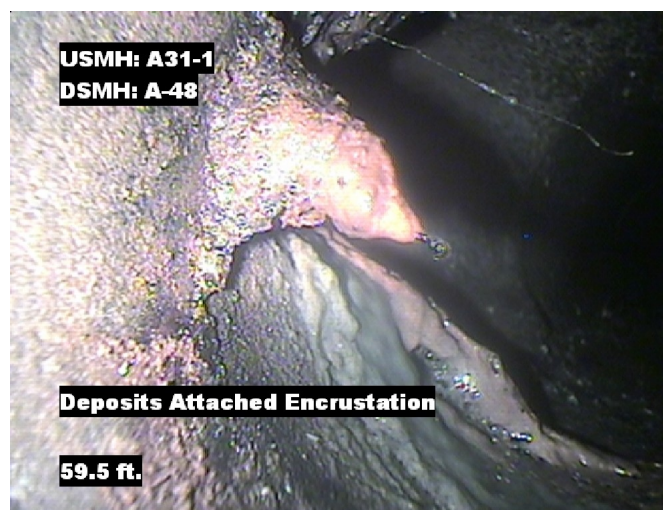
Distance: 59.5 ft. Grade: 2
Condition: Deposits Attached Encrustation
Remarks: N/A

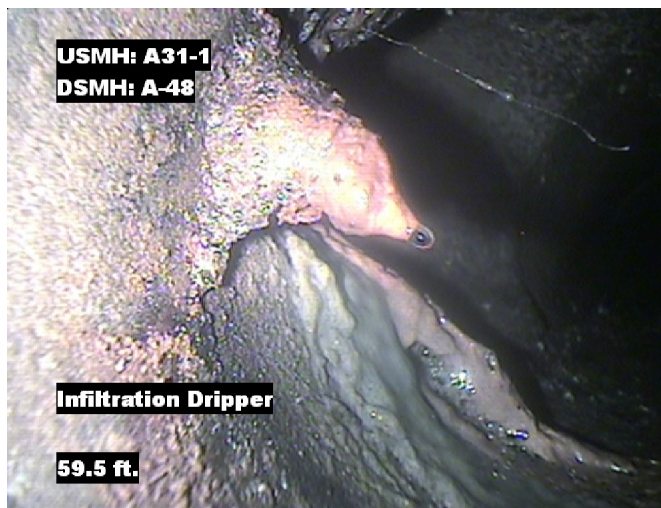
Distance: 59.5 ft. Grade: 3
Condition: Infiltration Dripper
Remarks: N/A

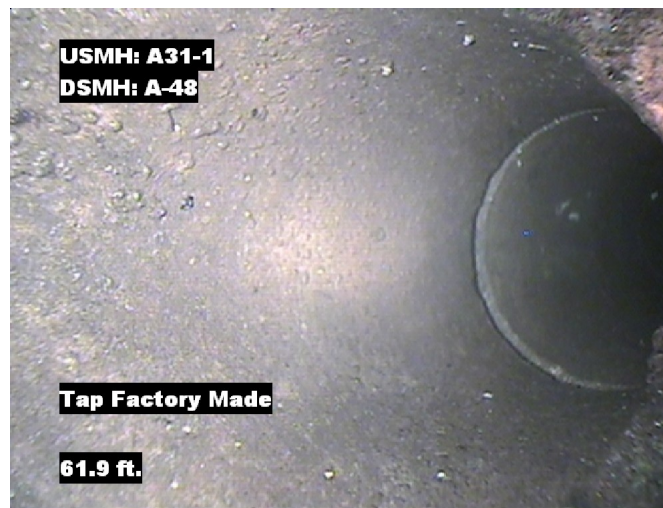
Distance: 61.9 ft. Grade: 0
Condition: Tap Factory Made
Remarks: N/A

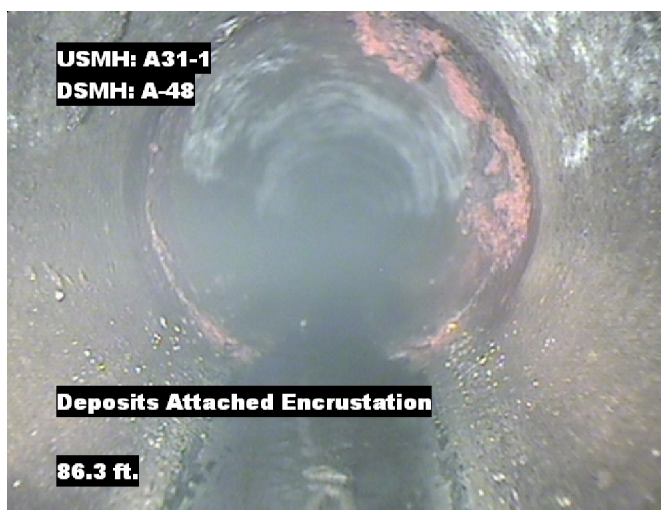
Distance: 86.3 ft. Grade: 2
Condition: Deposits Attached Encrustation
Remarks: N/A

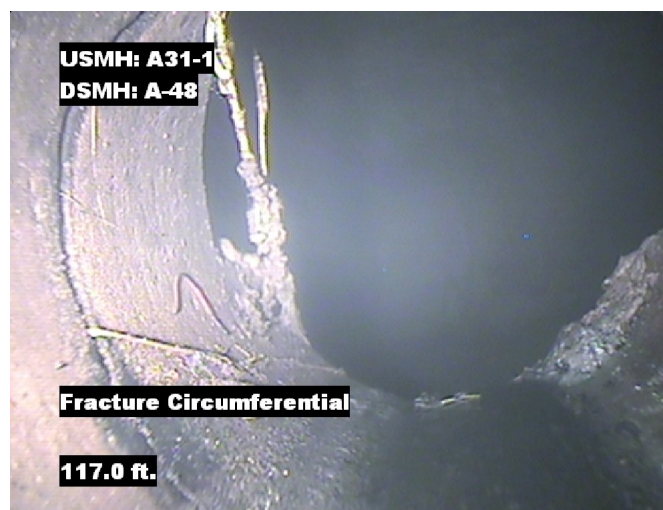
Distance: 117.0 ft. Grade: 2
Condition: Fracture Circumferential
Remarks: N/A

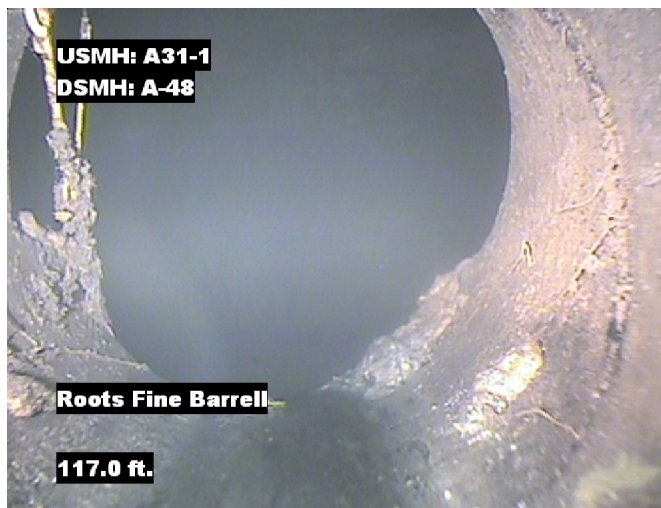
Distance: 117.0 ft. Grade: 2
Condition: Roots Fine Barrell
Remarks: N/A

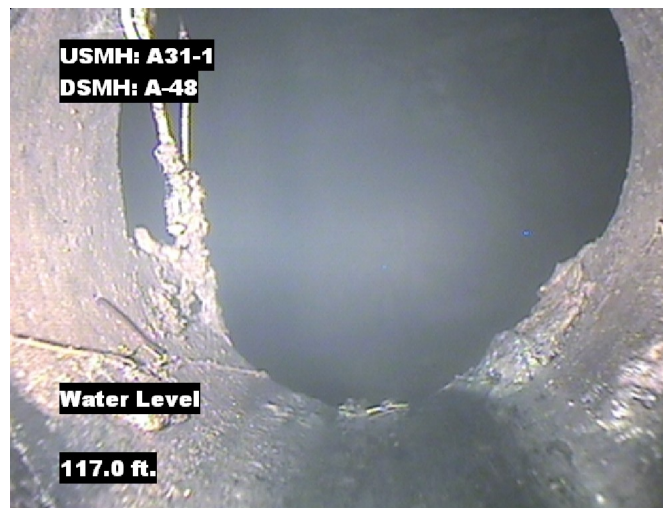
Distance: 117.0 ft. Grade: 0
Condition: Water Level
Remarks: N/A

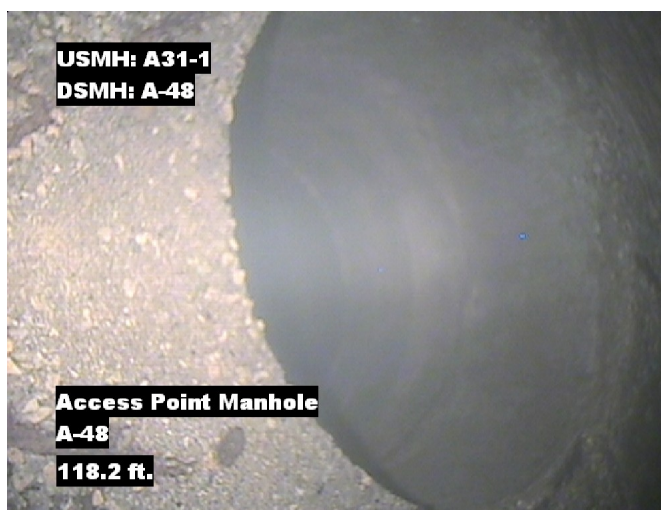
Distance: 118.2 ft. Grade: 0
Condition: Access Point Manhole
Remarks: A-48
