# **Defect Listing**

Pipe Segment Refere		С	ity	Street	Mat	Material		Sewer Use
A31-2_A31-1 Oliver Springs		Van hook Ct.	Concrete F	Concrete Pipe (non		Sanitary		
Upstre	am MH	Total	Length	Year Laid	Sh	Shape Circular		Details
A3	1-2	20	9.6		Circ			
DS M	anhole	Length surveyed 209.6		Year Renewed	Height	Width	Pipe Joint	
A3	1-1				8	8	4	
SPR	6	MPR	12	4397-03 GR		Customer		
						GRW Purpose		
SPRI	3	MPRI	2					
QSR	3200	QMR	2600	4397-02		Pre-Rehabilitation Survey		
Ol	PR	Surve	yed By	Direction	Da	ate	Media label	
1	8	Charlie Gordon		Downstream	2015	20150825		
OF	PRI	Certificate Number		Pre-Cleaning	Time		Weather	
2	2.3		7000491	Jetting	15	15:06 I End Time		
		Date C	Cleaned	End				Additional Info
20150825					15:21

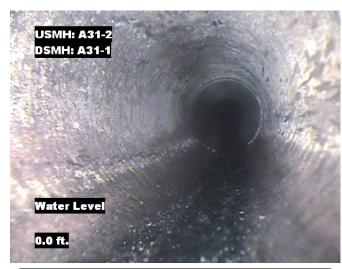
Distance: 0.0 ft. Grade: 0

Condition: Water Level

Remarks: N/A

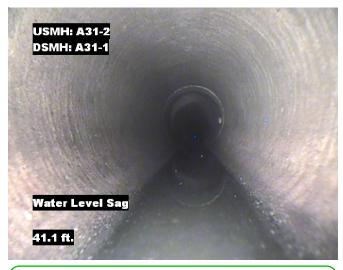
Distance: 41.1 ft. Grade: 2

Condition: Water Level Sag

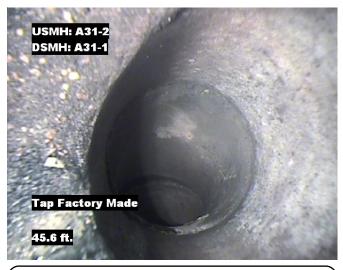
Distance: 45.6 ft. Grade: 0

Condition: Tap Factory Made

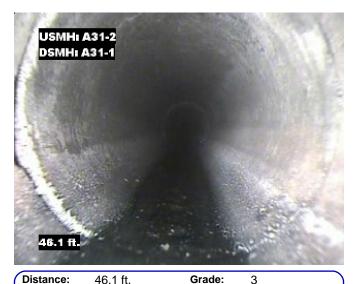
Distance: 46.1 ft

Condition: Hole Remarks: N/A

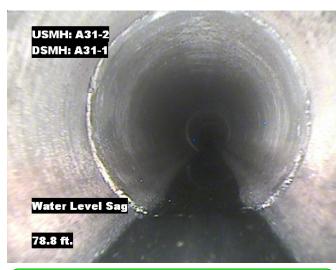
Distance: 78.7 ft. Grade: 2

Condition: Water Level Sag

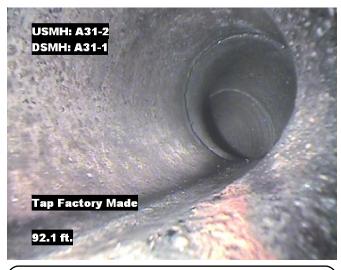
Distance: 92.1 ft. Grade: 0

Condition: Tap Factory Made

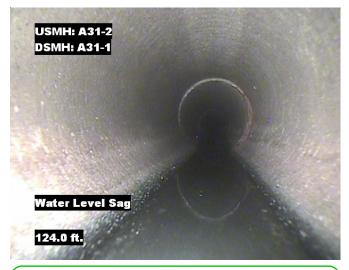
Distance: 123.9 ft. Grade: 2

Condition: Water Level Sag

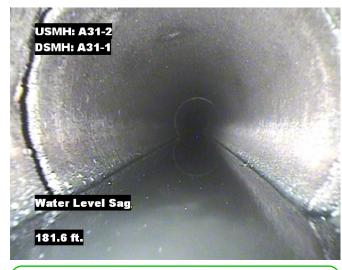
Distance: 181.6 ft. Grade: 2

Condition: Water Level Sag

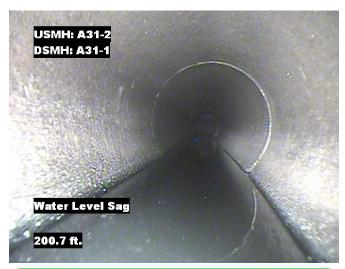
Distance: 200,7 ft. Grade: 2

Condition: Water Level Sag

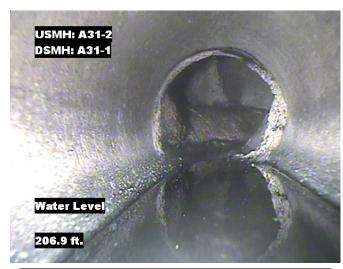
Distance: 206.8 ft. Grade: 0

Condition: Water Level

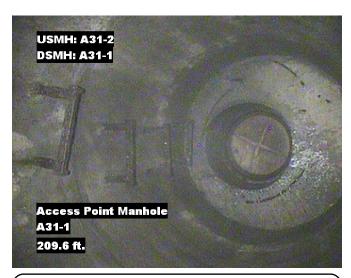
Distance: 209.6 ft. Grade: 0
Condition: Access Point Manhole

Remarks: A31-1
