Defect Listing

Pipe Segment Refere... A31-3_A31-2	City Oliver Springs	Street Van hook Ct.	Material Concrete Pipe (non-...	Location C... Light High...	Sewer Use Sanitary
Upstream MH A31-3	Total Length 225.9	Year Laid	Shape Circular	Location Details	
DS Manhole A31-2	Length surveyed 225.9	Year Renewed	Height 8	Width 8	Pipe Joint... 4

SPR 8	MPR 12	PO Number 4397-03		Customer GRW	
SPRI 2.7	MPRI 2	Work Order 4397-02		Purpose Pre-Rehabilitation Survey	
QSR 3221	QMR 2600				
OPR 20	Surveyed By Charlie Gordon	Direction Downstream	Date 20150825	Media label	
OPRI 2.2	Certificate Number U-615-07000491	Pre-Cleaning Jetting	Time 14:31	Weather Dry	
Date Cleaned 20150825			End Time 14:45	Additional Info

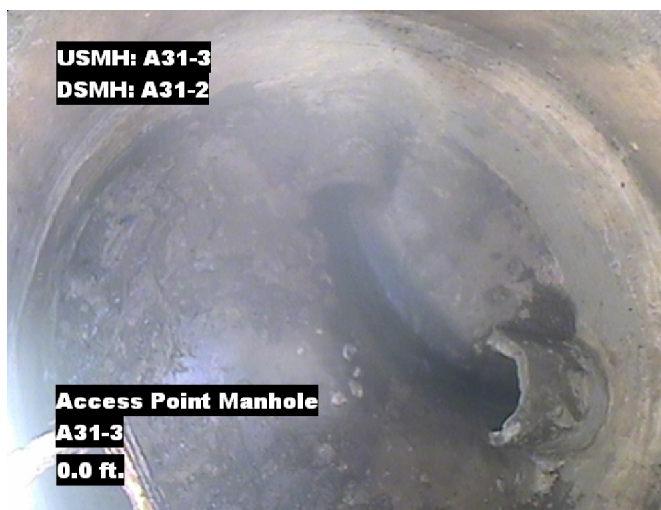
Distance: 0.0 ft. Grade: 0
Condition: Access Point Manhole
Remarks: A31-3

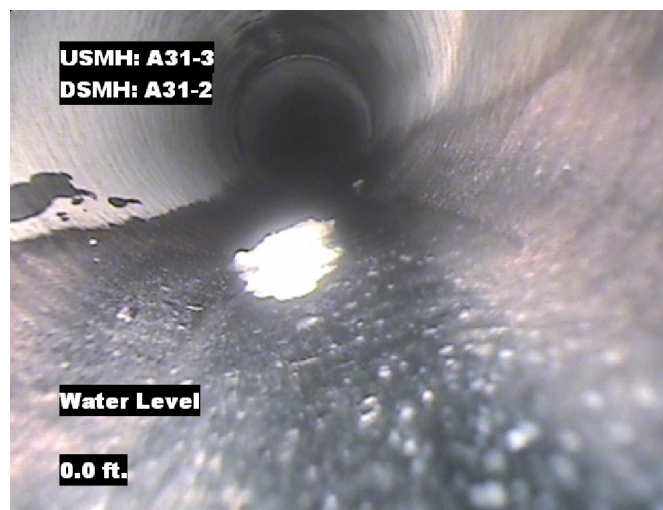
Distance: 0.0 ft. Grade: 0
Condition: Water Level
Remarks: N/A

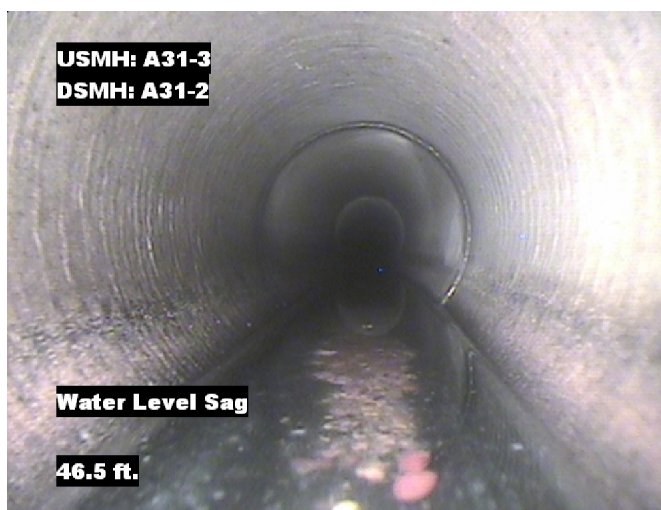
Distance: 46.5 ft. Grade: 2
Condition: Water Level Sag
Remarks: N/A

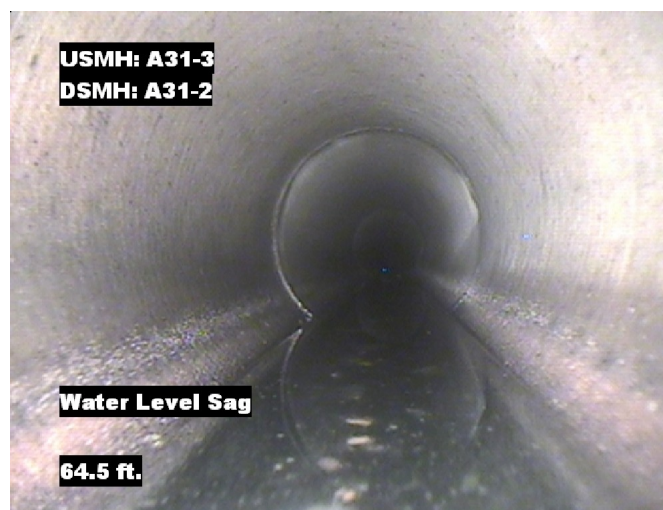
Distance: 64.5 ft. Grade: 2
Condition: Water Level Sag
Remarks: N/A

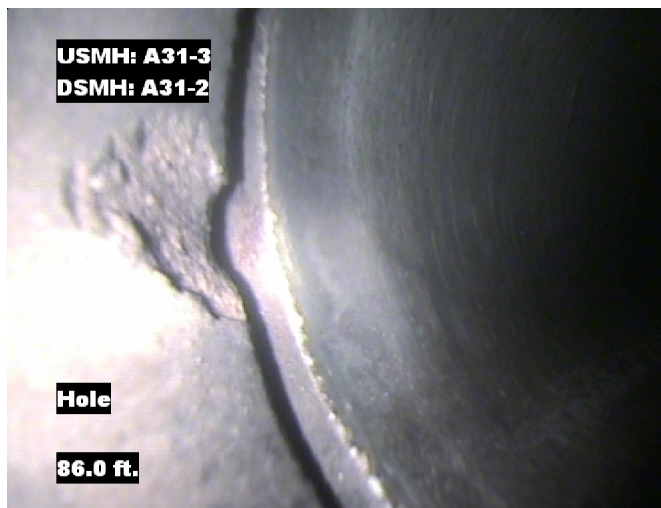
Distance: 86.0 ft. Grade: 3
Condition: Hole
Remarks: N/A

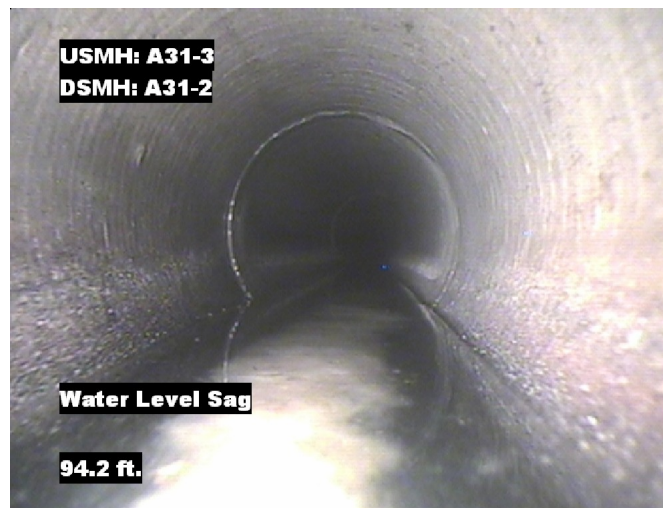
Distance: 94.2 ft. Grade: 2
Condition: Water Level Sag
Remarks: N/A

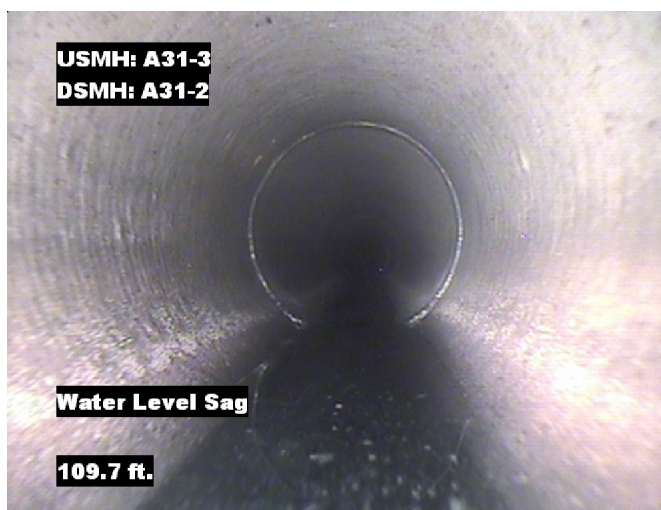
Distance: 109.6 ft. Grade: 2
Condition: Water Level Sag
Remarks: N/A

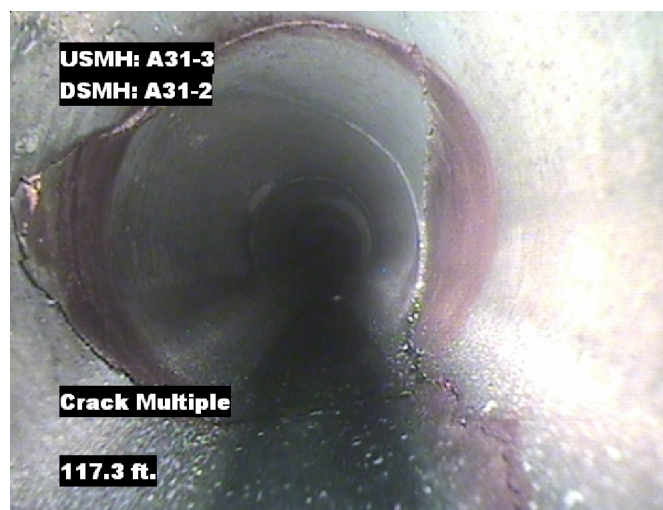
Distance: 117.3 ft. Grade: 3
Condition: Crack Multiple
Remarks: N/A

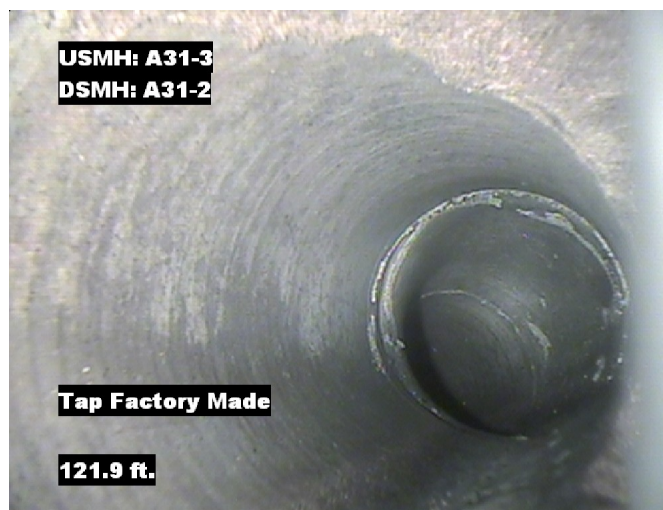
Distance: 121.9 ft. Grade: 0
Condition: Tap Factory Made
Remarks: N/A

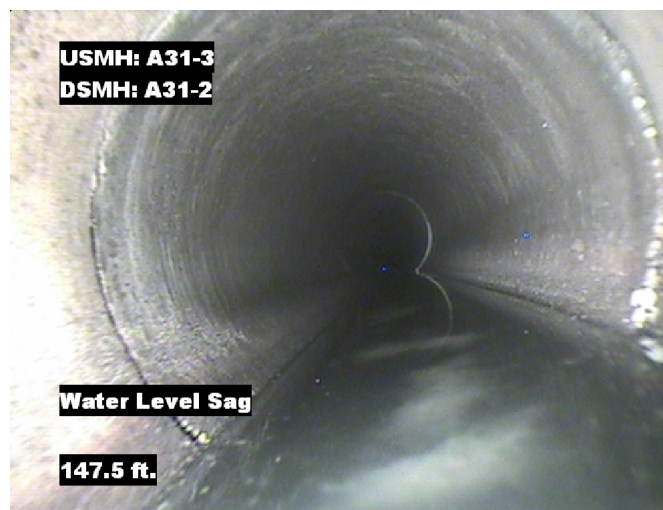
Distance: 147.5 ft. Grade: 2
Condition: Water Level Sag
Remarks: N/A

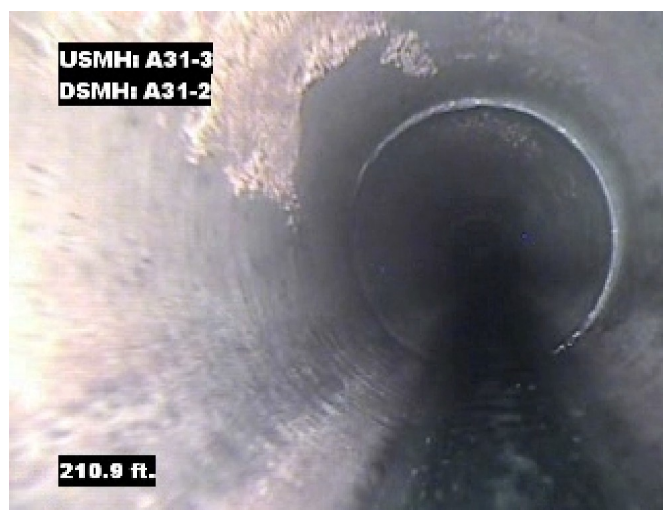
Distance: 210.8 ft. Grade: 2
Condition: Deposits Attached Grease
Remarks: N/A

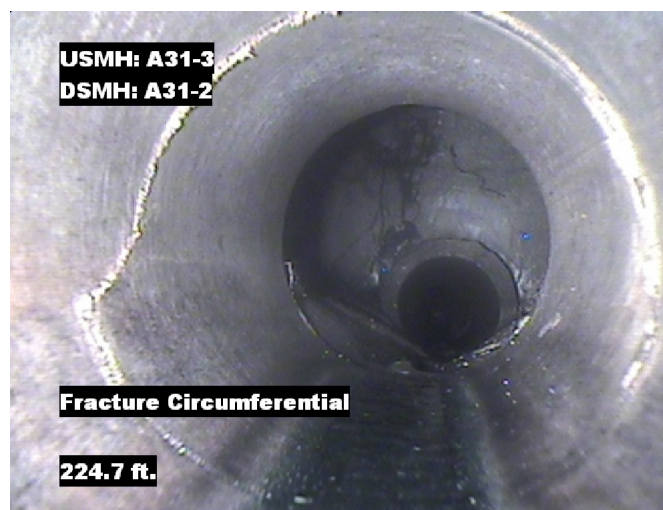
Distance: 224.7 ft. Grade: 2
Condition: Fracture Circumferential
Remarks: N/A

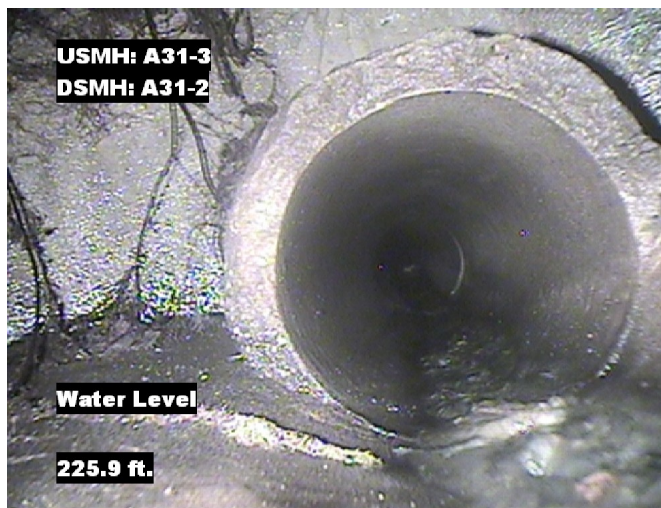
Distance: 225.9 ft. Grade: 0
Condition: Water Level
Remarks: N/A

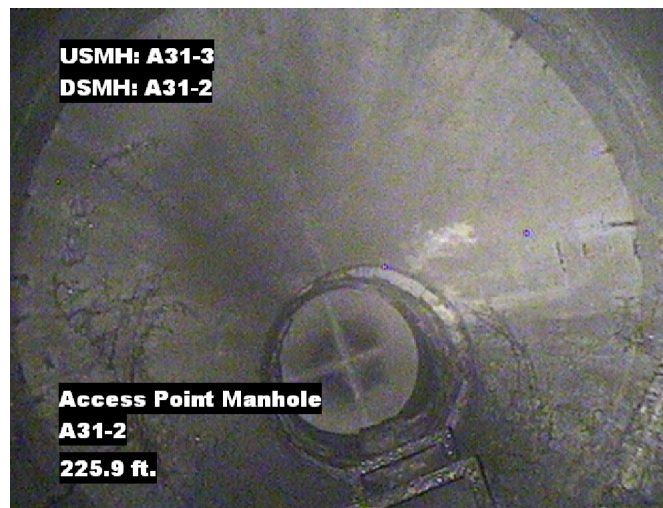
Distance: 225.9 ft. Grade: 0
Condition: Access Point Manhole
Remarks: A31-2
