## Defect Listing

Pipe Segment Refere... <b>A32-1_A-58</b>	City <b>Oliver SPings</b>	Street <b>Windrock Rd</b>	Material <b>Concrete Pipe (non-...</b>	Location C... <b>Easement/R...</b>	Sewer Use <b>Sanitary</b>
Upstream MH <b>A32-1</b>	Total Length <b>268.4</b>	Year Laid	Shape <b>Circular</b>	Location Details	
DS Manhole <b>A-58</b>	Length surveyed <b>268.4</b>	Year Renewed	Height <b>8</b>	Width <b>8</b>	Pipe Joint... <b>4</b>

SPR <b>N/A</b>	MPR <b>13</b>	PO Number <b>4397-03</b>	Customer <b>GRW</b>
SPRI <b>N/A</b>	MPRI <b>4.3</b>	Work Order <b>4397-02</b>	Purpose <b>Pre-Rehabilitation Survey</b>
QSR <b>N/A</b>	QMR <b>5142</b>		
OPR <b>13</b>	Surveyed By <b>Barry Rogers</b>	Direction <b>Downstream</b>	Date <b>20150728</b>
OPRI <b>4.3</b>	Certificate Number <b>U-1012-16405</b>	Pre-Cleaning <b>Jetting</b>	Time <b>13:05</b>
	Date Cleaned <b>20150728</b>	End Time <b>13:26</b>	Weather <b>Dry</b>
			Media label
			Additional Info

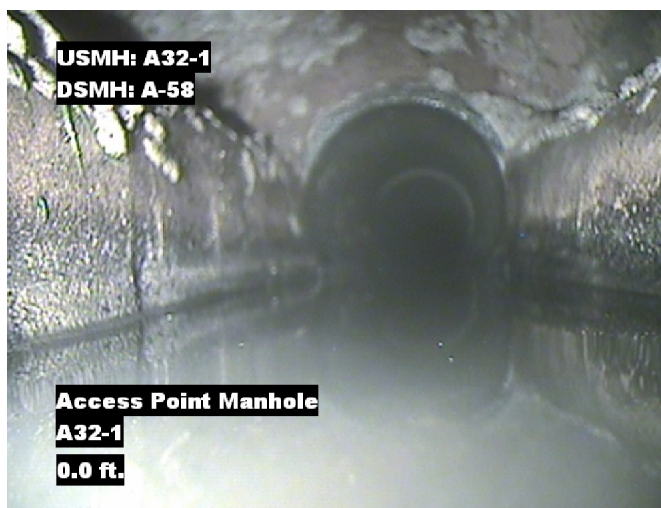
Distance: 0.0 ft. Grade: 0  
Condition: Access Point Manhole  
Remarks: A32-1

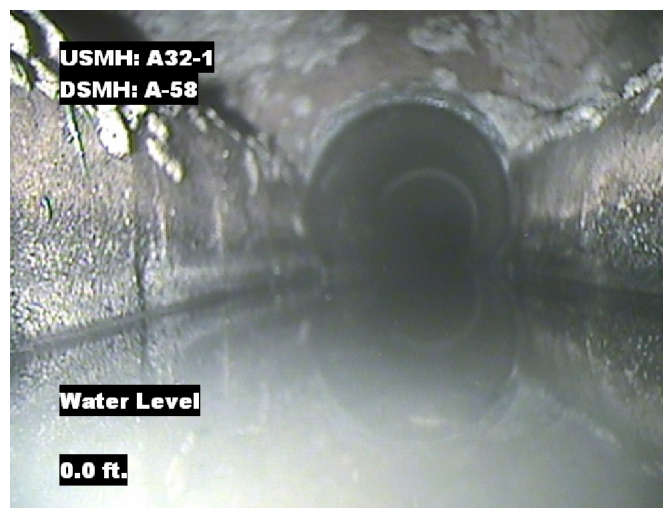
Distance: 0.0 ft. Grade: 0  
Condition: Water Level  
Remarks: N/A

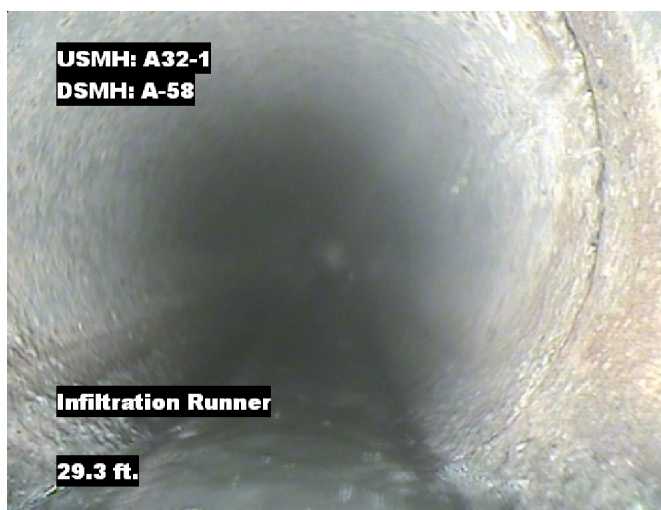
Distance: 29.3 ft. Grade: 4  
Condition: Infiltration Runner  
Remarks: N/A

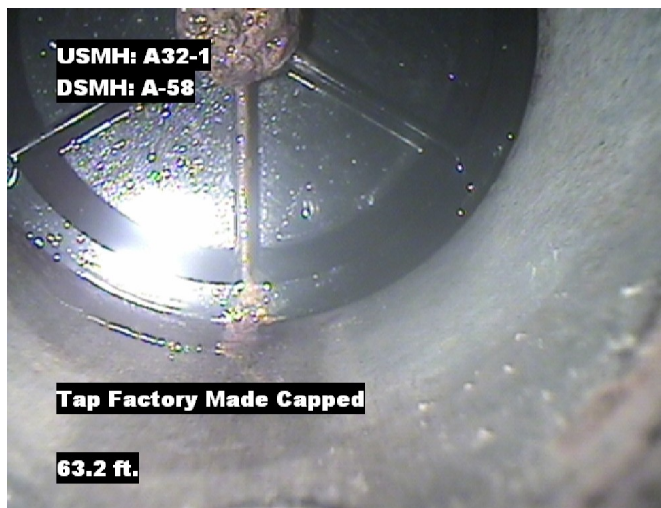
Distance: 63.2 ft. Grade: 0  
Condition: Tap Factory Made Capped  
Remarks: N/A

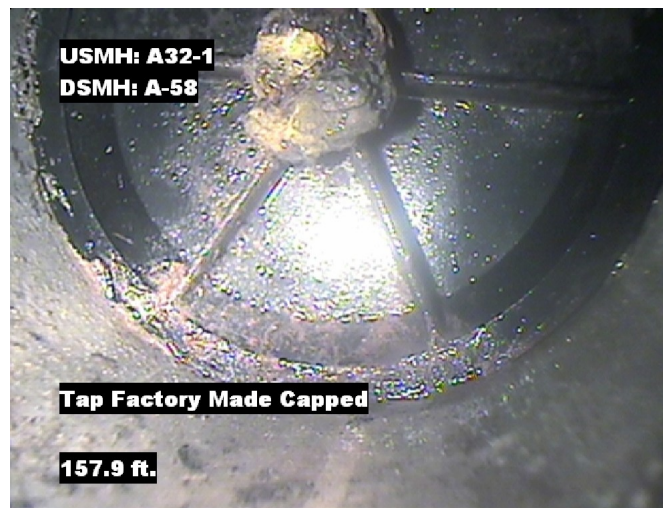
Distance: 157.9 ft. Grade: 0  
Condition: Tap Factory Made Capped  
Remarks: N/A

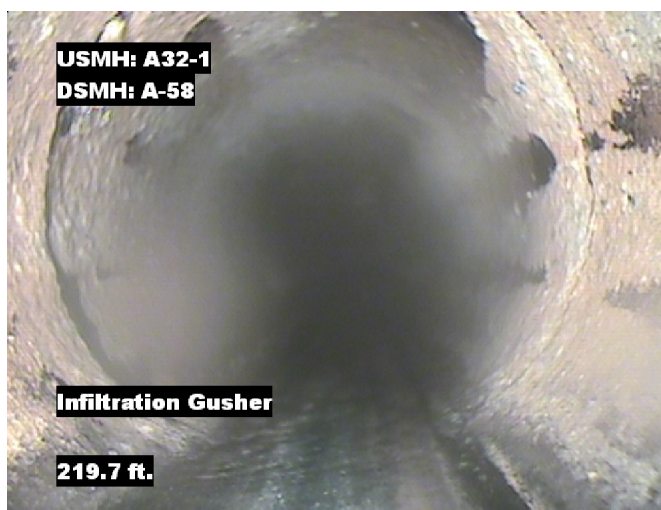
Distance: 219.7 ft. Grade: 5  
Condition: Infiltration Gusher  
Remarks: N/A

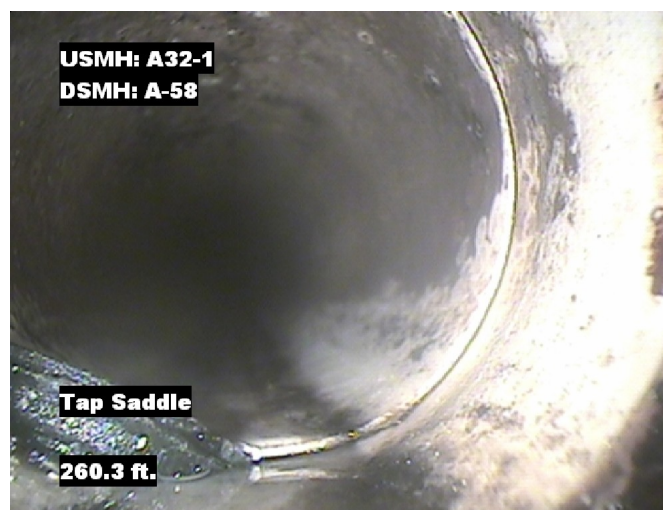
Distance: 260.3 ft. Grade: 0  
Condition: Tap Saddle  
Remarks: N/A

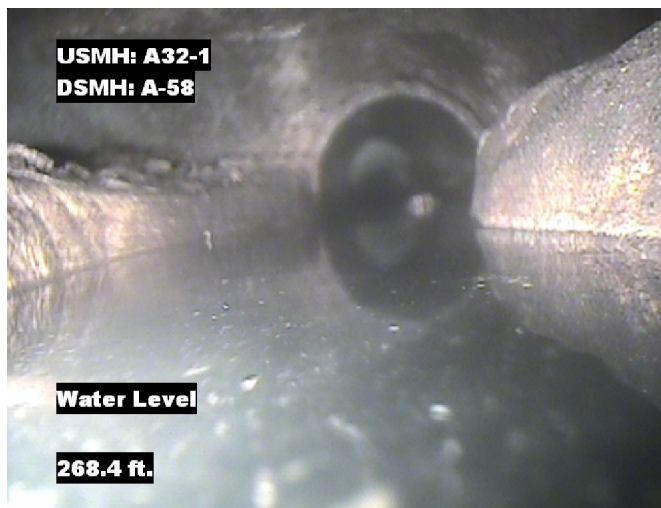
Distance: 268.4 ft.      Grade: 0  
Condition: Water Level  
Remarks: N/A

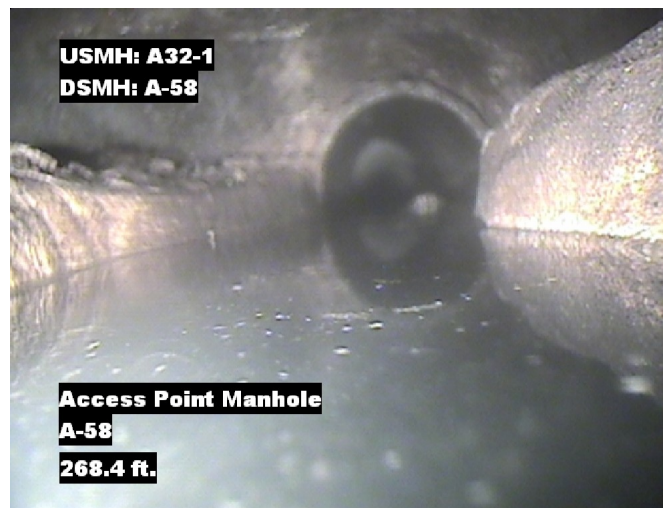
Distance: 268.4 ft.      Grade: 0  
Condition: Access Point Manhole  
Remarks: A-58
