# **Defect Listing**

Pipe Segment Refere		City		Street	Mat	Material		Sewer Use		
A32-3_A32-2		Oliver Springs		Green St	Concrete Pipe (non		Light High	Sanitary		
Upstre	am MH	Total I	Length	Year Laid	Sh	ape	pe Location Detai			
A3	2-3	30	3.8		Circ	ular				
DS M	anhole	Length s	surveyed	Year Renewed	Height	Width Pipe Joint				
A3	2-2	30	3.8		8	8	8 4			
SPR	1	MPR	4	PO Number			Customer			
	· · ·			4397-03	4397-03			GRW		
SPRI	1	MPRI	4	Work Order		Purpose				
QSR	1100	QMR	4100	4397-02	Pre-Rehabilitation		Rehabilitation S	tation Survey		
0	PR	Surve	yed By	Direction	Da	ate	Media	label		
	5	Barry_	Rogers	Downstream	20150728					
Ol	PRI	Certificat	e Number	Pre-Cleaning	Time		Weather			
2	2.5 U-1012-16405		2-16405	Jetting	12:01		Dry			
		Date C	leaned		End Time		Additional Info			
		2015	0728		12:14

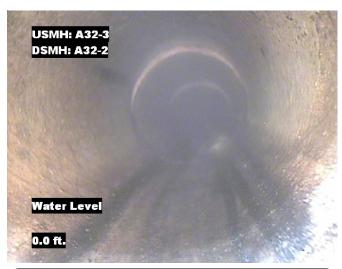
Distance: 0.0 ft. Grade: 0

Condition: Access Point Manhole

Remarks: A32-3

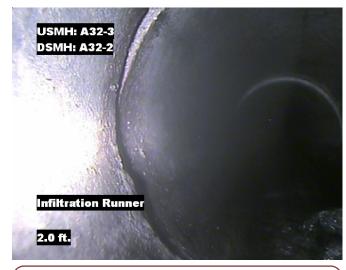
Distance: 2.0 ft. Grade: 1

Condition: Joint Offset Medium

Remarks: N/A

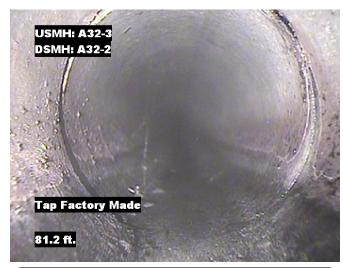
Distance: 81.2 ft. Grade: 0

Condition: Tap Factory Made

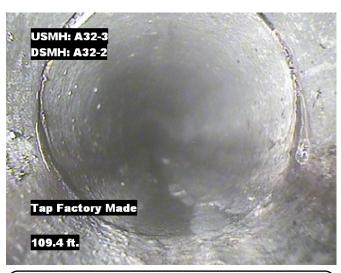
Distance: 109.4 ft. Grade: 0

Condition: Tap Factory Made

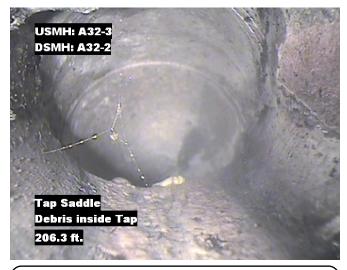
Distance: 206.3 ft. Grade: 0

Condition: Tap Saddle
Remarks: Debris inside Tap

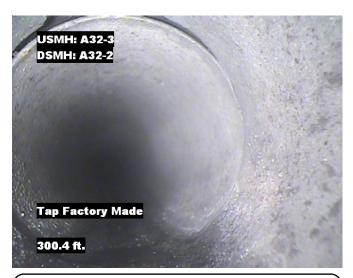
Distance: 300.4 ft. Grade: 0

Condition: Tap Factory Made

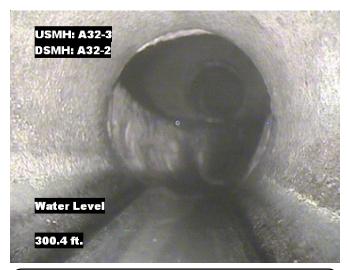
Distance: 300.4 ft. Grade: 0

Condition: Water Level

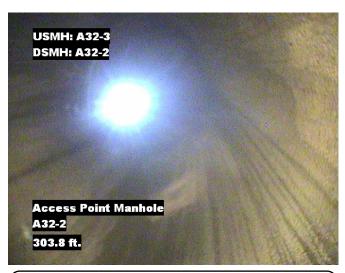
Distance: 303.8 ft. Grade: 0

Condition: Access Point Manhole

Remarks: A32-2
