## Defect Listing

Pipe Segment Refere... <b>A32-4_A32-3</b>	City <b>Oliver Springs</b>	Street <b>Cox Circle</b>	Material <b>Concrete Pipe (non-...</b>	Location C... <b>Light High...</b>	Sewer Use <b>Sanitary</b>
Upstream MH <b>A32-4</b>	Total Length <b>38</b>	Year Laid	Shape <b>Circular</b>	Location Details	
DS Manhole <b>A32-3</b>	Length surveyed <b>38</b>	Year Renewed	Height <b>8</b>	Width <b>8</b>	Pipe Joint... <b>4</b>

SPR <b>7</b>	MPR <b>N/A</b>	PO Number <b>4397-03</b>	Customer <b>GRW</b>
SPRI <b>3.5</b>	MPRI <b>N/A</b>	Work Order <b>4397-02</b>	Purpose <b>Pre-Rehabilitation Survey</b>
QSR <b>5121</b>	QMR <b>N/A</b>		
OPR <b>7</b>	Surveyed By <b>Barry Rogers</b>	Direction <b>Upstream</b>	Date <b>20150728</b>
OPRI <b>3.5</b>	Certificate Number <b>U-1012-16405</b>	Pre-Cleaning <b>Jetting</b>	Time <b>11:42</b>
	Date Cleaned <b>20150728</b>	End Time <b>11:46</b>	Weather <b>Dry</b>
			Media label
			Additional Info

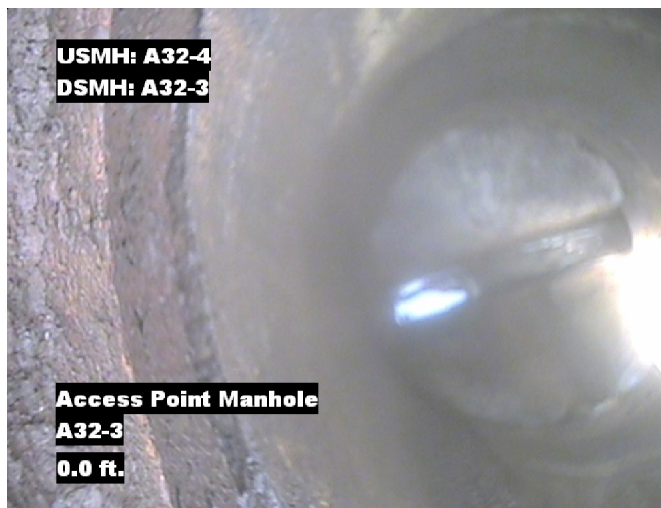
Distance: 0.0 ft. Grade: 0  
Condition: Access Point Manhole  
Remarks: A32-3

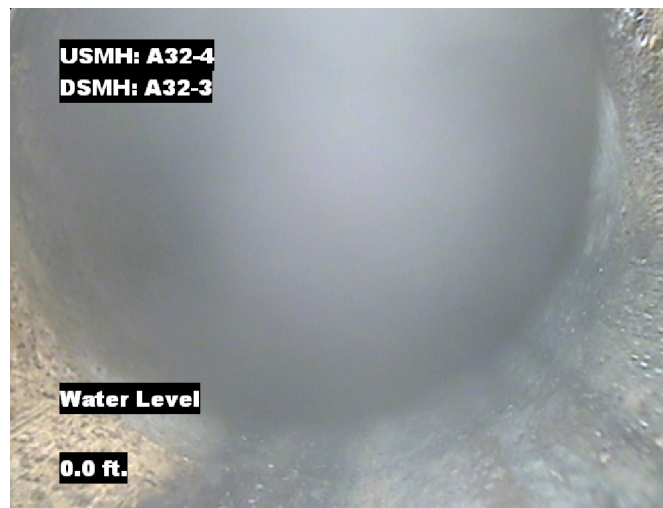
Distance: 0.0 ft. Grade: 0  
Condition: Water Level  
Remarks: N/A

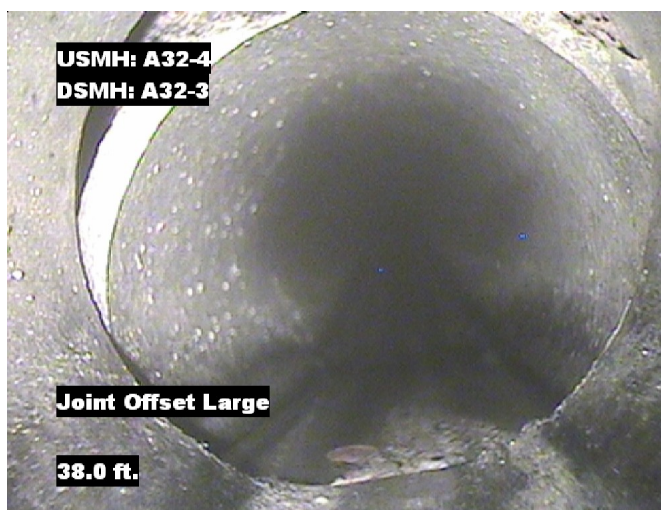
Distance: 38.0 ft. Grade: 2  
Condition: Joint Offset Large  
Remarks: N/A

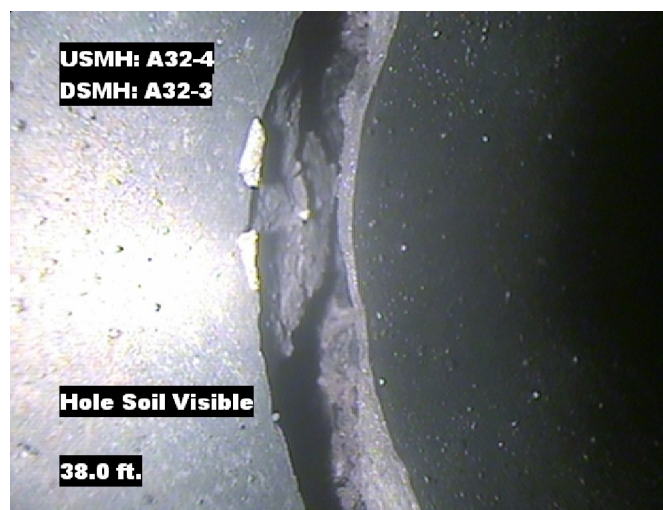
Distance: 38.0 ft. Grade: 5  
Condition: Hole Soil Visible  
Remarks: N/A

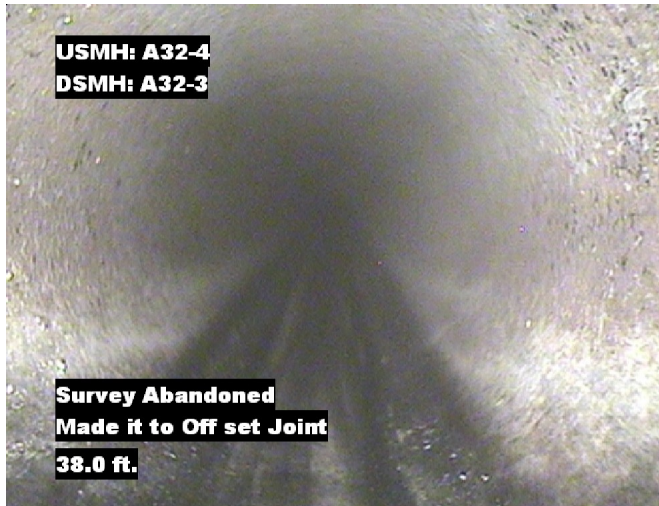
Distance: 38.0 ft. Grade: 0  
Condition: Survey Abandoned  
Remarks: Made it to Off set Joint
