Defect Listing

Pipe Segment Refere... A32-5_A32-4	City Oliver Springs	Street Cox Circle	Material Concrete Pipe (non-...	Location C... Light High...	Sewer Use Sanitary
Upstream MH A32-5	Total Length 280.7	Year Laid	Shape Circular	Location Details	
DS Manhole A32-4	Length surveyed 280.7	Year Renewed	Height 8	Width 8	Pipe Joint... 4

SPR N/A	MPR N/A	PO Number 4397-03	Customer GRW
SPRI N/A	MPRI N/A	Work Order 4397-02	Purpose Pre-Rehabilitation Survey
QSR N/A	QMR N/A		
OPR N/A	Surveyed By Barry Rogers	Direction Downstream	Date 20150728
OPRI N/A	Certificate Number U-1012-16405	Pre-Cleaning Jetting	Time 09:52
	Date Cleaned 20150728	End Time 10:07	Weather Dry
			Additional Info

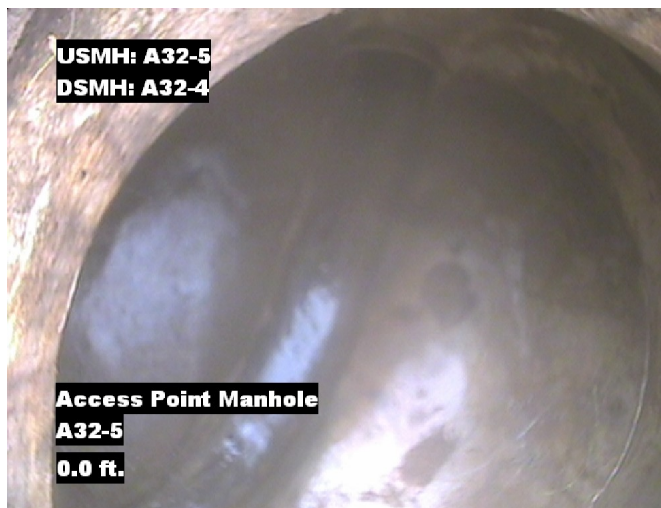
Distance: 0.0 ft. Grade: 0
Condition: Access Point Manhole
Remarks: A32-5

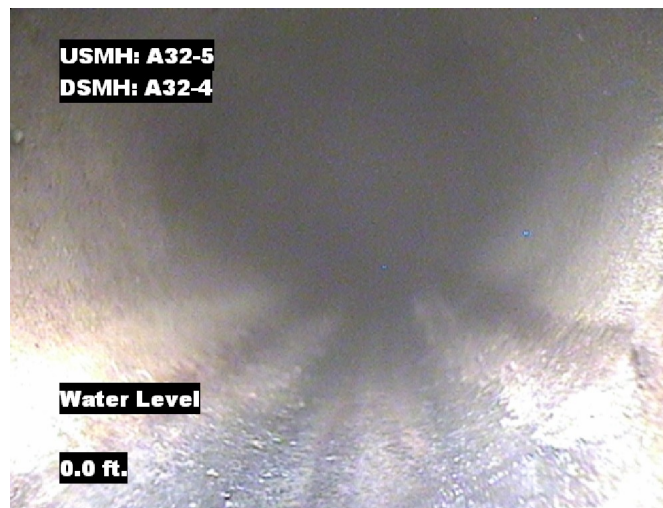
Distance: 0.0 ft. Grade: 0
Condition: Water Level
Remarks: N/A

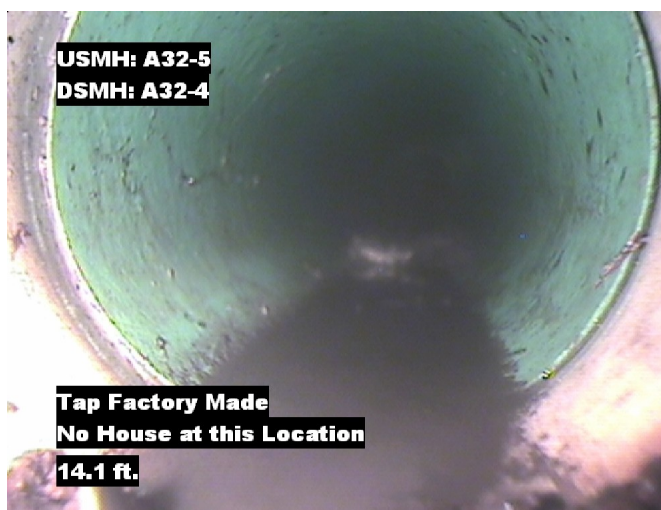
Distance: 14.1 ft. Grade: 0
Condition: Tap Factory Made
Remarks: No House at this Location

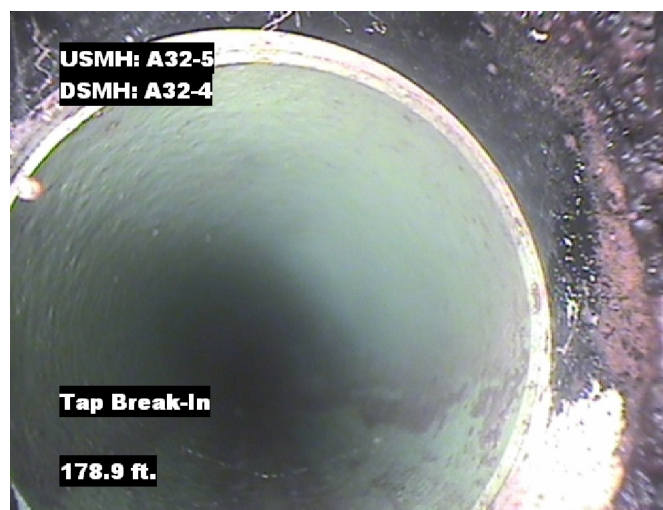
Distance: 178.9 ft. Grade: 0
Condition: Tap Break-In
Remarks: N/A

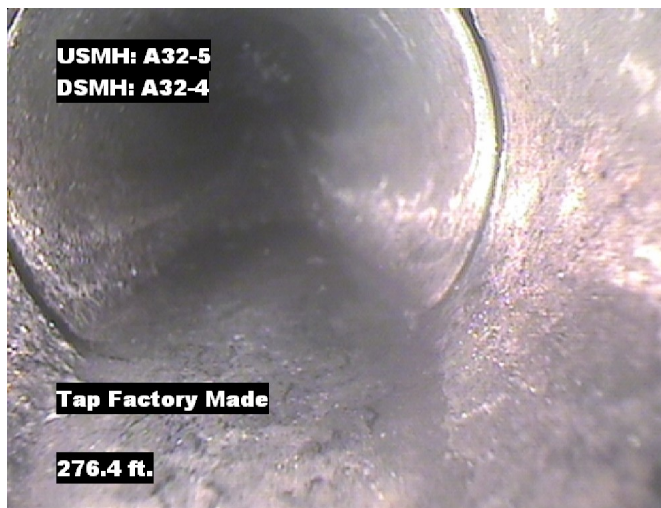
Distance: 276.4 ft. Grade: 0
Condition: Tap Factory Made
Remarks: N/A

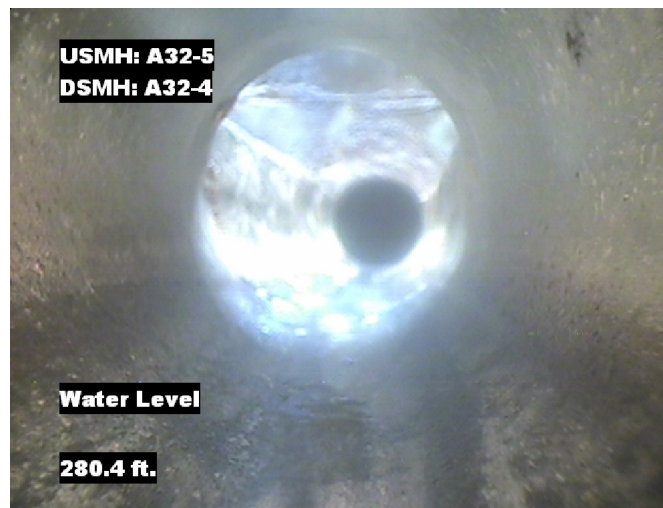
Distance: 280.4 ft. Grade: 0
Condition: Water Level
Remarks: N/A

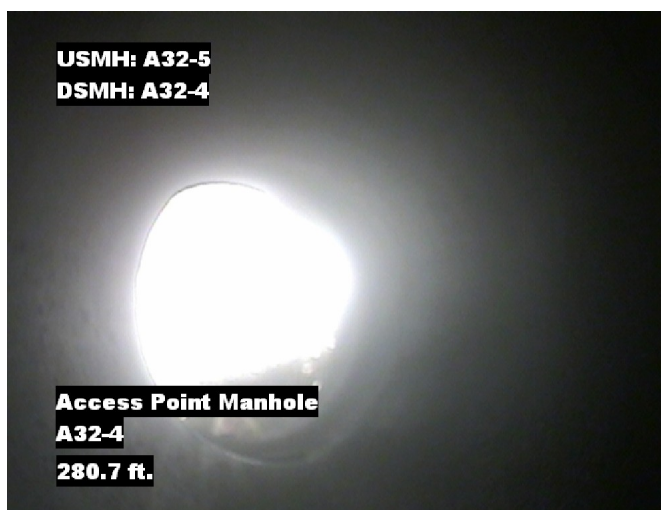
Distance: 280.7 ft. Grade: 0
Condition: Access Point Manhole
Remarks: A32-4
