Defect Listing

Pipe Segment Refere... A33-1_A-63	City Oliver Springs	Street Green St	Material Concrete Pipe (non-...	Location C... Light High...	Sewer Use Sanitary
Upstream MH A33-1	Total Length 177.3	Year Laid	Shape Circular	Location Details	
DS Manhole A-63	Length surveyed 177.3	Year Renewed	Height 8	Width 8	Pipe Joint... 4

Image Report 4/Page

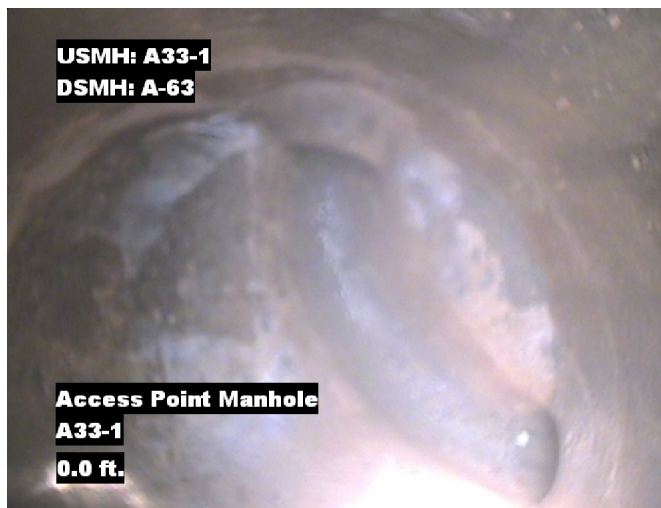
Distance: 0.0 ft. Grade: 0
Condition: Access Point Manhole
Remarks: A33-1

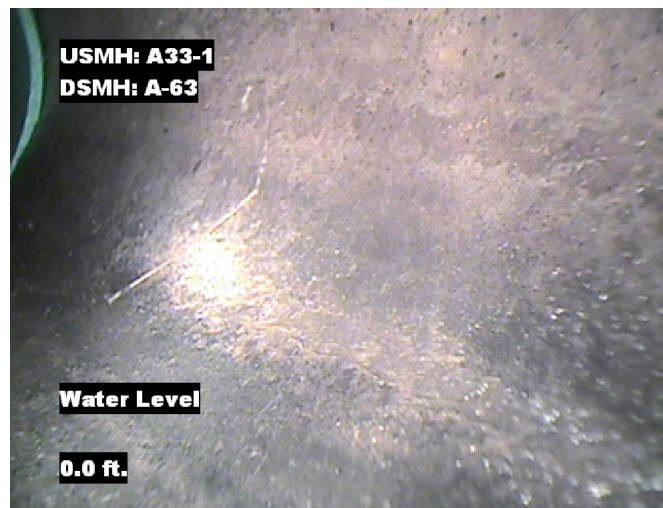
Distance: 0.0 ft. Grade: 0
Condition: Water Level
Remarks: N/A

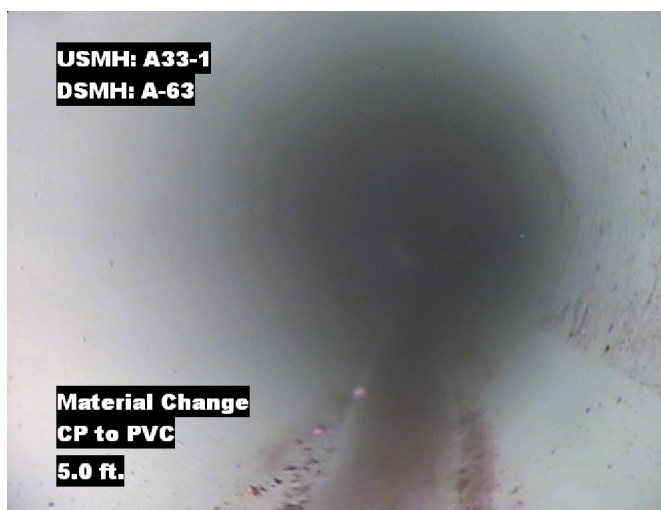
Distance: 5.0 ft. Grade: 0
Condition: Material Change
Remarks: CP to PVC

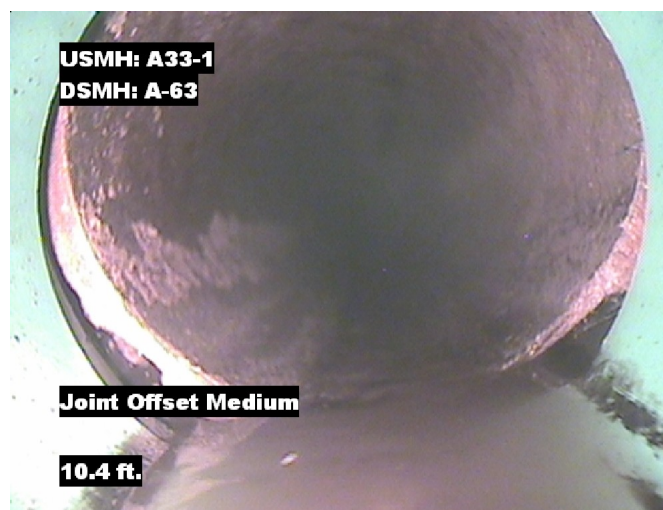
Distance: 10.4 ft. Grade: 1
Condition: Joint Offset Medium
Remarks: N/A

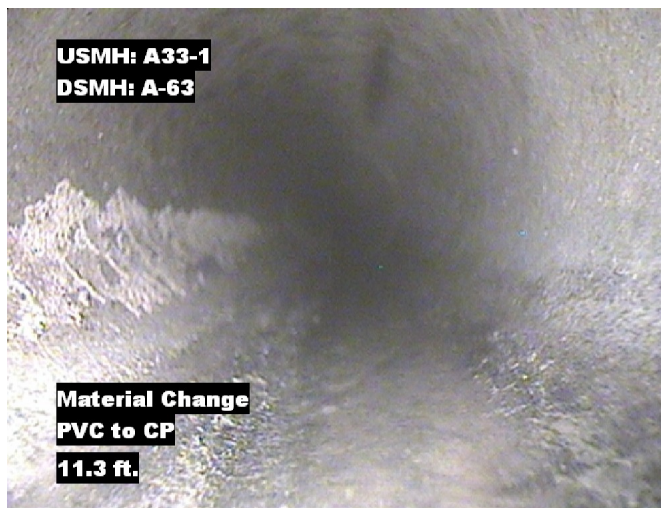
Distance: 11.3 ft. Grade: 0
Condition: Material Change
Remarks: PVC to CP

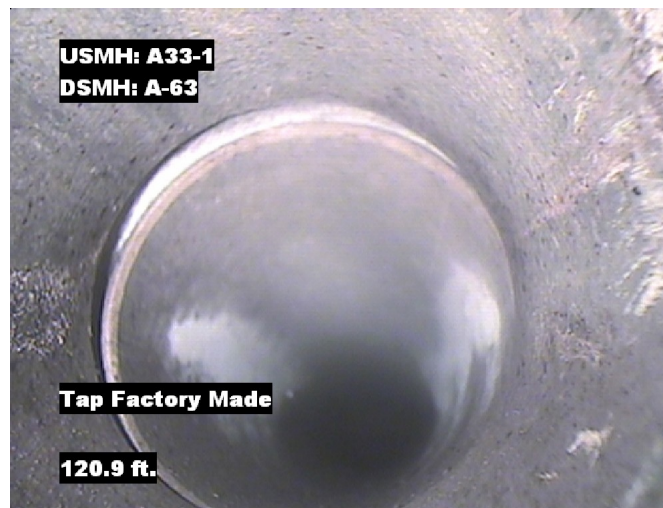
Distance: 120.9 ft. Grade: 0
Condition: Tap Factory Made
Remarks: N/A

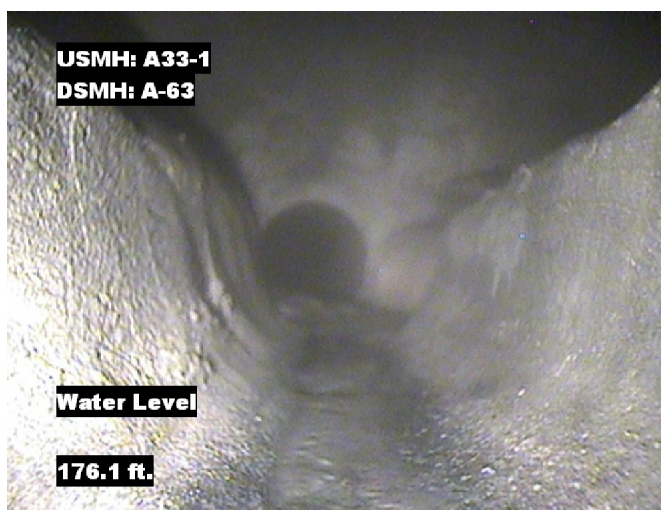
Distance: 176.1 ft. Grade: 0
Condition: Water Level
Remarks: N/A

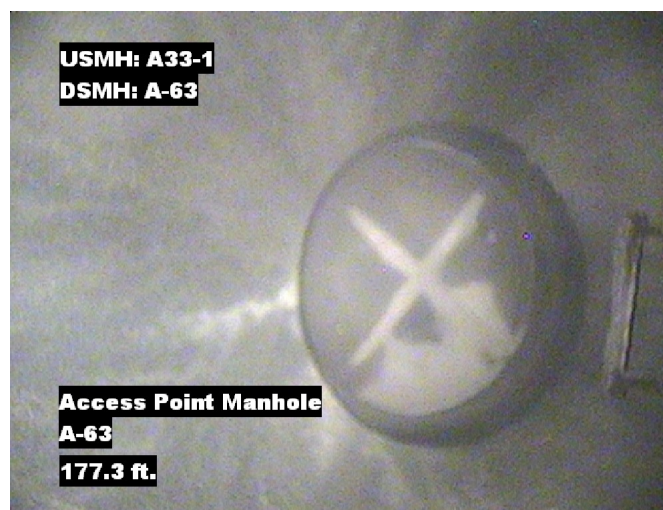
Distance: 177.3 ft. Grade: 0
Condition: Access Point Manhole
Remarks: A-63
