Defect Listing

Pipe Segment Refere... A33-2_A33-1	City Oliver Springs	Street Back Circle	Material PolyVinyl Chloride	Location C... Light High...	Sewer Use Sanitary
Upstream MH A33-2	Total Length 253.2	Year Laid	Shape Circular	Location Details 314	
DS Manhole A33-1	Length surveyed 253.2	Year Renewed	Height 8	Width 8	Pipe Joint... 13

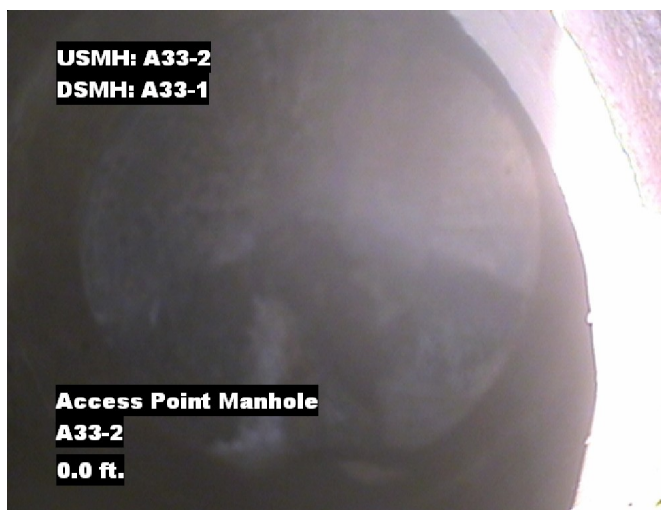
Distance: 0.0 ft. Grade: 0
Condition: Access Point Manhole
Remarks: A33-2

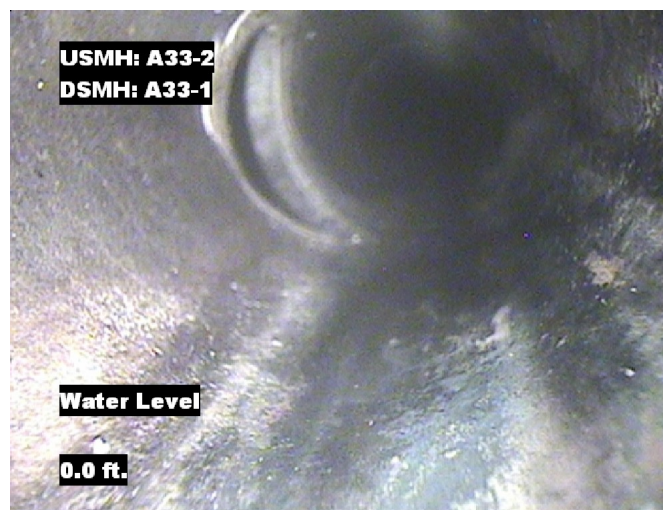
Distance: 0.0 ft. Grade: 0
Condition: Water Level
Remarks: N/A

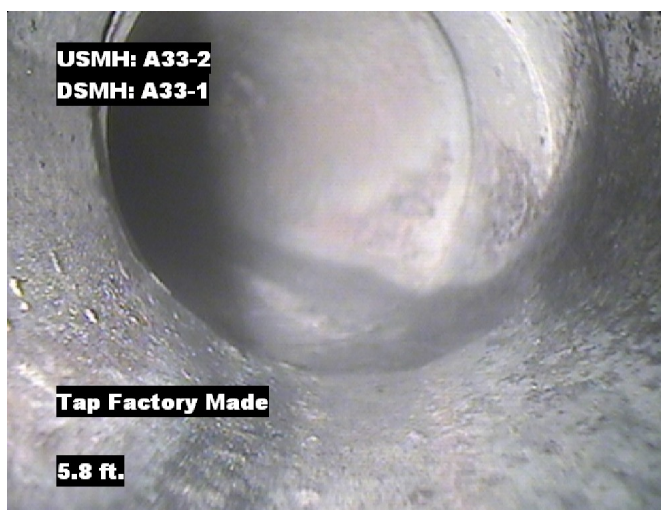
Distance: 5.8 ft. Grade: 0
Condition: Tap Factory Made
Remarks: N/A

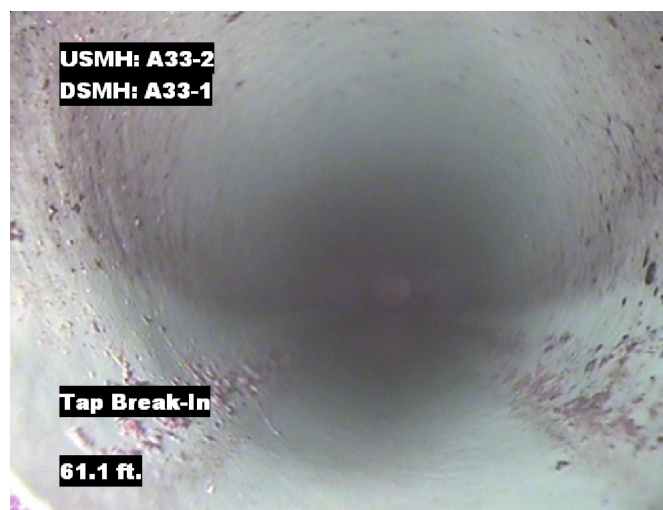
Distance: 61.1 ft. Grade: 0
Condition: Tap Break-In
Remarks: N/A

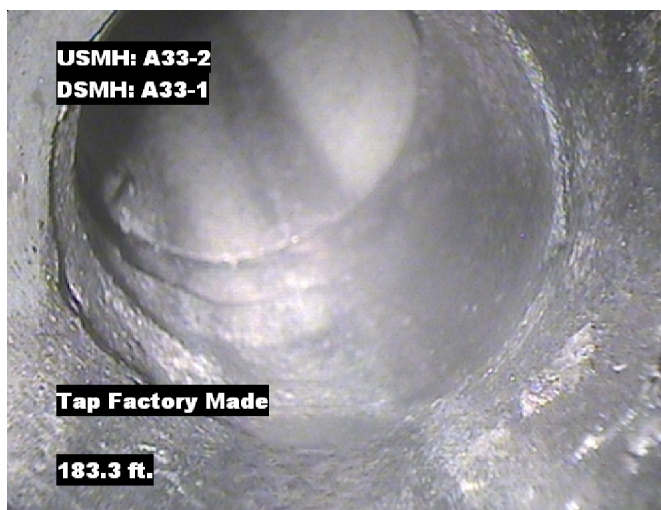
Distance: 183.3 ft. Grade: 0
Condition: Tap Factory Made
Remarks: N/A

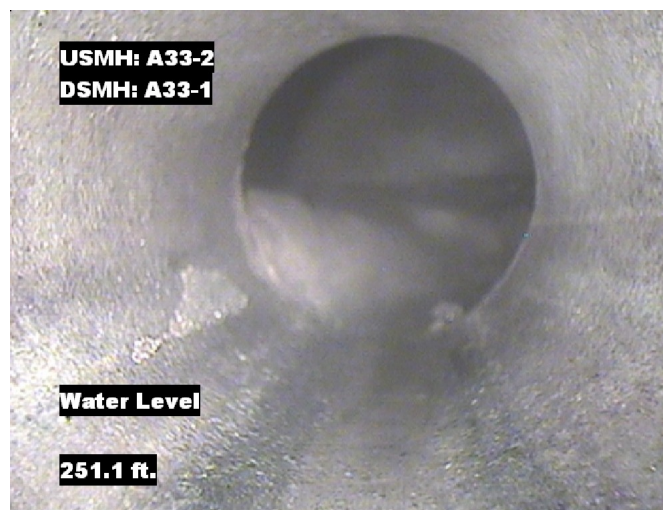
Distance: 251.1 ft. Grade: 0
Condition: Water Level
Remarks: N/A

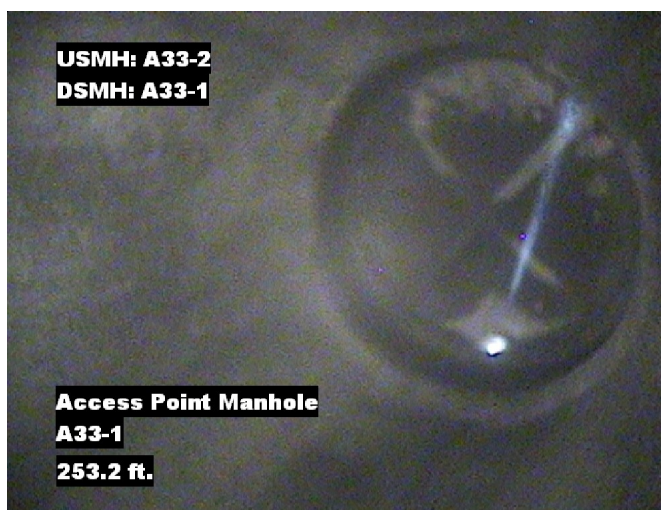
Distance: 253.2 ft. Grade: 0
Condition: Access Point Manhole
Remarks: A33-1
