Defect Listing

Pipe Segment Refere... A34-1_A-65	City Oliver Springs	Street Lookout Avenue	Material Concrete Pipe (non-...	Location C... Light High...	Sewer Use Sanitary
Upstream MH A34-1	Total Length 188.4	Year Laid	Shape Circular	Location Details	
DS Manhole A-65	Length surveyed 188.4	Year Renewed	Height 8	Width 8	Pipe Joint... 4

SPR N/A	MPR 5	PO Number 4397-03	Customer GRW
SPRI N/A	MPRI 1.3	Work Order 4397-02	Purpose Pre-Rehabilitation Survey
QSR N/A	QMR 2113		
OPR 5	Surveyed By Barry Rogers	Direction Upstream	Date 20150727
OPRI 1.3	Certificate Number U-1012-16405	Pre-Cleaning Jetting	Time 14:02
	Date Cleaned 20150727	End Time 14:14	Weather Dry
			Media label
			Additional Info

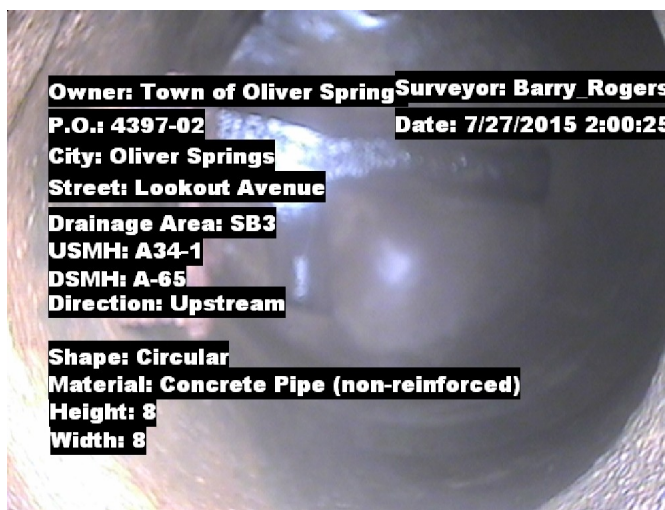
Distance: 0.0 ft. Grade: 0
Condition: Access Point Manhole
Remarks: A-65

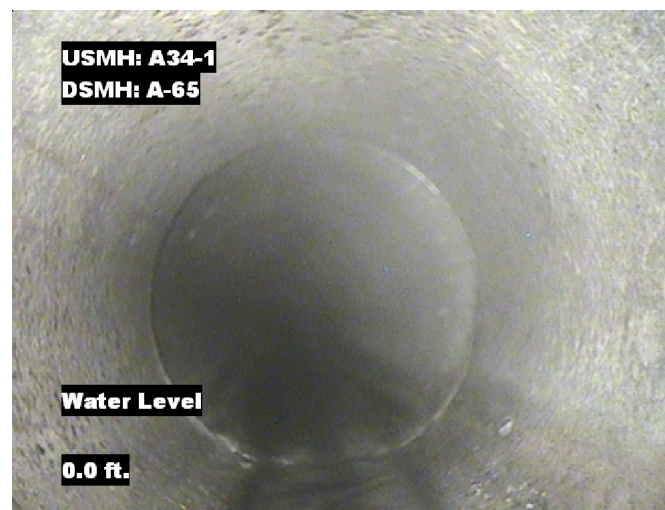
Distance: 0.0 ft. Grade: 0
Condition: Water Level
Remarks: N/A

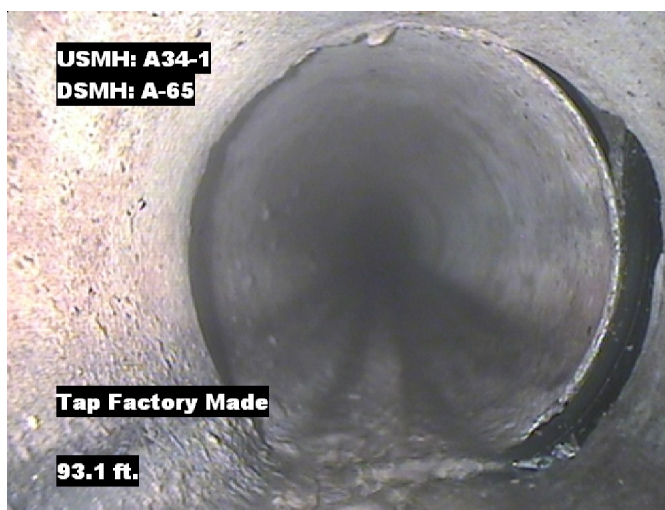
Distance: 93.1 ft. Grade: 0
Condition: Tap Factory Made
Remarks: N/A

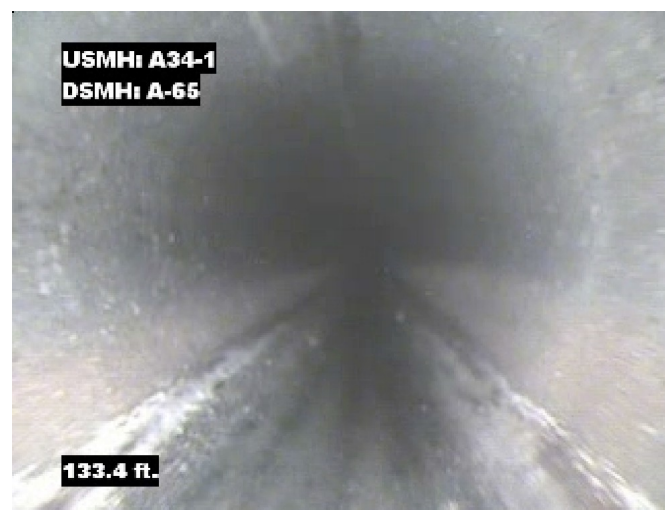
Distance: 133.4 ft. Grade: 2
Condition: Deposits Attached Grease
Remarks: N/A

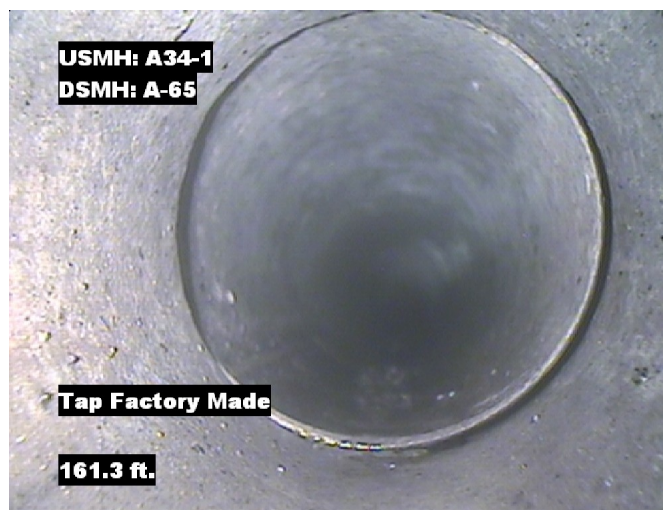
Distance: 161.3 ft. Grade: 0
Condition: Tap Factory Made
Remarks: N/A

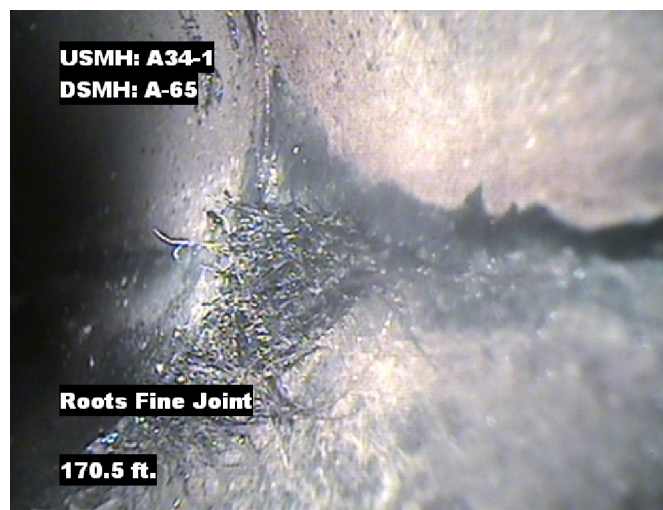
Distance: 170.5 ft. Grade: 1
Condition: Roots Fine Joint
Remarks: N/A

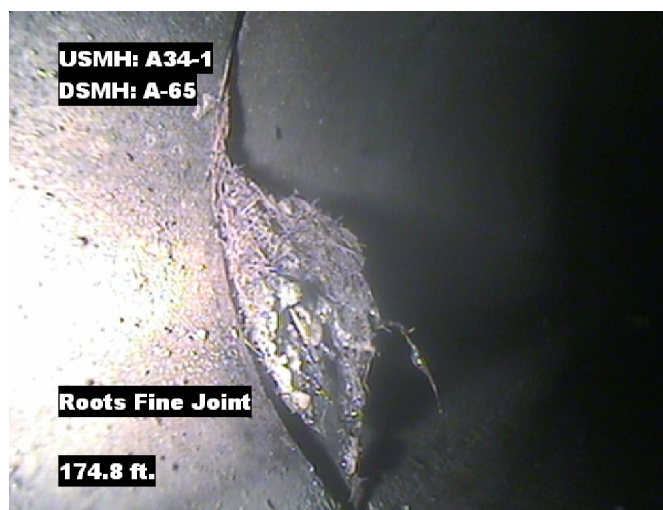
Distance: 174.8 ft. Grade: 1
Condition: Roots Fine Joint
Remarks: N/A

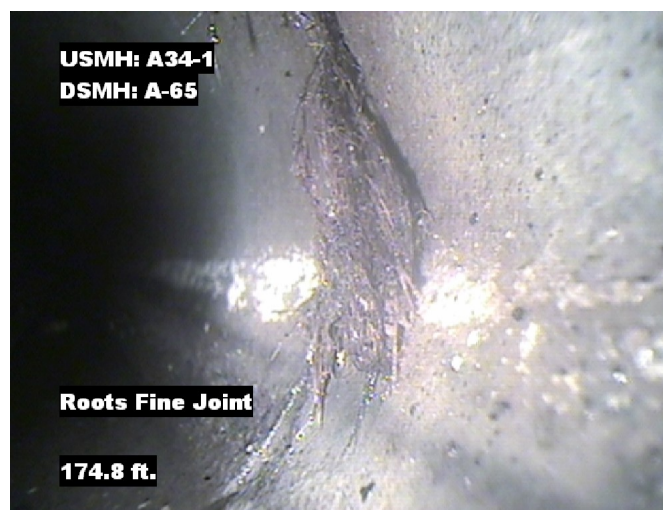
Distance: 174.8 ft. Grade: 1
Condition: Roots Fine Joint
Remarks: N/A

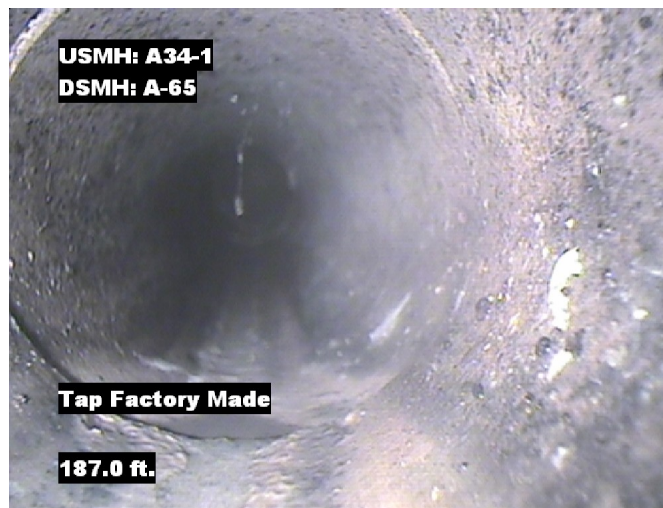
Distance: 187.0 ft. Grade: 0
Condition: Tap Factory Made
Remarks: N/A

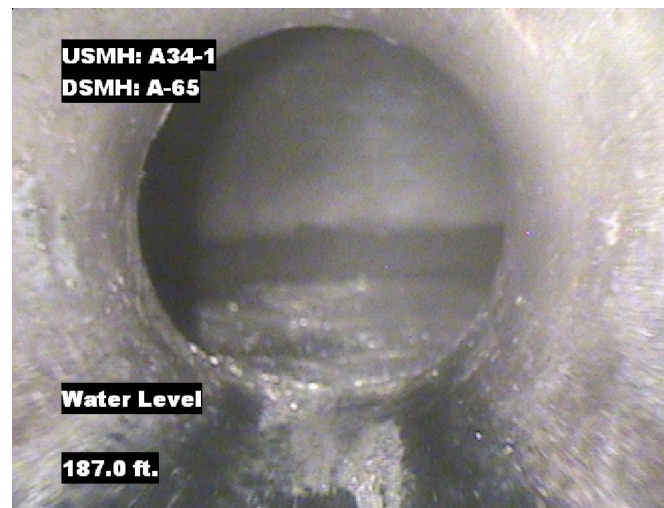
Distance: 187.0 ft. Grade: 0
Condition: Water Level
Remarks: N/A

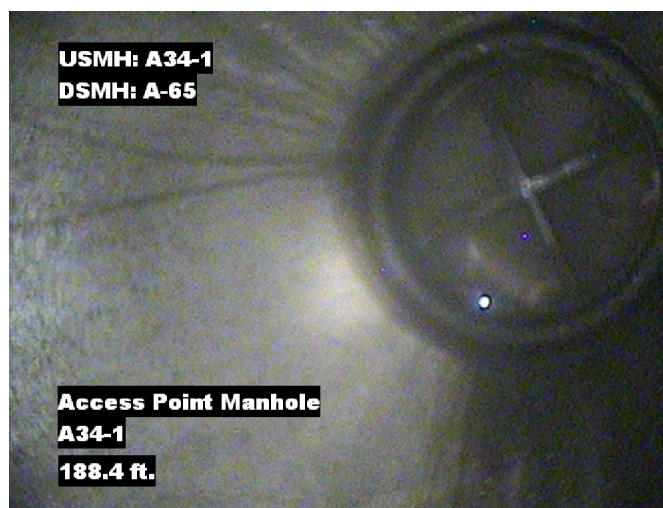
Distance: 188.4 ft. Grade: 0
Condition: Access Point Manhole
Remarks: A34-1
