Defect Listing

Pipe Segment Refere... A35-1_A6-3	City Oliver Springs	Street Highway 61	Material Concrete Pipe (non-...	Location C... Main Highw...	Sewer Use Sanitary
Upstream MH A35-1	Total Length 141.8	Year Laid	Shape Circular	Location Details	
DS Manhole A6-3	Length surveyed 141.8	Year Renewed	Height 8	Width 8	Pipe Joint... 4

SPR N/A	MPR 11	PO Number 4397-03	Customer GRW
SPRI N/A	MPRI 2.8	Work Order 4397-02	Purpose Pre-Rehabilitation Survey
QSR N/A	QMR 4131		
OPR 11	Surveyed By Charlie Gordon	Direction Downstream	Date 20150901
OPRI 2.8	Certificate Number U-615-07000491	Pre-Cleaning No Pre-Cleaning	Time 07:15
	Date Cleaned	End Time 07:32	Weather Dry
		Additional Info

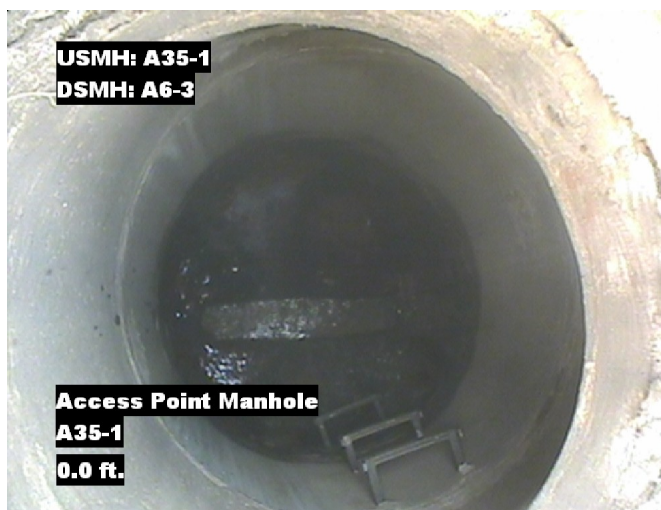
Distance: 0.0 ft. Grade: 0
Condition: Access Point Manhole
Remarks: A35-1

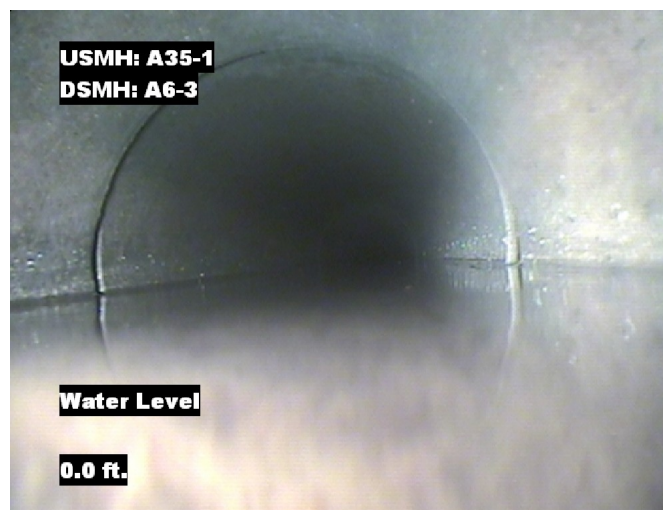
Distance: 0.0 ft. Grade: 0
Condition: Water Level
Remarks: N/A

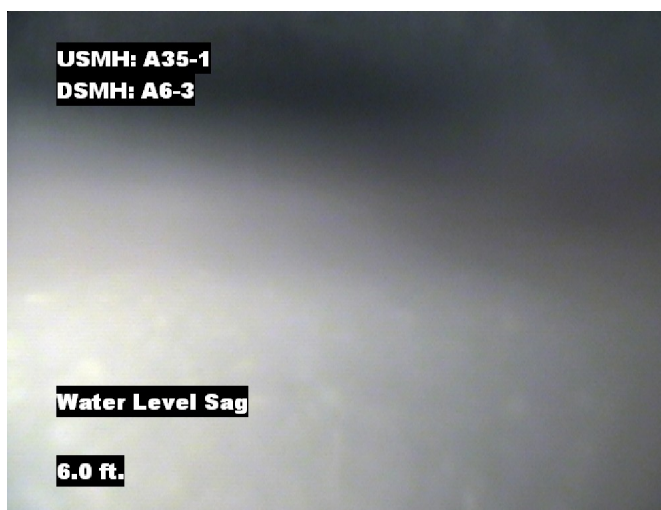
Distance: 6.0 ft. Grade: 3
Condition: Water Level Sag
Remarks: N/A

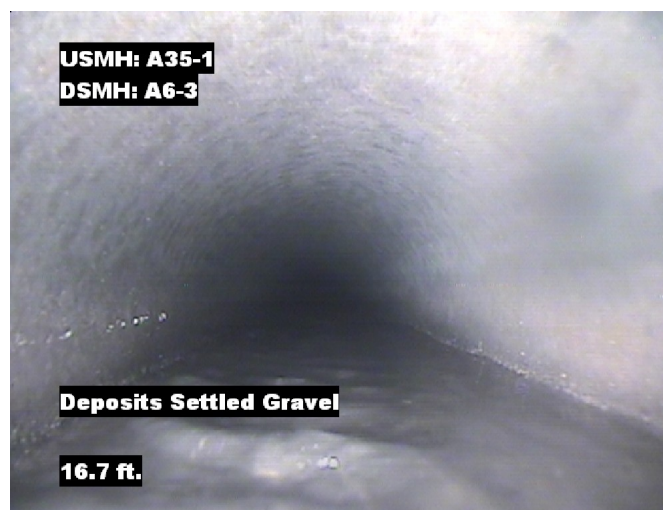
Distance: 16.7 ft. Grade: 2
Condition: Deposits Settled Gravel
Remarks: N/A

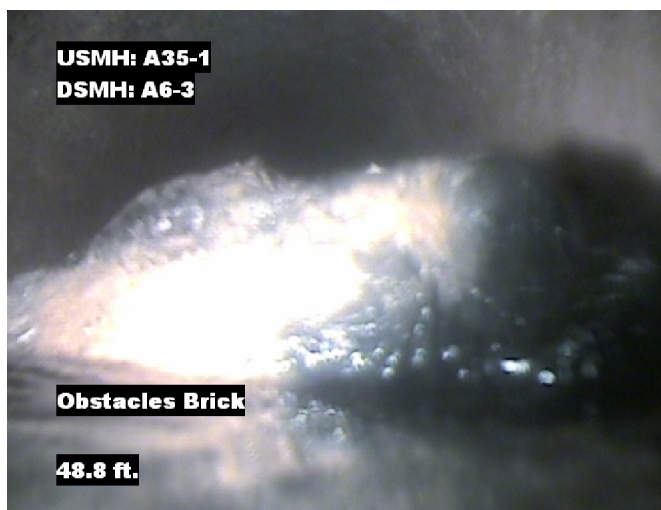
Distance: 48.8 ft. Grade: 4
Condition: Obstacles Brick
Remarks: N/A

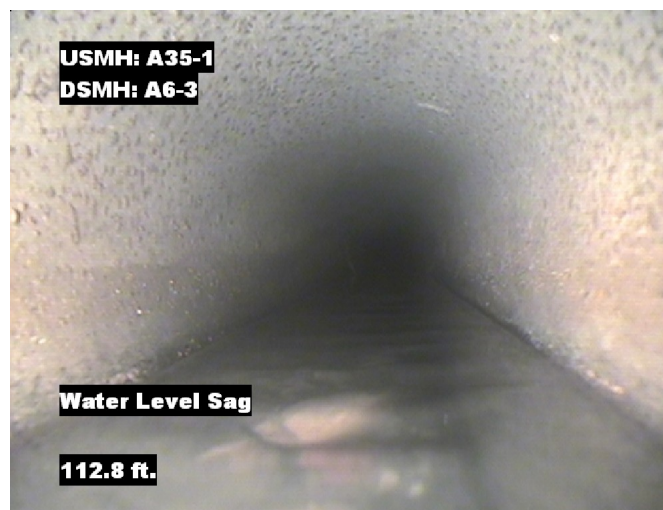
Distance: 112.8 ft. Grade: 2
Condition: Water Level Sag
Remarks: N/A

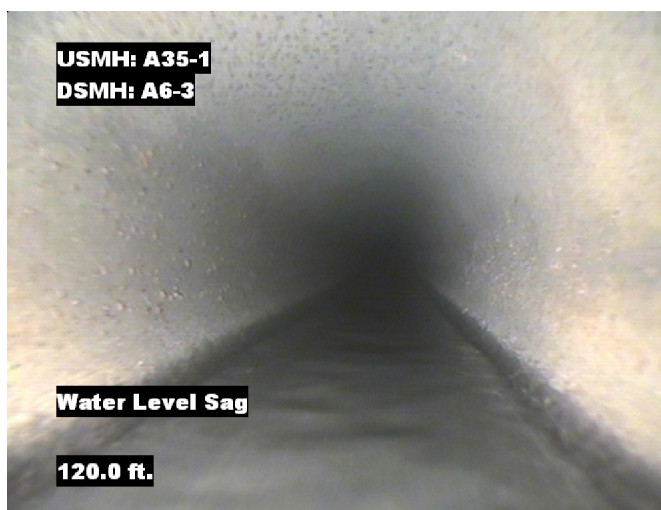
Distance: 119.8 ft. Grade: 2
Condition: Water Level Sag
Remarks: N/A

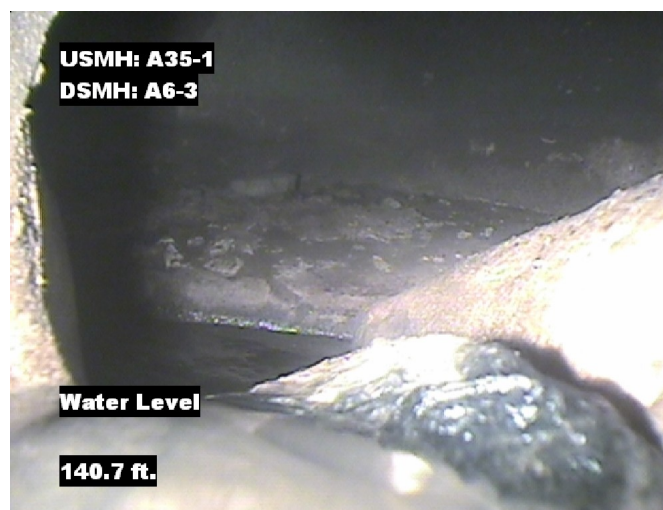
Distance: 140.7 ft. Grade: 0
Condition: Water Level
Remarks: N/A

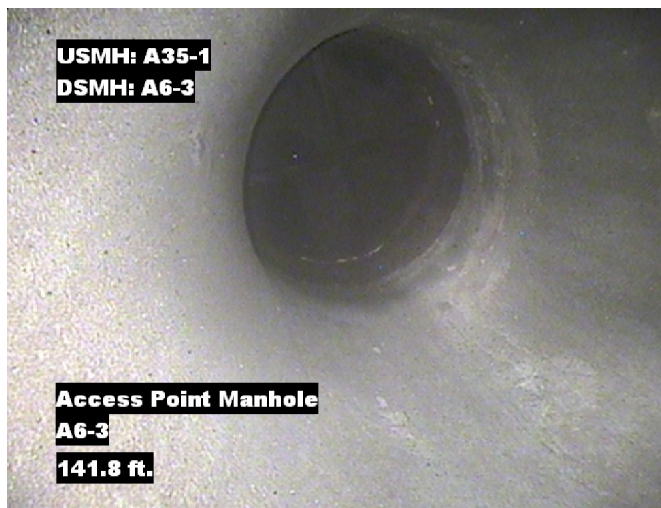
Distance: 141.8 ft. Grade: 0
Condition: Access Point Manhole
Remarks: A6-3
