Defect Listing

Pipe Segment Refere... A35-2_A35-1	City Oliver Springs	Street Wiley St.	Material Fibreglass Reinforc...	Location C... Easement/R...	Sewer Use Sanitary
Upstream MH A35-2	Total Length 258.6	Year Laid	Shape Circular	Location Details	
DS Manhole A35-1	Length surveyed 258.6	Year Renewed	Height 8	Width 8	Pipe Joint... N/A

SPR N/A	MPR N/A	PO Number 4397-03	Customer GRW
SPRI N/A	MPRI N/A	Work Order 4397-02	Purpose Pre-Rehabilitation Survey
QSR N/A	QMR N/A		
OPR N/A	Surveyed By Charlie Gordon	Direction Downstream	Date 20150826
OPRI N/A	Certificate Number U-615-07000491	Pre-Cleaning Jetting	Time 07:40
	Date Cleaned 20150826	End Time 07:53	Weather Dry
		Additional Info Mh A36-1_A36-2 Does...

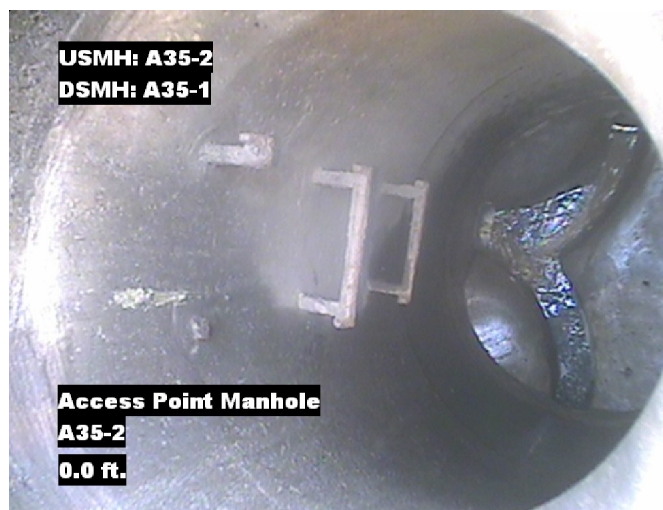
Distance: 0.0 ft. Grade: 0
Condition: Access Point Manhole
Remarks: A35-2

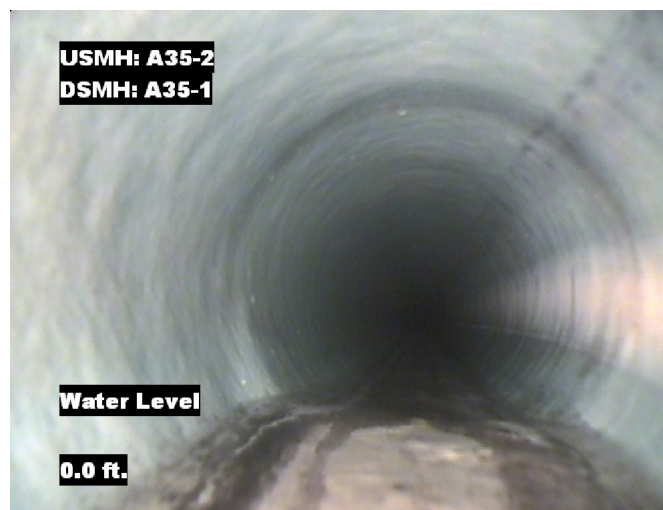
Distance: 0.0 ft. Grade: 0
Condition: Water Level
Remarks: N/A

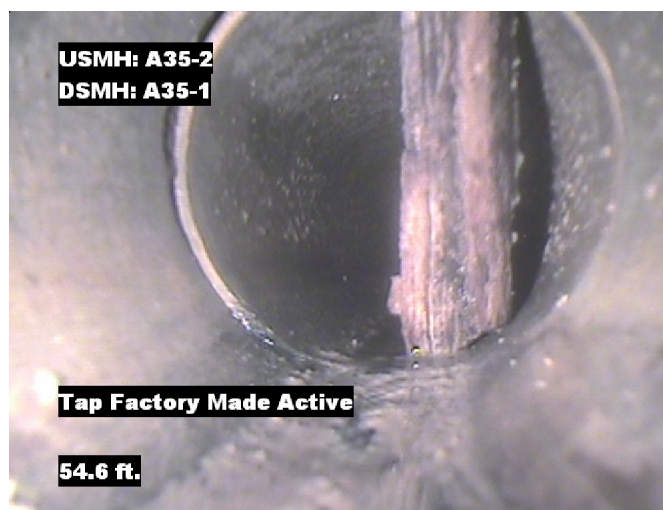
Distance: 54.6 ft. Grade: 0
Condition: Tap Factory Made Active
Remarks: N/A

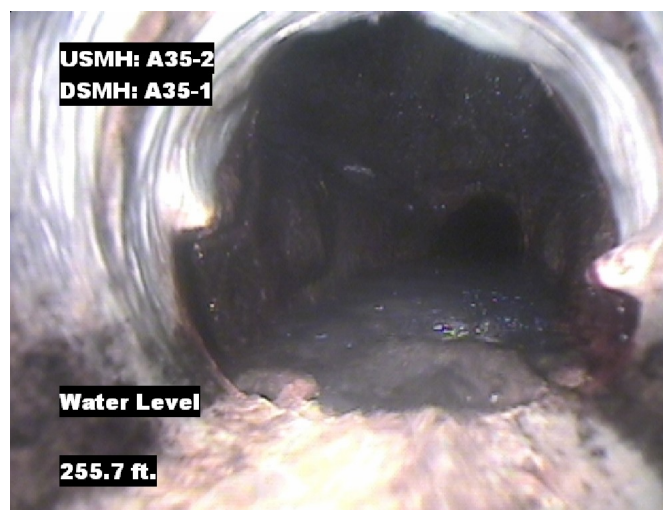
Distance: 255.7 ft. Grade: 0
Condition: Water Level
Remarks: N/A

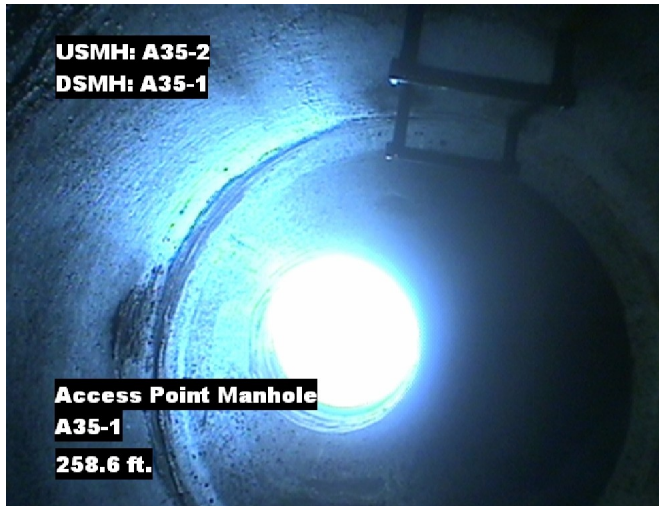
Distance: 258.6 ft. Grade: 0
Condition: Access Point Manhole
Remarks: A35-1
