Defect Listing

Pipe Segment Refere... A35-3_A35-2	City Oliver Springs	Street Hen Valley	Material Concrete Pipe (non-...		Location C... Light High...	Sewer Use Sanitary
Upstream MH A35-3	Total Length 264.7	Year Laid	Shape Circular		Location Details Middle of the road	
DS Manhole A35-2	Length surveyed 264.7	Year Renewed	Height 8	Width 8	Pipe Joint... 4

SPR 75	MPR 38	PO Number 4397-03		Customer GRW	
SPRI 3	MPRI 2.9	Work Order 4397-02		Purpose Pre-Rehabilitation Survey	
QSR 3D00	QMR 4627				
OPR 113	Surveyed By Dustin	Direction Downstream	Date 20150807	Media label	
OPRI 3	Certificate Number U-214-06020262	Pre-Cleaning Jetting	Time 07:40	Weather Dry	
Date Cleaned 20150807			End Time 09:15	Additional Info

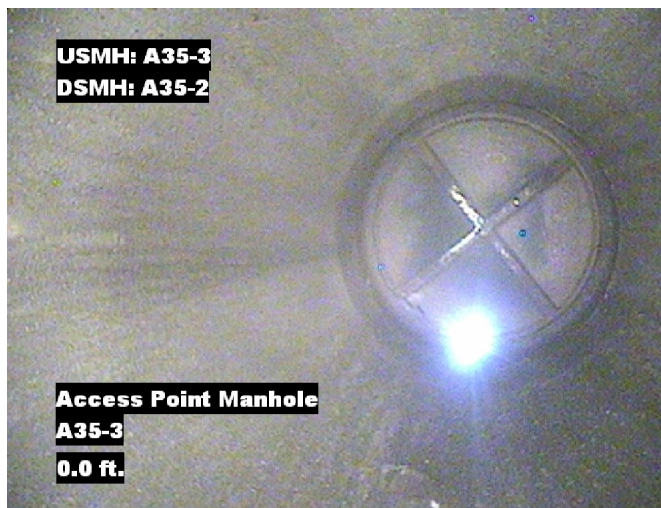
Distance: 0.0 ft. Grade: 0
Condition: Access Point Manhole
Remarks: A35-3

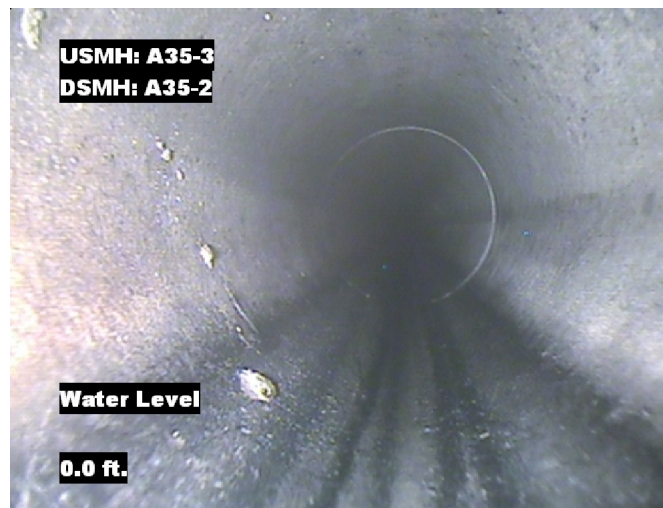
Distance: 0.0 ft. Grade: 0
Condition: Water Level
Remarks: N/A

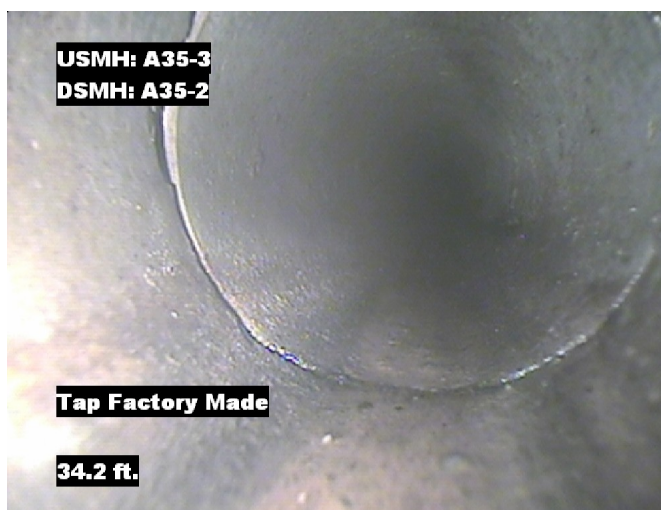
Distance: 34.2 ft. Grade: 0
Condition: Tap Factory Made
Remarks: N/A

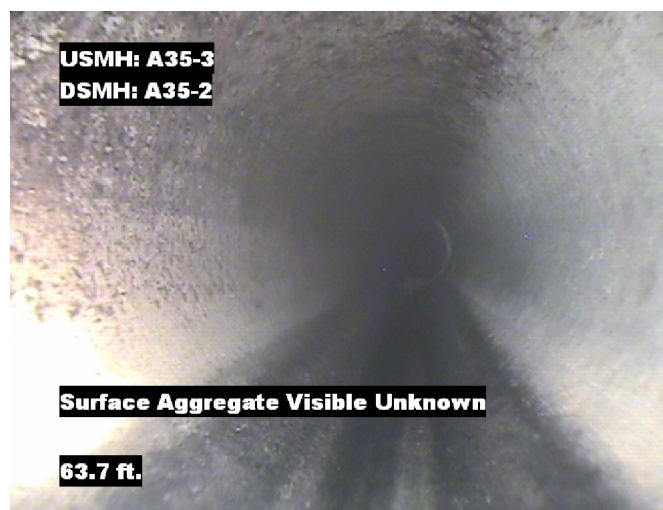
Distance: 63.7 ft. Grade: 3
Condition: Surface Aggregate Visible Unknown
Remarks: N/A

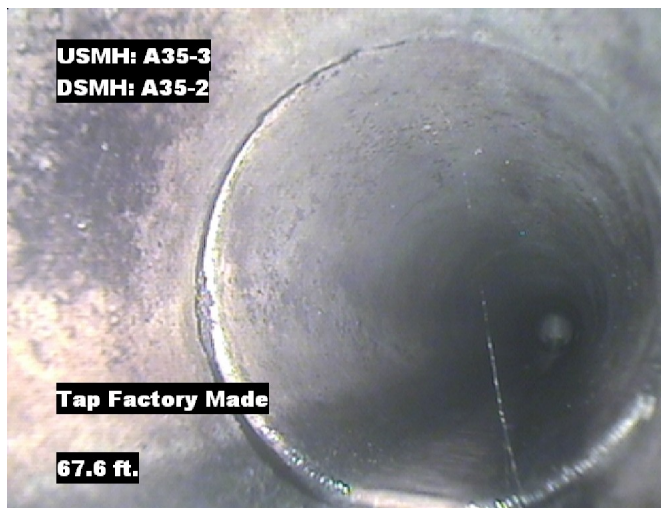
Distance: 67.6 ft. Grade: 0
Condition: Tap Factory Made
Remarks: N/A

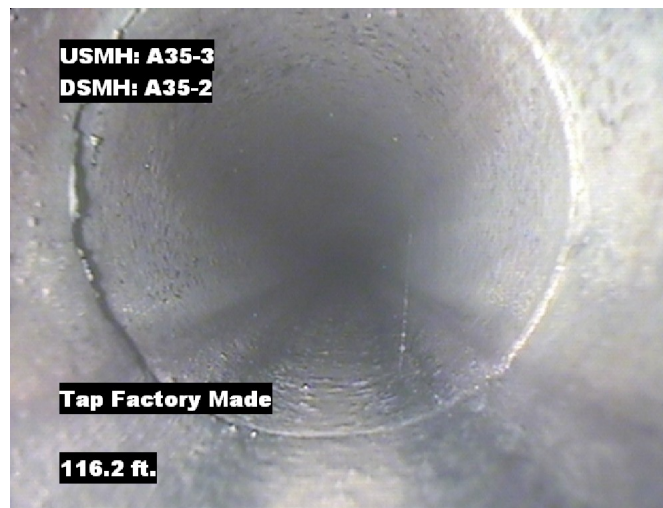
Distance: 116.2 ft. Grade: 0
Condition: Tap Factory Made
Remarks: N/A

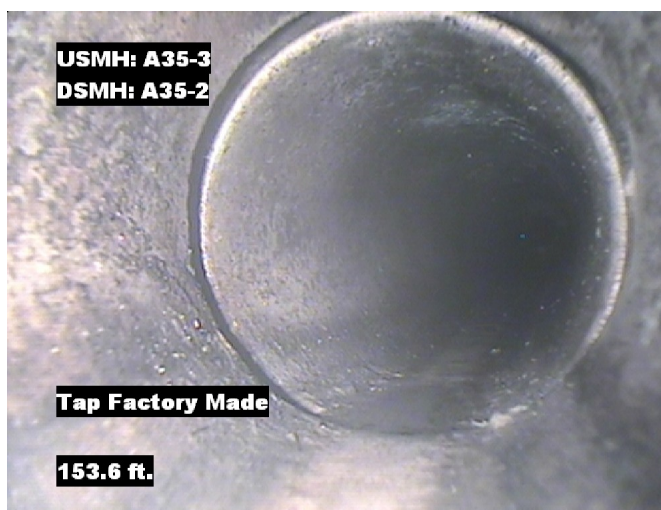
Distance: 153.6 ft. Grade: 0
Condition: Tap Factory Made
Remarks: N/A

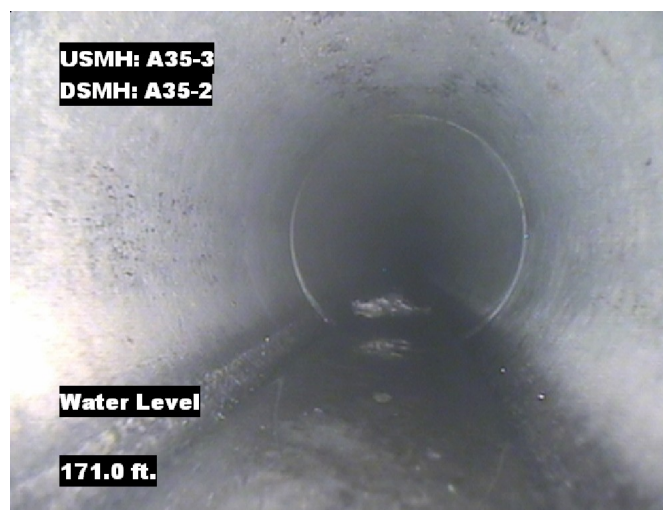
Distance: 171.0 ft. Grade: 0
Condition: Water Level
Remarks: N/A

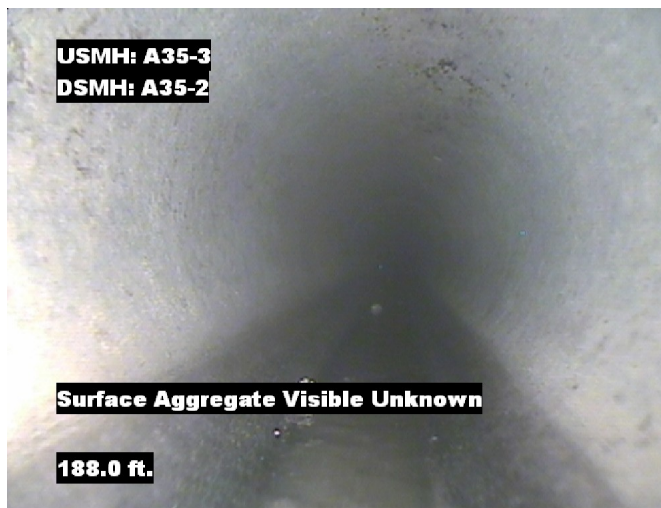
Distance: 188.0 ft. Grade: 3
Condition: Surface Aggregate Visible Unknown
Remarks: N/A

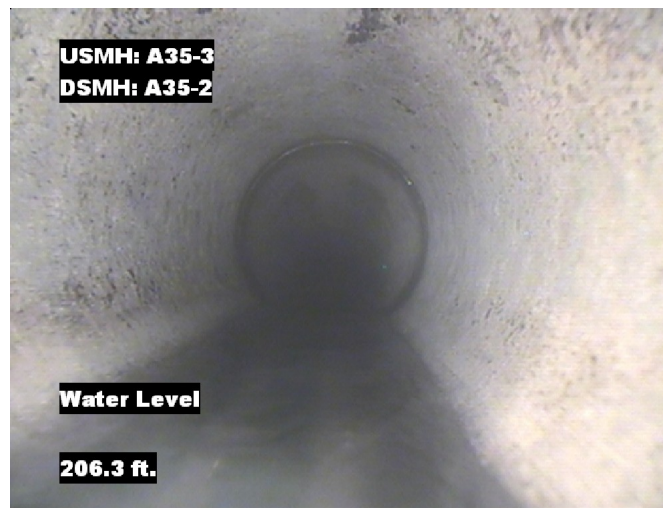
Distance: 206.3 ft. Grade: 0
Condition: Water Level
Remarks: N/A

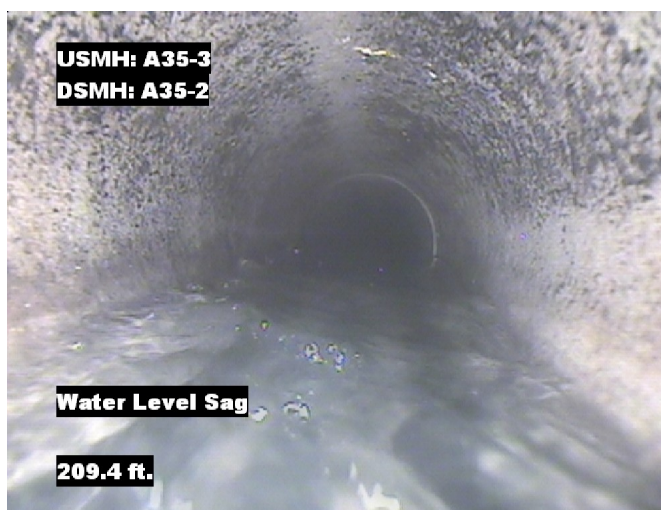
Distance: 209.4 ft. Grade: 2
Condition: Water Level Sag
Remarks: N/A

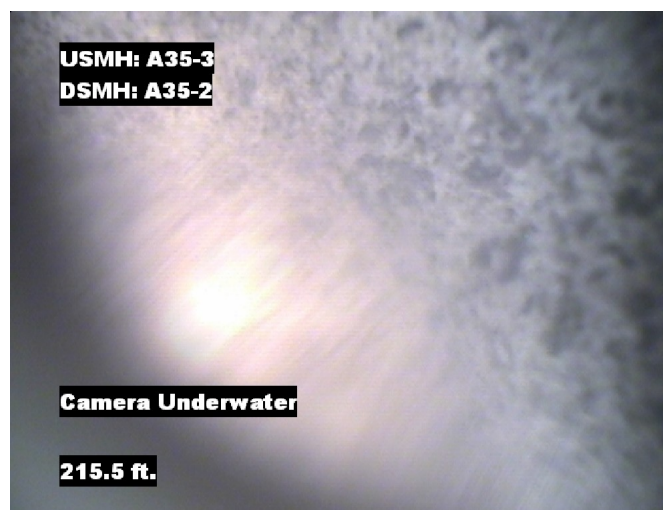
Distance: 215.5 ft. Grade: 4
Condition: Camera Underwater
Remarks: N/A

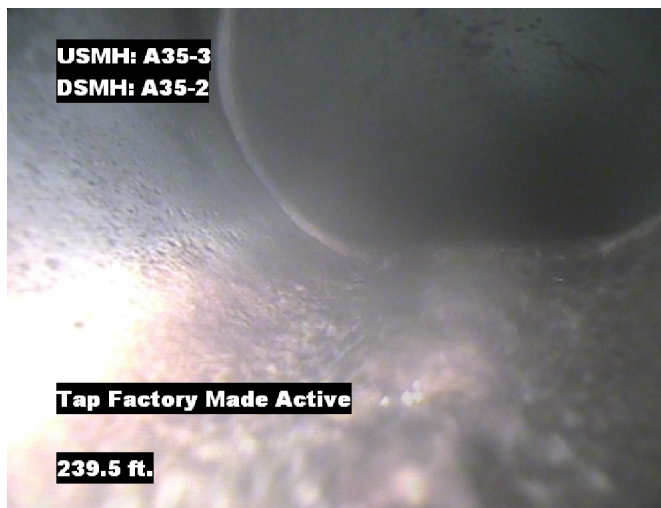
Distance: 239.5 ft. Grade: 0
Condition: Tap Factory Made Active
Remarks: N/A

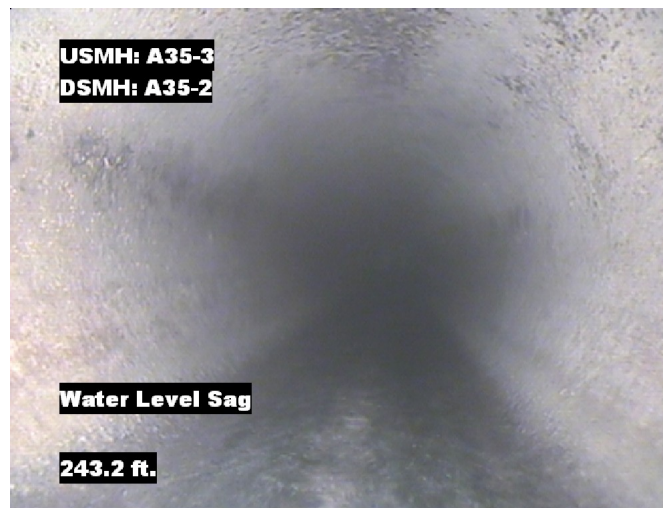
Distance: 243.2 ft. Grade: 2
Condition: Water Level Sag
Remarks: N/A

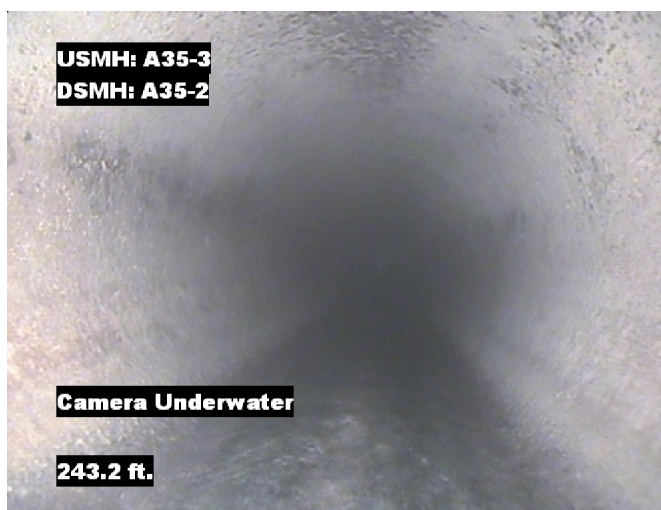
Distance: 243.2 ft. Grade: 4
Condition: Camera Underwater
Remarks: N/A

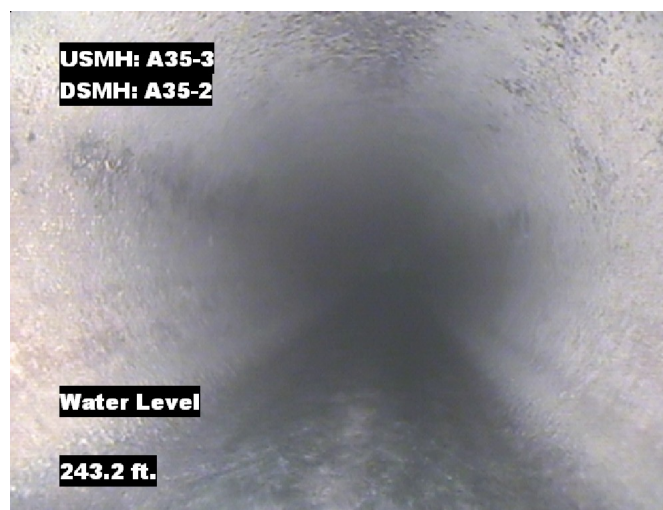
Distance: 243.2 ft. Grade: 0
Condition: Water Level
Remarks: N/A

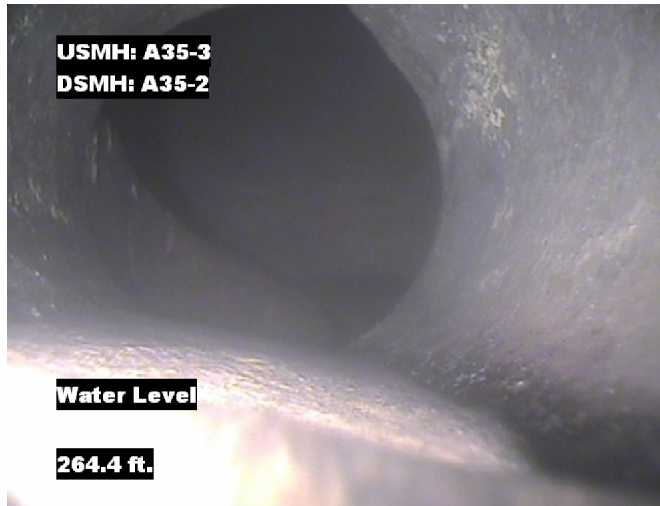
Distance: 264.3 ft. Grade: 0
Condition: Water Level
Remarks: N/A

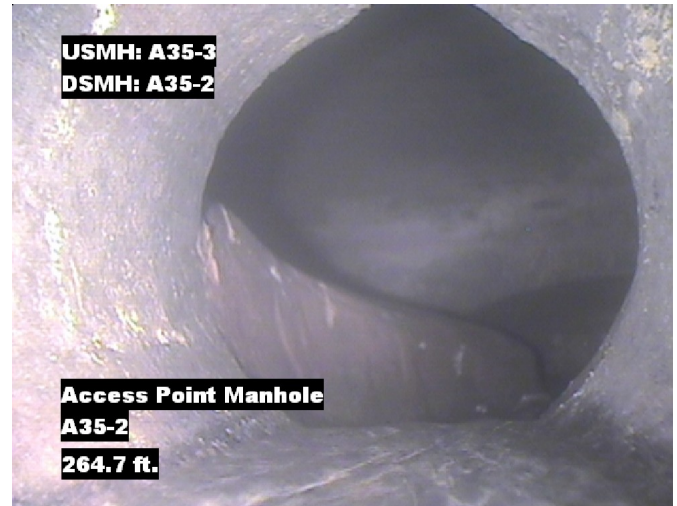
Distance: 264.7 ft. Grade: 0
Condition: Access Point Manhole
Remarks: A35-2
