# **Defect Listing**

Pipe Segment Refere		City		Street	Mat	Material		Sewer Use	
A37-1_A6-9		Oliver Springs		Parnell Dr	Concrete F	Concrete Pipe (non		Sanitary	
Upstream MH A37-1 DS Manhole A6-9		Total Length 241.8 Length surveyed 241.8		Year Laid	Sh	Shape Circular		Details	
					Circ				
				Year Renewed	Height	Width	Pipe Joint		
					8	8	4		
SPR	8	MPR	2	PO Number 4397-03 Work Order		Customer			
ODDI		MDDI					GRW		
SPRI	2.7	MPRI	2						
QSR	4131	QMR	2100	4397-02		Pre-	Pre-Rehabilitation Survey		
OI	PR	Surve	yed By	Direction	Di	Date		alabel	
1	0	Barry_Rogers		Downstream	2015	20150810			
OF	PRI	Certificate Number		Pre-Cleaning	Ti	Time			
2.5		U-1012-16405		Jetting	08	08:05			
		Date C	Cleaned	En		End Time		nal Info	
		2015	0810		08	:23

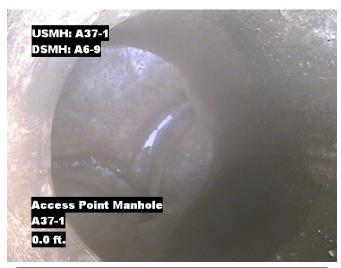
Distance: 0.0 ft. Grade: 0

Condition: Access Point Manhole

Remarks: A37-1

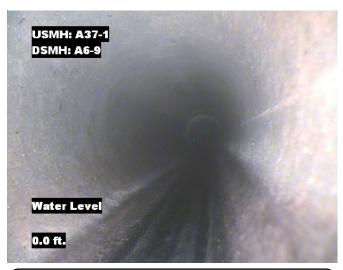
Distance: 0.0 ft. Grade: 0

Condition: Water Level

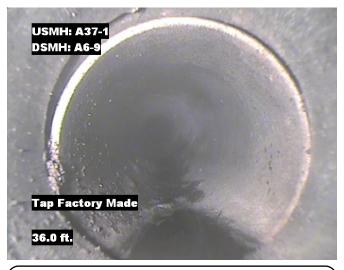
Distance: 36.0 ft. Grade: 0

Condition: Tap Factory Made

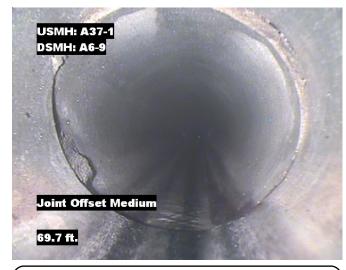
Distance: 69.7 ft. Grade: 1

Condition: Joint Offset Medium

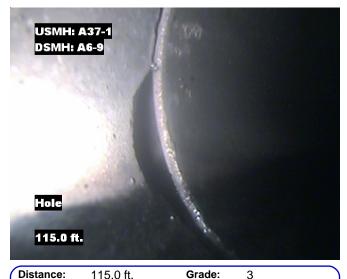
Distance: 115.0 ft.

Condition: Hole Remarks: N/A

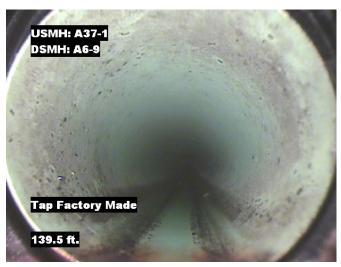
Distance: 139.5 ft. Grade: 0

Condition: Tap Factory Made

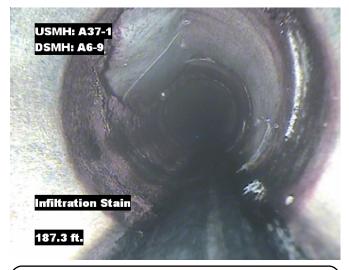
Distance: 187.3 ft. Grade: 0

Condition: Infiltration Stain

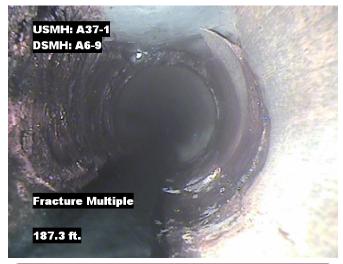
Distance: 187.3 ft. Grade: 4

**Condition:** Fracture Multiple

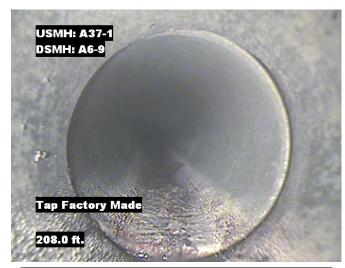
Distance: 208.0 ft. Grade: 0

Condition: Tap Factory Made

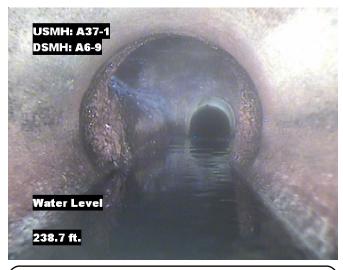
Distance: 238.6 ft. Grade: 0

Condition: Water Level

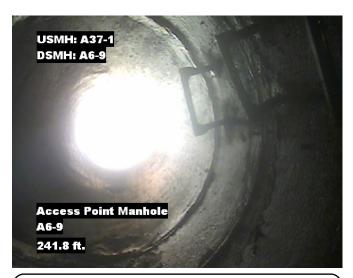
Distance: 241.8 ft. Grade: 0

Condition: Access Point Manhole

Remarks: A6-9
