Defect Listing

Image Report 4/Page

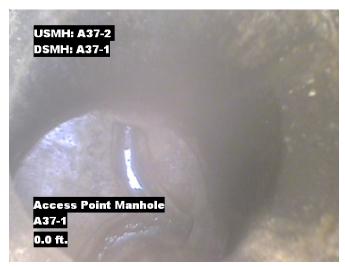
Distance: 0.0 ft. Grade: 0

Condition: Access Point Manhole

Remarks: A37-1

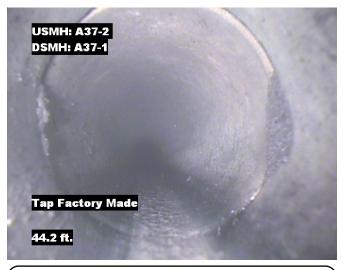
Distance: 44.2 ft. Grade: 0

Condition: Tap Factory Made

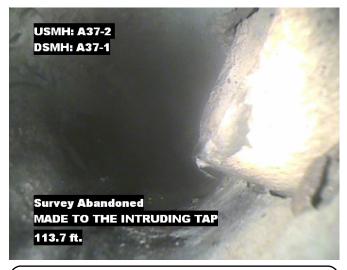
Distance: 113.7 ft. Grade: 0

Condition: Survey Abandoned

Remarks: MADE TO THE INTRUDING TAP
