Defect Listing

| Pipe Segment Refere... A38-1_A37-1 | City Oliver Springs | Street Hen Valley | Material Concrete Pipe (non-... | Location C... Light High... | Sewer Use Sanitary |

| SPRI N/A | MPRI N/A | Work Order 4397-02 | | Purpose Pre-Rehabilitation Survey | |

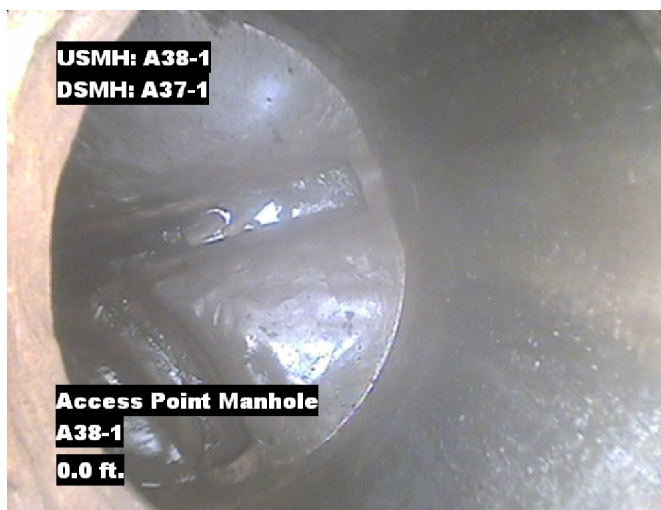
Distance: 0.0 ft. Grade: 0
Condition: Access Point Manhole
Remarks: A38-1

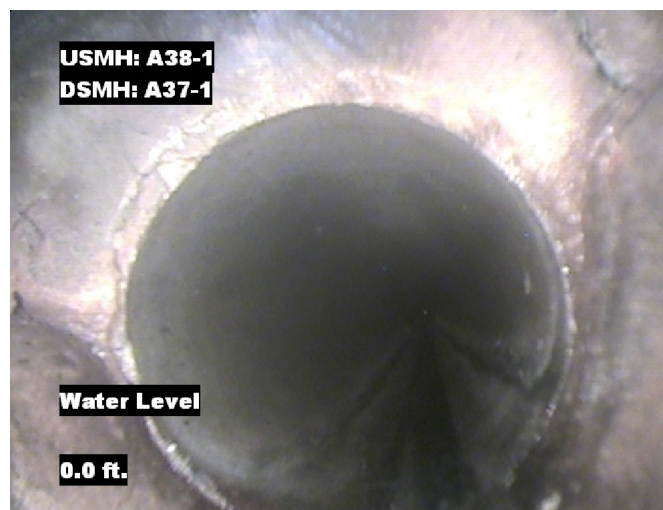
Distance: 0.0 ft. Grade: 0
Condition: Water Level
Remarks: N/A

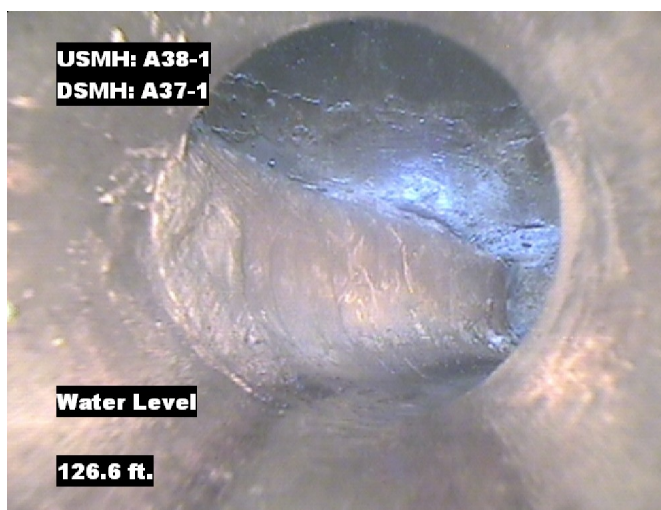
Distance: 126.5 ft. Grade: 0
Condition: Water Level
Remarks: N/A

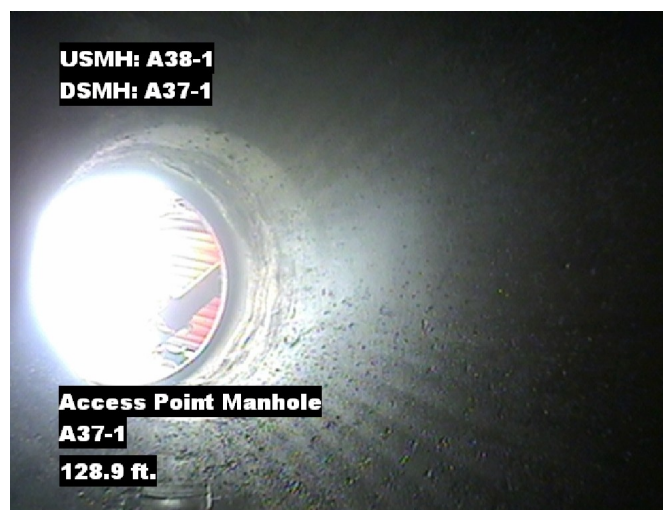
Distance: 128.9 ft. Grade: 0
Condition: Access Point Manhole
Remarks: A37-1
