Defect Listing

Pipe Segment Refere... A39-1_A6-8	City Oliver Springs	Street Tri_county Boulevar...	Material Concrete Pipe (non-...	Location C... Light High...	Sewer Use Sanitary
Upstream MH A39-1	Total Length 4	Year Laid	Shape Circular	Location Details	
DS Manhole A6-8	Length surveyed 4	Year Renewed	Height 8	Width 8	Pipe Joint... 4

SPR 7	MPR N/A	PO Number 4397-03	Customer GRW
SPRI 3.5	MPRI N/A	Work Order 4397-02	Purpose Pre-Rehabilitation Survey
QSR 5121	QMR N/A		
OPR 7	Surveyed By Charlie Gordon	Direction Upstream	Date 20150826
OPRI 3.5	Certificate Number U-615-07000491	Pre-Cleaning Jetting	Time 09:24
	Date Cleaned 20150826	End Time 09:28	Weather Damp
			Media label Upstream mh is buri...

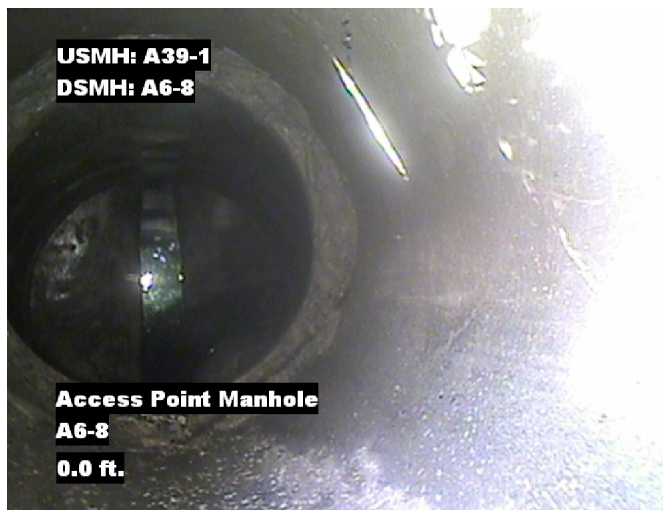
Distance: 0.0 ft. Grade: 0
Condition: Access Point Manhole
Remarks: A6-8

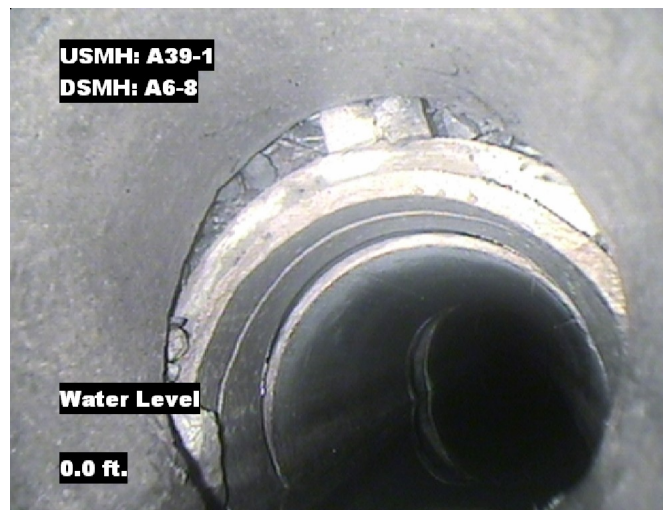
Distance: 0.0 ft. Grade: 0
Condition: Water Level
Remarks: N/A

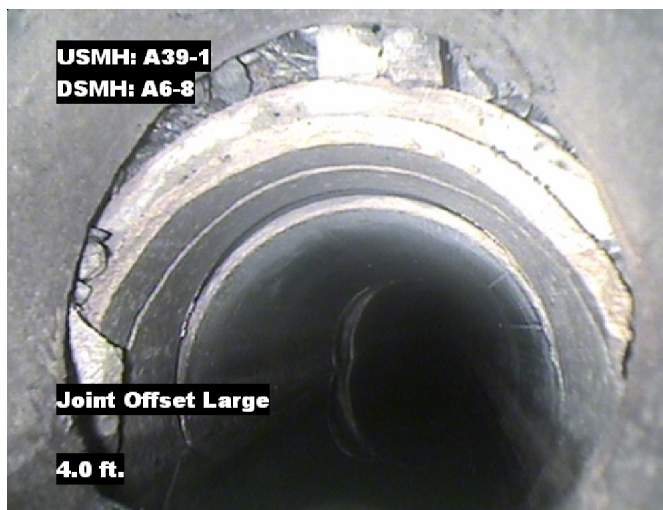
Distance: 4.0 ft. Grade: 2
Condition: Joint Offset Large
Remarks: N/A

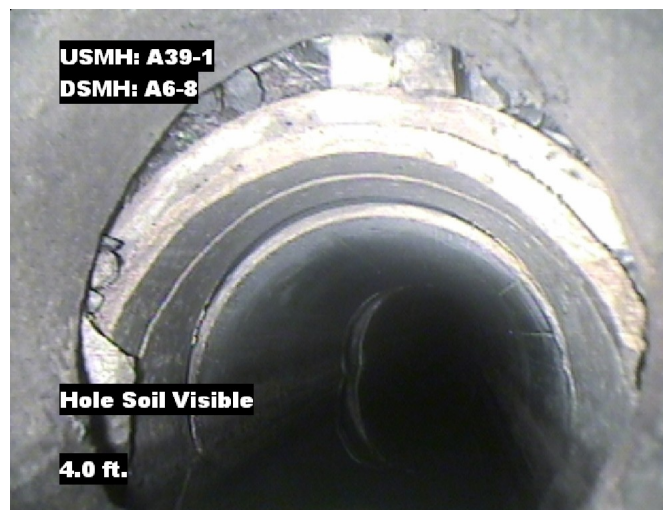
Distance: 4.0 ft. Grade: 5
Condition: Hole Soil Visible
Remarks: N/A

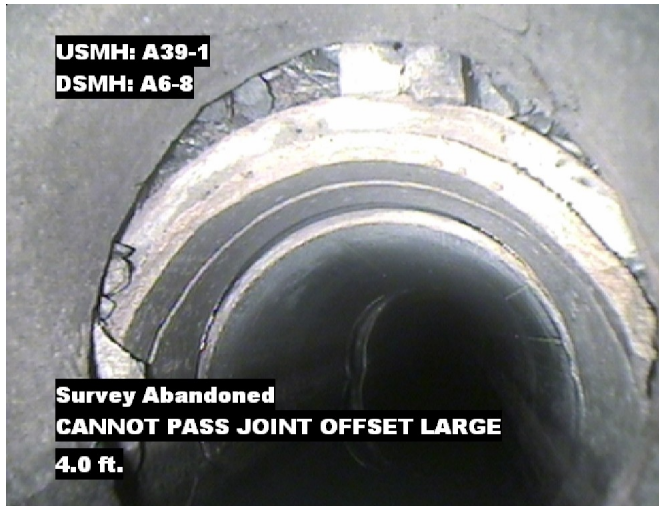
Distance: 4.0 ft. Grade: 0
Condition: Survey Abandoned
Remarks: CANNOT PASS JOINT OFFSET LARGE
