## Defect Listing

Pipe Segment Refere... <b>A39-2_A39-1</b>	City <b>Oliver Springs</b>	Street <b>Butler mill Rd</b>	Material <b>Concrete Pipe (non-...</b>	Location C... <b>Light High...</b>	Sewer Use <b>Sanitary</b>
Upstream MH <b>A39-2</b>	Total Length <b>233.5</b>	Year Laid	Shape <b>Circular</b>	Location Details	
DS Manhole <b>A39-1</b>	Length surveyed <b>233.5</b>	Year Renewed	Height <b>8</b>	Width <b>8</b>	Pipe Joint... <b>4</b>

SPR <b>N/A</b>	MPR <b>1</b>	PO Number <b>4397-03</b>	Customer <b>GRW</b>
SPRI <b>N/A</b>	MPRI <b>1</b>	Work Order <b>4397-02</b>	Purpose <b>Pre-Rehabilitation Survey</b>
QSR <b>N/A</b>	QMR <b>1100</b>		
OPR <b>1</b>	Surveyed By <b>Charlie Gordon</b>	Direction <b>Downstream</b>	Date <b>20150826</b>
OPRI <b>1</b>	Certificate Number <b>U-615-07000491</b>	Pre-Cleaning <b>No Pre-Cleaning</b>	Time <b>08:19</b>
	Date Cleaned	End Time <b>08:32</b>	Weather <b>Damp</b>
			Additional Info <b>Unable to clean bec...</b>

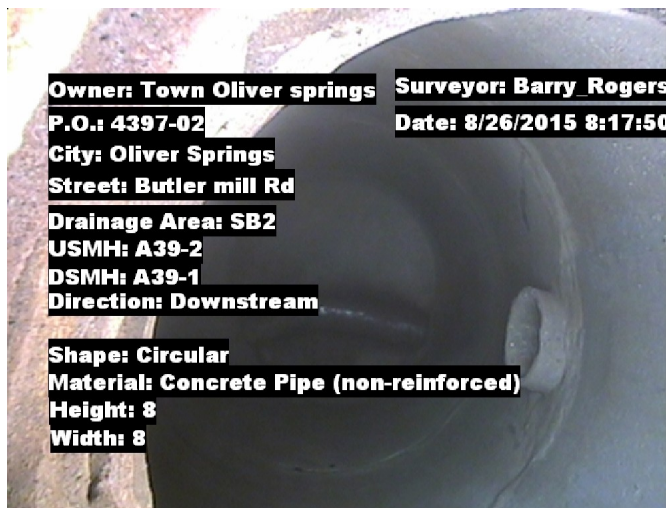
Distance: 0.0 ft. Grade: 0  
Condition: Access Point Manhole  
Remarks: A39-2

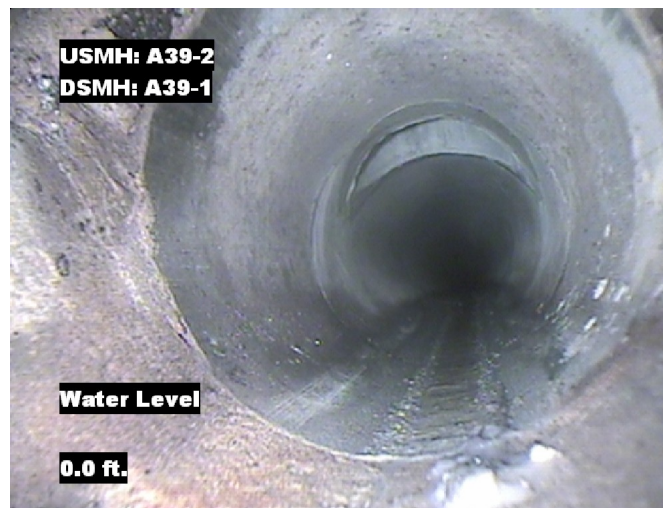
Distance: 0.0 ft. Grade: 0  
Condition: Water Level  
Remarks: N/A

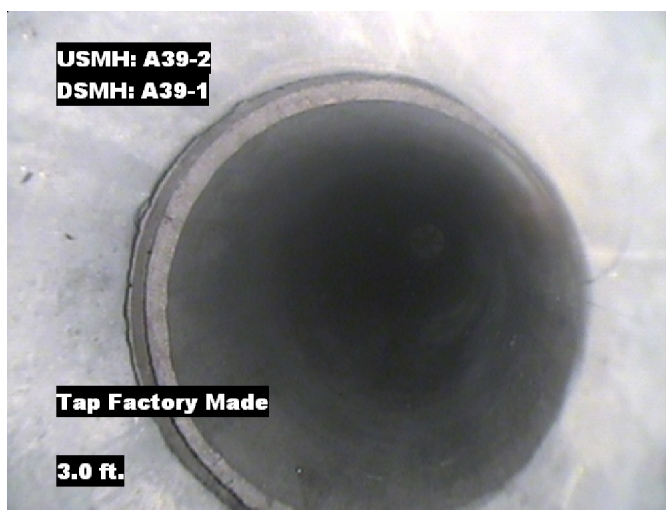
Distance: 3.0 ft. Grade: 0  
Condition: Tap Factory Made  
Remarks: N/A

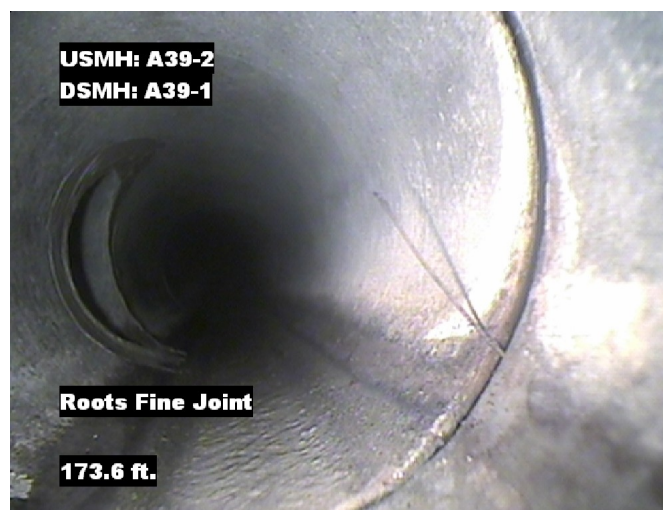
Distance: 173.6 ft. Grade: 1  
Condition: Roots Fine Joint  
Remarks: N/A

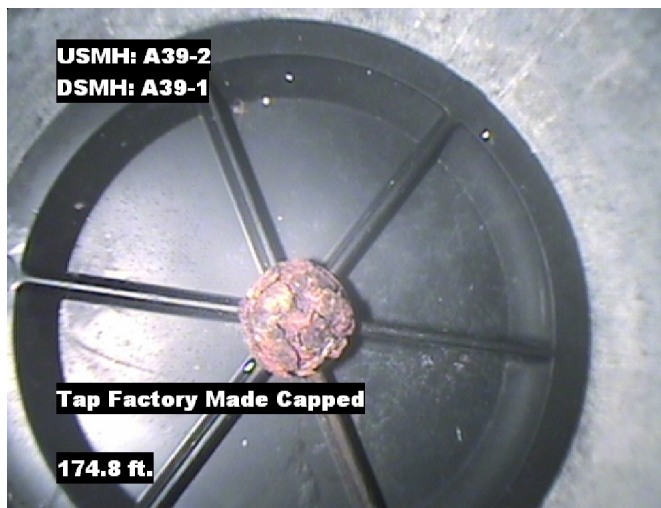
Distance: 174.8 ft. Grade: 0  
Condition: Tap Factory Made Capped  
Remarks: N/A

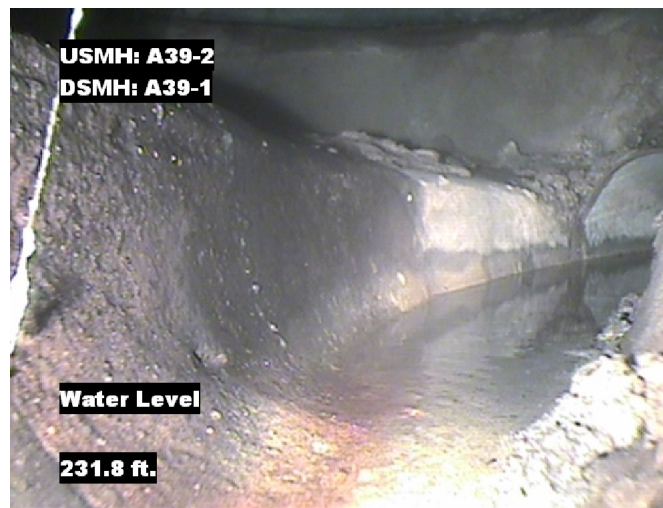
Distance: 231.8 ft. Grade: 0  
Condition: Water Level  
Remarks: N/A

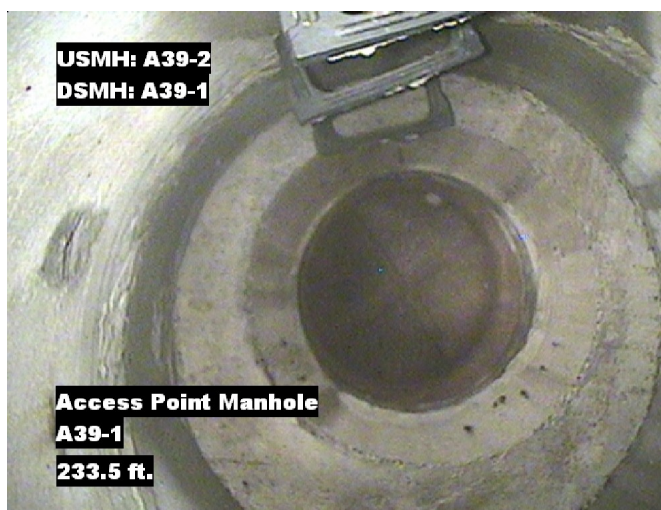
Distance: 233.5 ft. Grade: 0  
Condition: Access Point Manhole  
Remarks: A39-1
