Defect Listing

Pipe Segment Refere... A39-3_A39-2	City Oliver Springs	Street Butler Mill Drive	Material Concrete Pipe (non-...		Location C... Light High...	Sewer Use Sanitary
Upstream MH A39-3	Total Length 221.9	Year Laid	Shape Circular		Location Details	
DS Manhole A39-2	Length surveyed 221.9	Year Renewed	Height 8	Width 8	Pipe Joint... 4

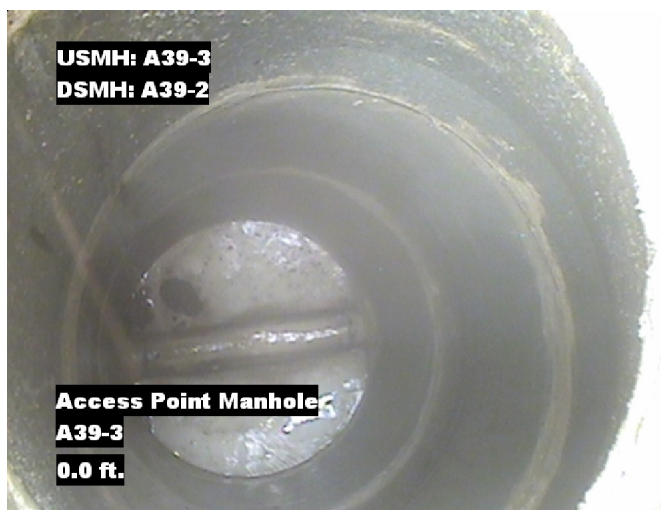
Distance: 0.0 ft. Grade: 0
Condition: Access Point Manhole
Remarks: A39-3

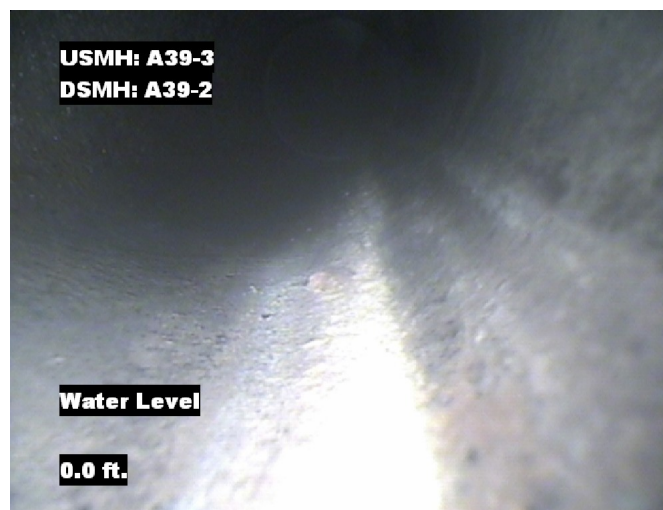
Distance: 0.0 ft. Grade: 0
Condition: Water Level
Remarks: N/A

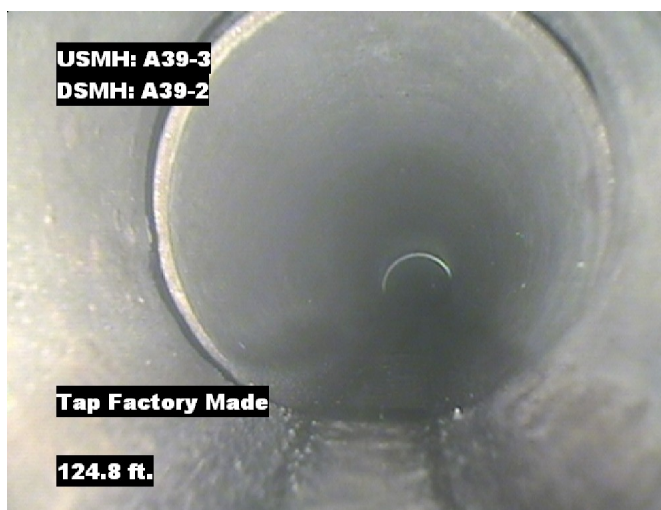
Distance: 124.8 ft. Grade: 0
Condition: Tap Factory Made
Remarks: N/A

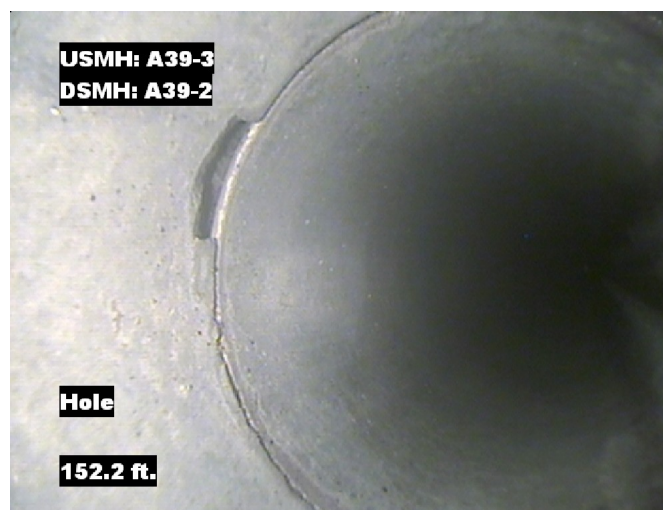
Distance: 152.2 ft. Grade: 3
Condition: Hole
Remarks: N/A

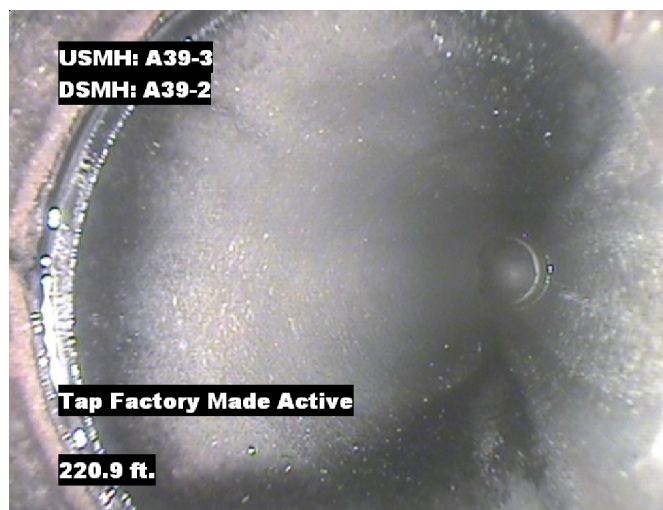
Distance: 220.9 ft. Grade: 0
Condition: Tap Factory Made Active
Remarks: N/A

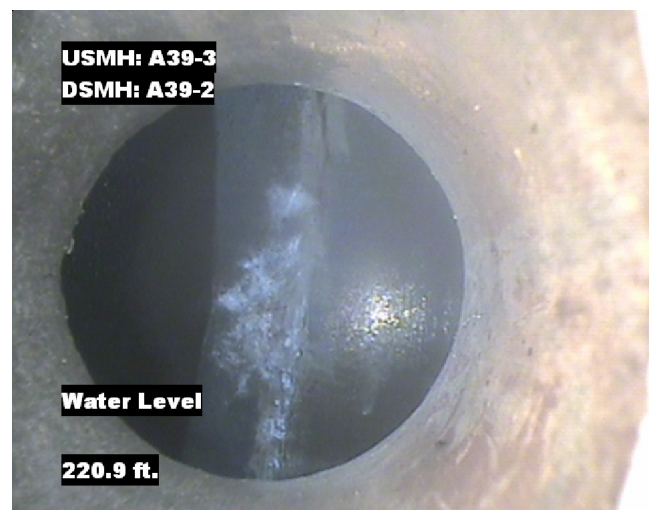
Distance: 220.9 ft. Grade: 0
Condition: Water Level
Remarks: N/A

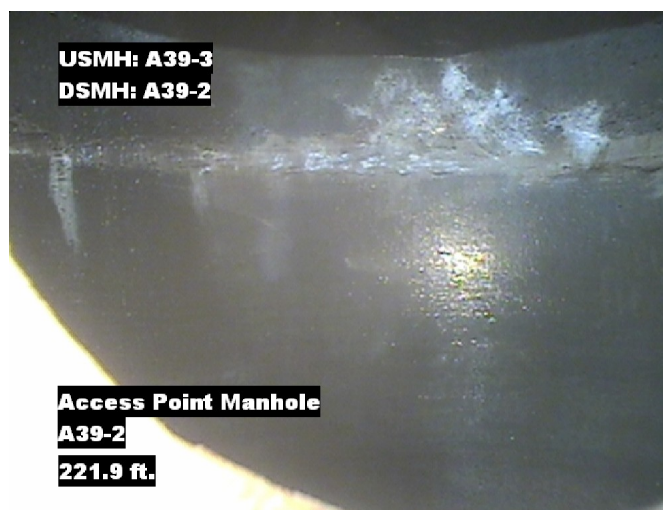
Distance: 221.9 ft. Grade: 0
Condition: Access Point Manhole
Remarks: A39-2
