Defect Listing

Pipe Segment Refere... A39-4_A39-3	City Oliver Springs	Street Butler Mill Dr	Material Fibreglass Reinforc...	Location C... Yard	Sewer Use Sanitary
Upstream MH A39-4	Total Length 227.3	Year Laid	Shape Circular	Location Details	
DS Manhole A39-3	Length surveyed 227.3	Year Renewed	Height 8	Width 8	Pipe Joint... N/A

SPR 3	MPR 2	PO Number 4397-03		Customer GRW	
SPRI 3	MPRI 2	Work Order 4397-02		Purpose Pre-Rehabilitation Survey	
QSR 3100	QMR 2100				
OPR 5	Surveyed By Charlie Gordon	Direction Upstream	Date 20150819	Media label	
OPRI 2.5	Certificate Number U-615-07000491	Pre-Cleaning Jetting	Time 13:59	Weather Damp	
Date Cleaned 20150819			End Time 14:20	Additional Info

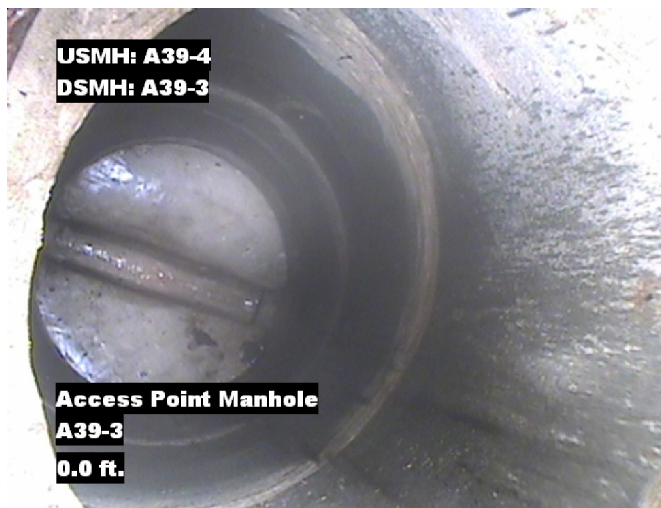
Distance: 0.0 ft. Grade: 0
Condition: Access Point Manhole
Remarks: A39-3

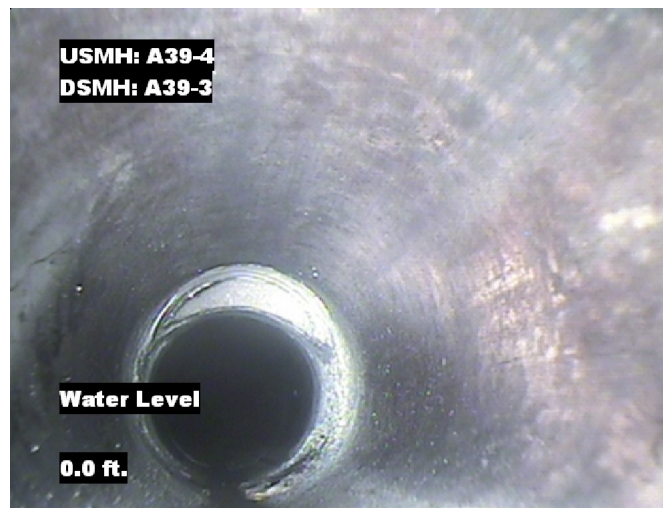
Distance: 0.0 ft. Grade: 0
Condition: Water Level
Remarks: N/A

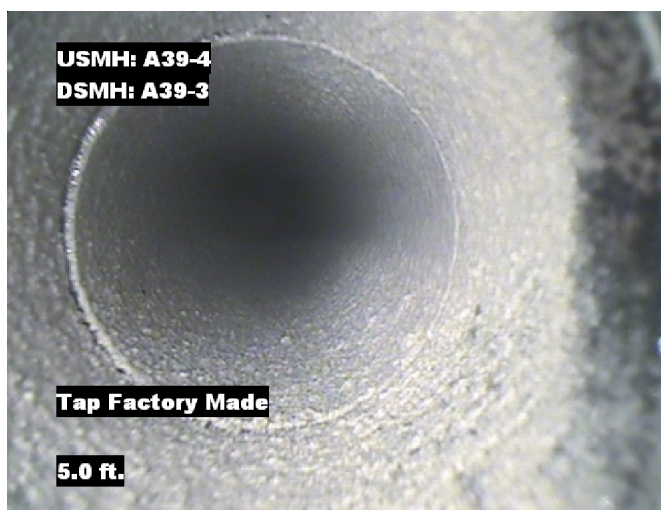
Distance: 5.0 ft. Grade: 0
Condition: Tap Factory Made
Remarks: N/A

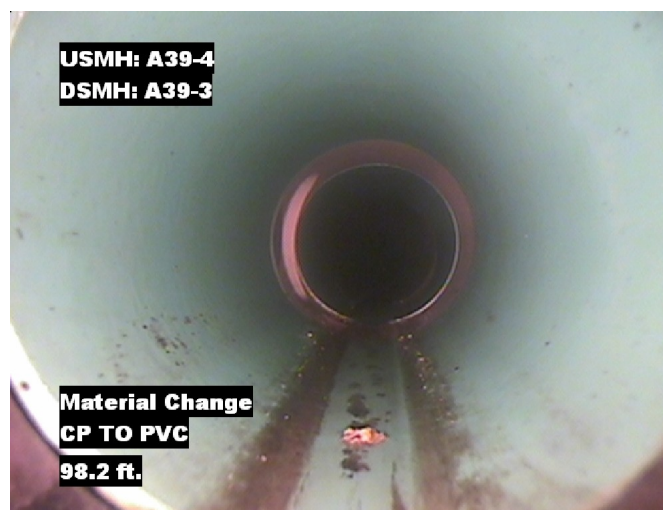
Distance: 98.2 ft. Grade: 0
Condition: Material Change
Remarks: CP TO PVC

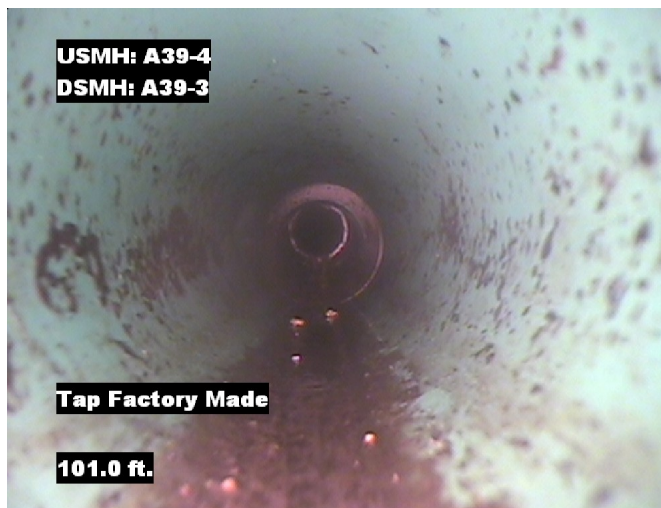
Distance: 101.0 ft. Grade: 0
Condition: Tap Factory Made
Remarks: N/A

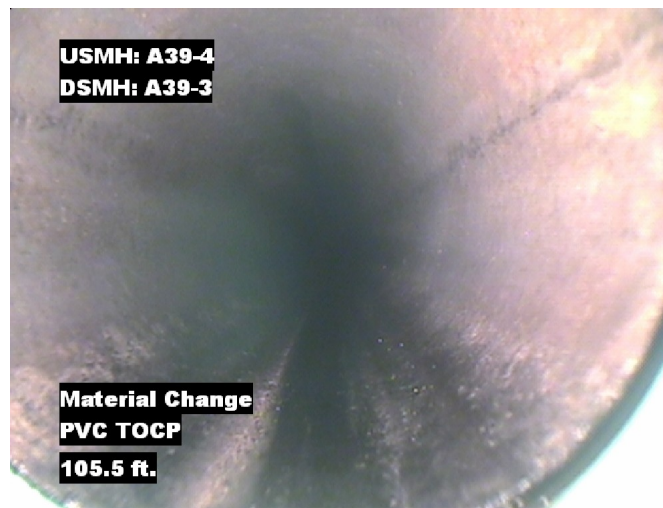
Distance: 105.5 ft. Grade: 0
Condition: Material Change
Remarks: PVC TOCP

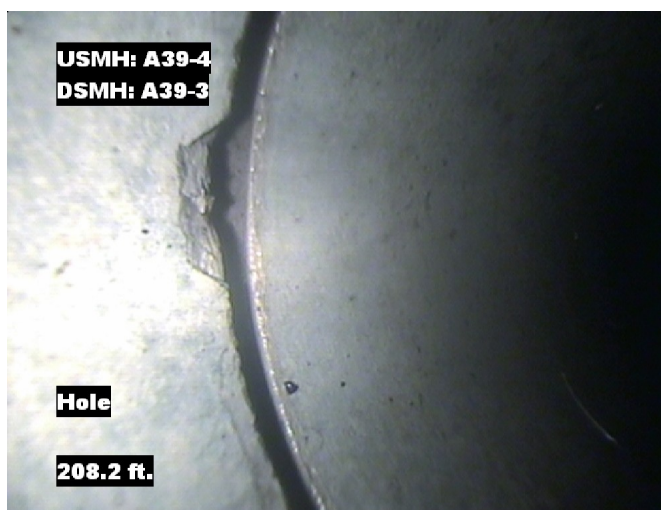
Distance: 208.2 ft. Grade: 3
Condition: Hole
Remarks: N/A

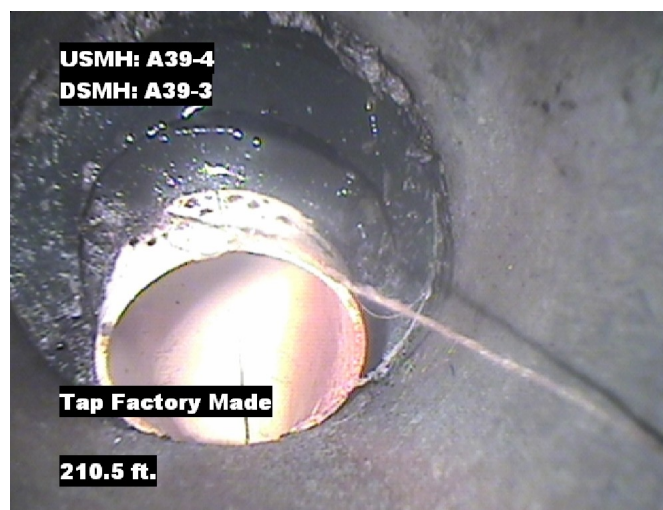
Distance: 210.5 ft. Grade: 0
Condition: Tap Factory Made
Remarks: N/A

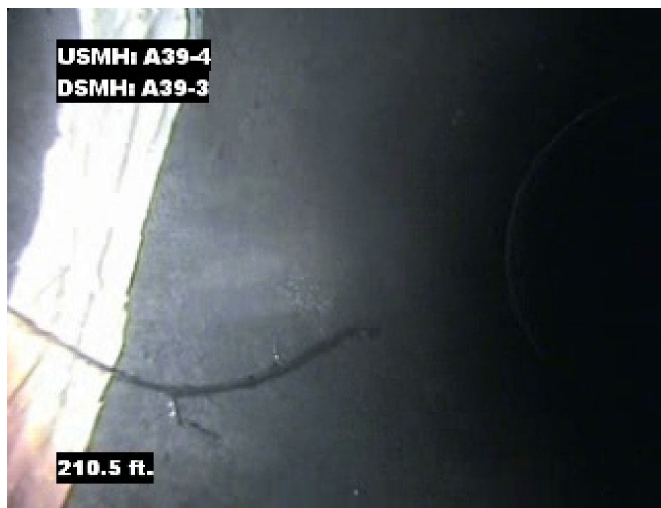
Distance: 210.5 ft. Grade: 2
Condition: Roots Fine Barrell
Remarks: N/A

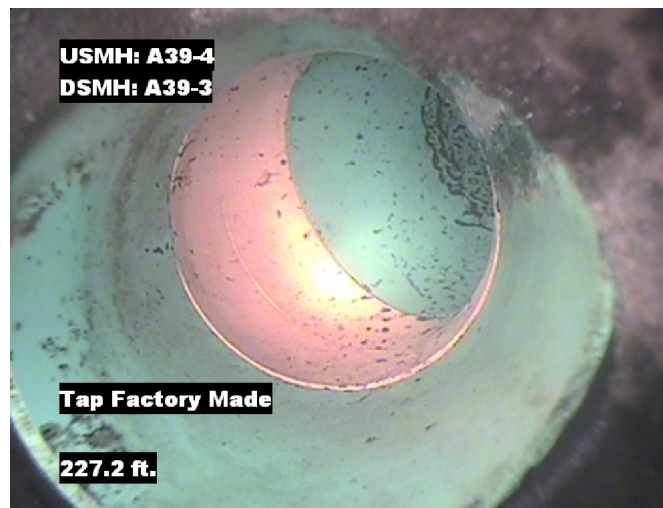
Distance: 227.2 ft. Grade: 0
Condition: Tap Factory Made
Remarks: N/A

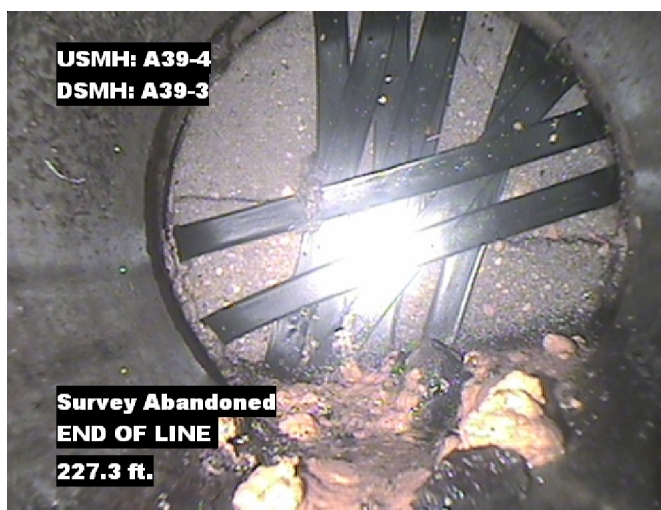
Distance: 227.3 ft. Grade: 0
Condition: Survey Abandoned
Remarks: END OF LINE
