## Defect Listing

Pipe Segment Refere... <b>A40-1_A6-15</b>	City <b>Oliver Springs</b>	Street <b>Highway 61</b>	Material <b>Concrete Pipe (non-...</b>	Location C... <b>Main Highw...</b>	Sewer Use <b>Sanitary</b>
Upstream MH <b>A40-1</b>	Total Length <b>188.3</b>	Year Laid	Shape <b>Circular</b>	Location Details	
DS Manhole <b>A6-15</b>	Length surveyed <b>188.3</b>	Year Renewed	Height <b>8</b>	Width <b>8</b>	Pipe Joint... <b>4</b>

SPR <b>4</b>	MPR <b>2</b>	PO Number <b>4397-03</b>	Customer <b>GRW</b>
SPRI <b>2</b>	MPRI <b>2</b>	Work Order <b>4397-02</b>	Purpose <b>Pre-Rehabilitation Survey</b>
QSR <b>2200</b>	QMR <b>2100</b>		
OPR <b>6</b>	Surveyed By <b>Charlie Gordon</b>	Direction <b>Upstream</b>	Date <b>20150820</b>
OPRI <b>2</b>	Certificate Number <b>U-615-07000491</b>	Pre-Cleaning <b>Jetting</b>	Time <b>09:53</b>
	Date Cleaned <b>20150820</b>	End Time <b>10:14</b>	Weather <b>Light Rain</b>
			Media label
			Additional Info

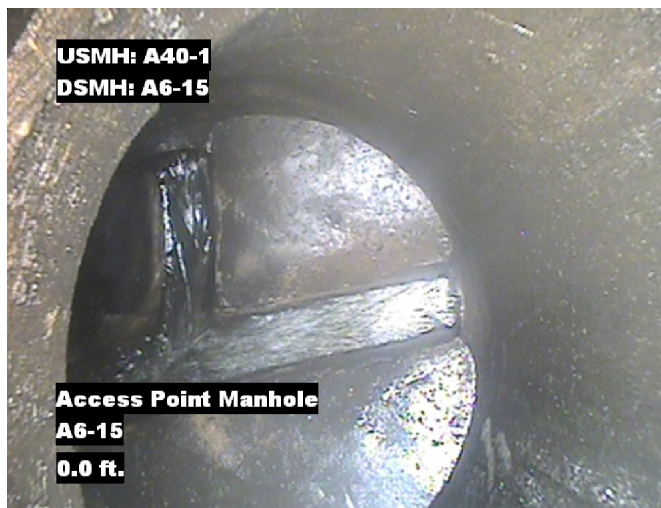
Distance: 0.0 ft. Grade: 0  
Condition: Access Point Manhole  
Remarks: A6-15

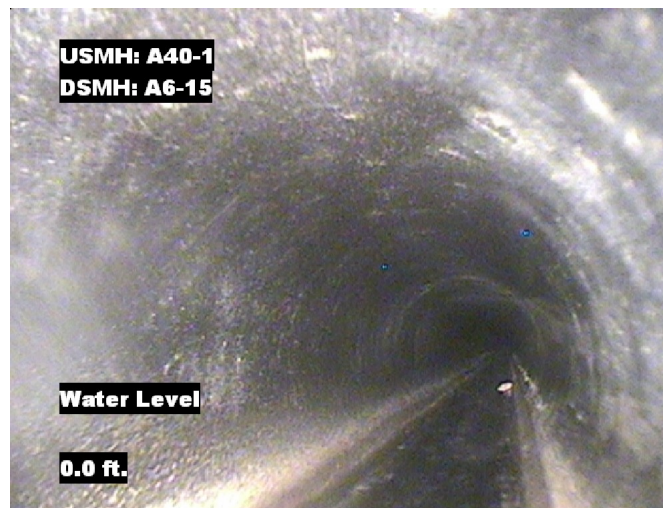
Distance: 0.0 ft. Grade: 0  
Condition: Water Level  
Remarks: N/A

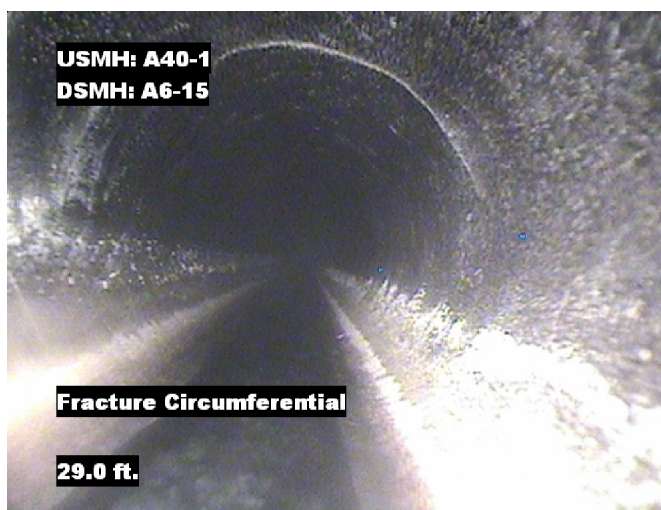
Distance: 29.0 ft. Grade: 2  
Condition: Fracture Circumferential  
Remarks: N/A

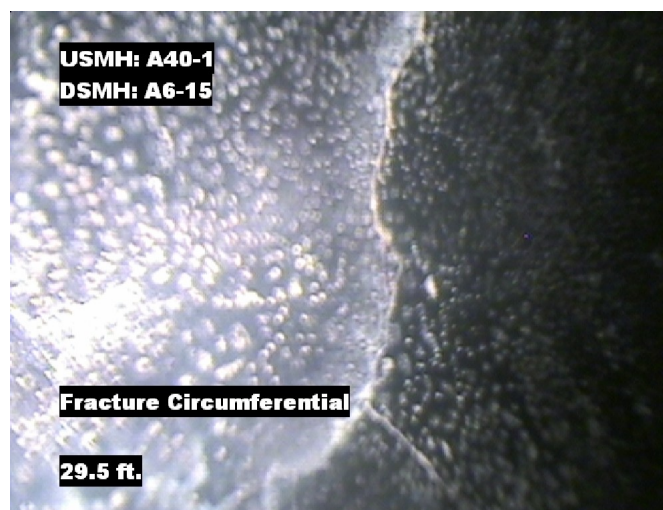
Distance: 29.5 ft. Grade: 2  
Condition: Fracture Circumferential  
Remarks: N/A

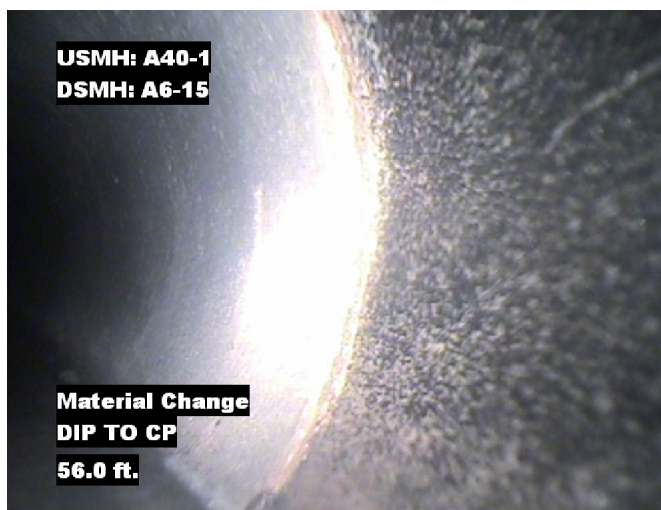
Distance: 56.0 ft. Grade: 0  
Condition: Material Change  
Remarks: DIP TO CP

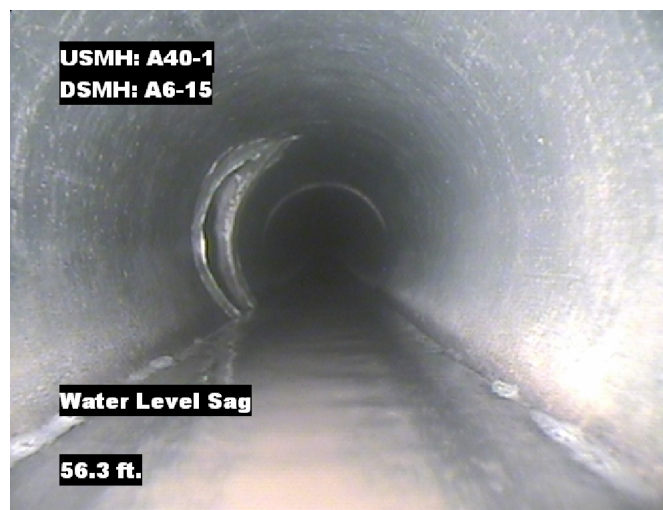
Distance: 56.3 ft. Grade: 2  
Condition: Water Level Sag  
Remarks: N/A

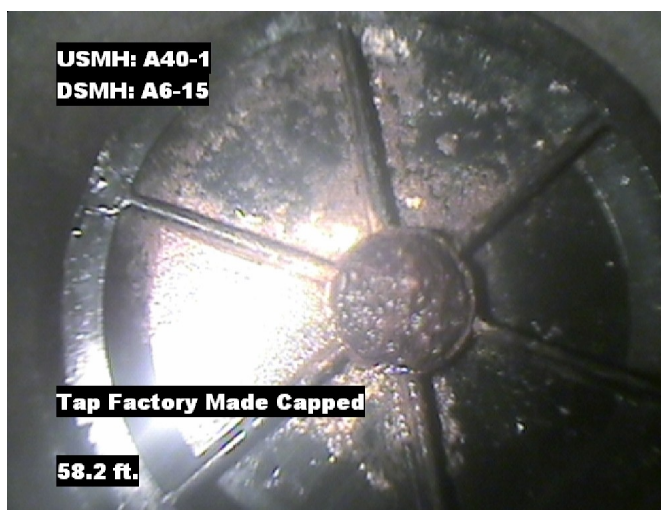
Distance: 58.2 ft. Grade: 0  
Condition: Tap Factory Made Capped  
Remarks: N/A

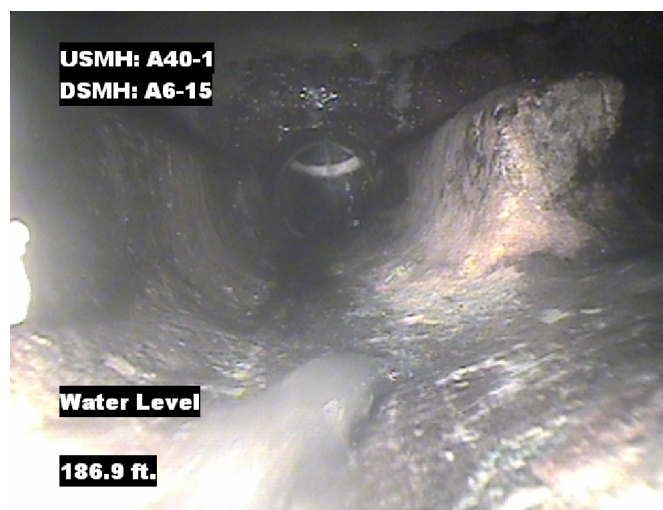
Distance: 186.9 ft. Grade: 0  
Condition: Water Level  
Remarks: N/A

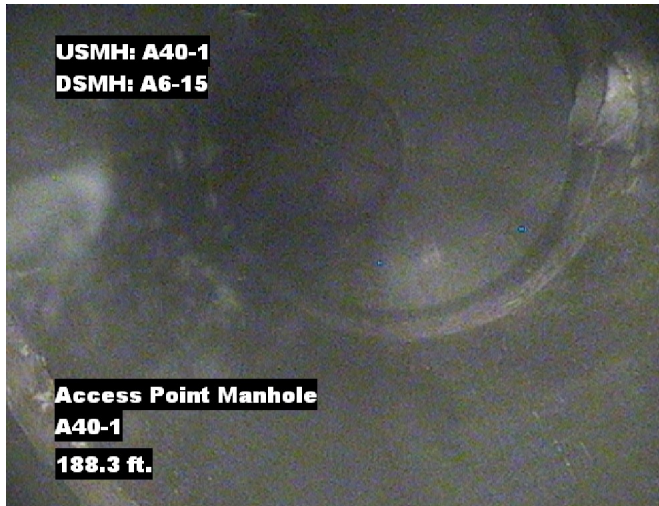
Distance: 188.3 ft.      Grade: 0  
Condition: Access Point Manhole  
Remarks: A40-1
