Defect Listing

Pipe Segment Refere... A40-2_A40-1	City Oliver Springs	Street Butler Mill Dr	Material Concrete Pipe (non-...	Location C... Yard	Sewer Use Sanitary
Upstream MH A40-2	Total Length 173.1	Year Laid	Shape Circular	Location Details	
DS Manhole A40-1	Length surveyed 173.1	Year Renewed	Height 8	Width 8	Pipe Joint... 4

SPR 1	MPR N/A	PO Number 4397-03	Customer GRW
SPRI 1	MPRI N/A	Work Order 4397-02	Purpose Pre-Rehabilitation Survey
QSR 1100	QMR N/A		
OPR 1	Surveyed By Charlie Gordon	Direction Downstream	Date 20150819
OPRI 1	Certificate Number U-615-07000491	Pre-Cleaning Jetting	Time 08:32
	Date Cleaned 20150819	End Time 08:46	Weather Light Rain
			Media label
			Additional Info

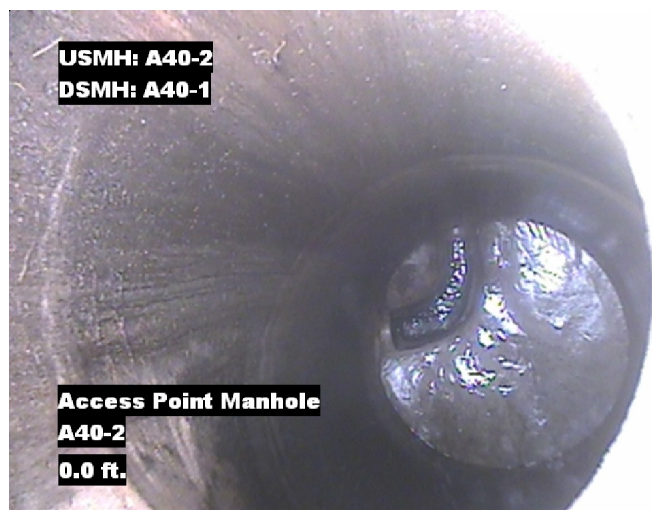
Distance: 0.0 ft. Grade: 0
Condition: Access Point Manhole
Remarks: A40-2

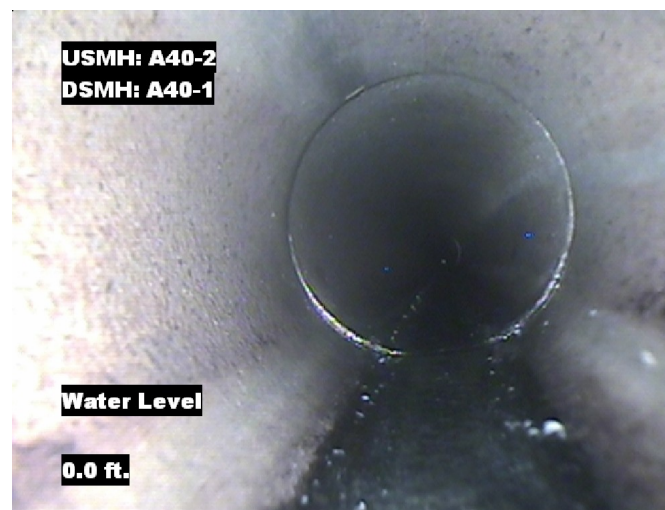
Distance: 0.0 ft. Grade: 0
Condition: Water Level
Remarks: N/A

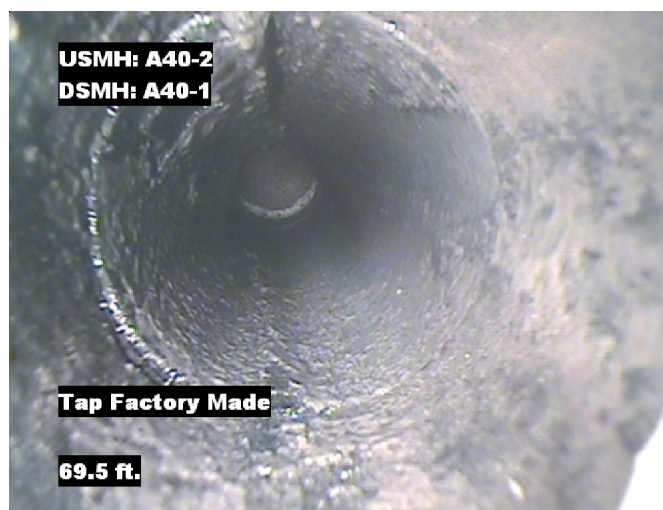
Distance: 69.5 ft. Grade: 0
Condition: Tap Factory Made
Remarks: N/A

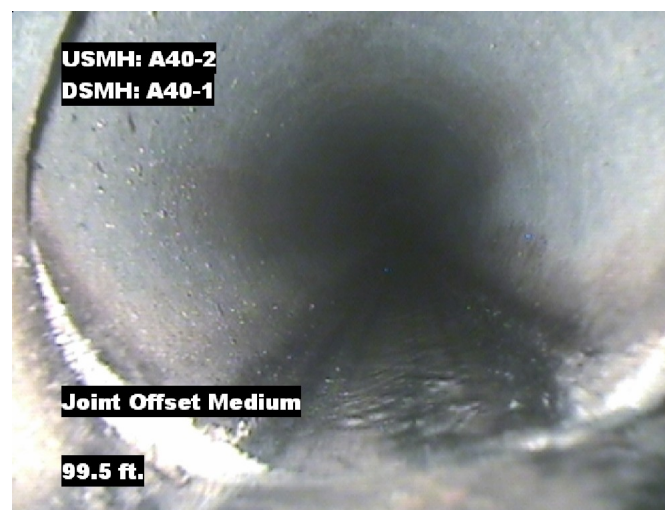
Distance: 99.5 ft. Grade: 1
Condition: Joint Offset Medium
Remarks: N/A

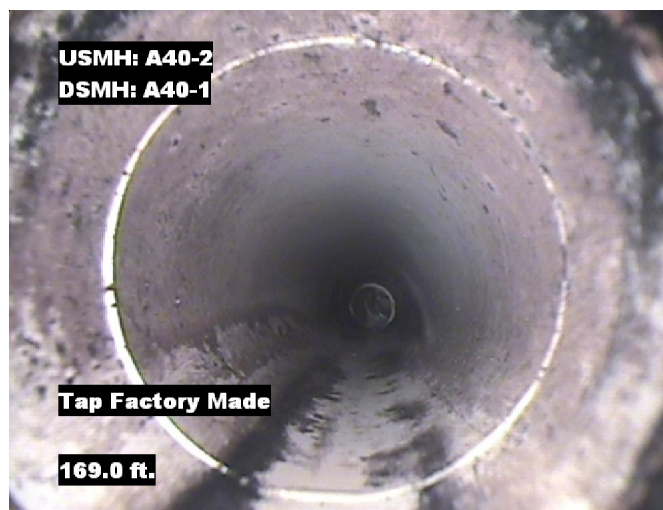
Distance: 169.0 ft. Grade: 0
Condition: Tap Factory Made
Remarks: N/A

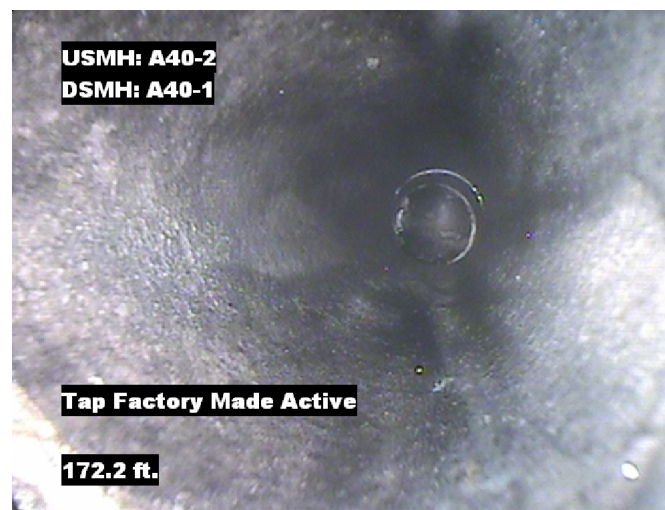
Distance: 172.2 ft. Grade: 0
Condition: Tap Factory Made Active
Remarks: N/A

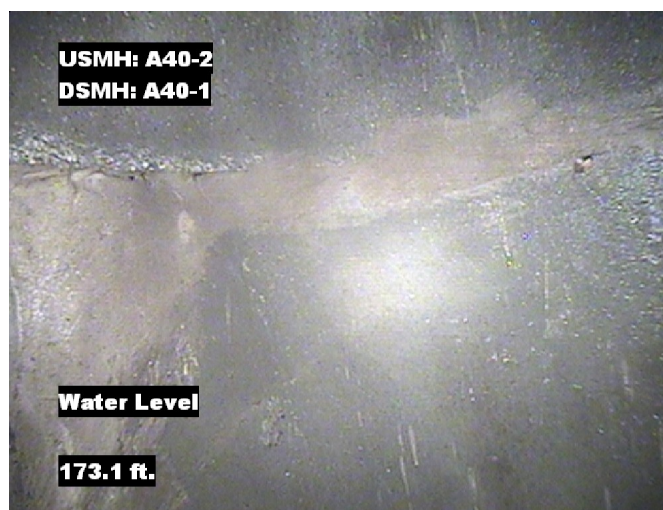
Distance: 173.1 ft. Grade: 0
Condition: Water Level
Remarks: N/A

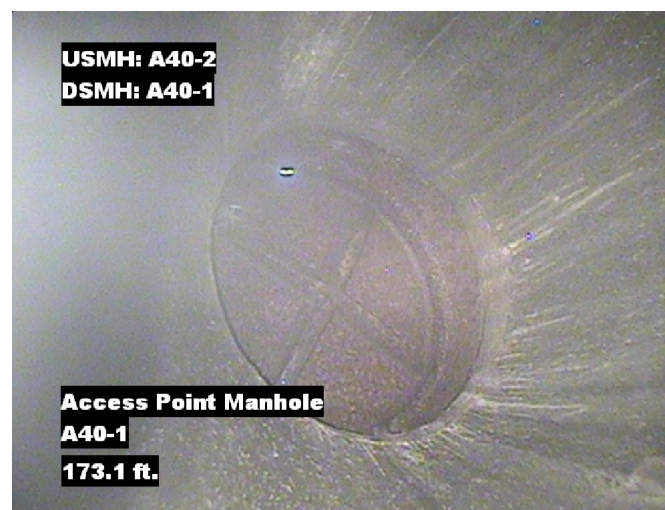
Distance: 173.1 ft. Grade: 0
Condition: Access Point Manhole
Remarks: A40-1
