Defect Listing

Pipe Segment Refere... A40-3_A40-2	City Oliver Springs	Street Butler mill Dr	Material Concrete Pipe (non-...	Location C... Light High...	Sewer Use Sanitary
Upstream MH A40-3	Total Length 211.9	Year Laid	Shape Circular	Location Details	
DS Manhole A40-2	Length surveyed 211.9	Year Renewed	Height 8	Width 8	Pipe Joint... 4

SPR 7	MPR 2	PO Number 4397-03	Customer GRW
SPRI 3.5	MPRI 2	Work Order 4397-02	Purpose Pre-Rehabilitation Survey
QSR 5121	QMR 2100		
OPR 9	Surveyed By Charlie Gordon	Direction Downstream	Date 20150819
OPRI 3	Certificate Number U-615-07000491	Pre-Cleaning Jetting	Time 07:30
	Date Cleaned 20150819	End Time 07:51	Weather Light Rain
			Media label
			Additional Info

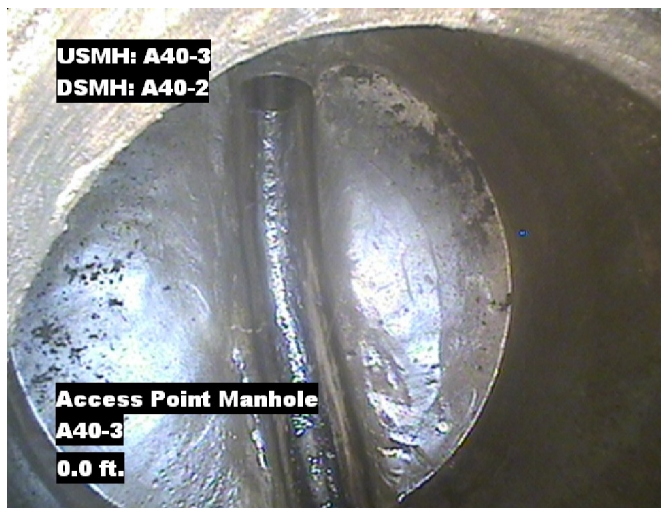
Distance: 0.0 ft. Grade: 0
Condition: Access Point Manhole
Remarks: A40-3

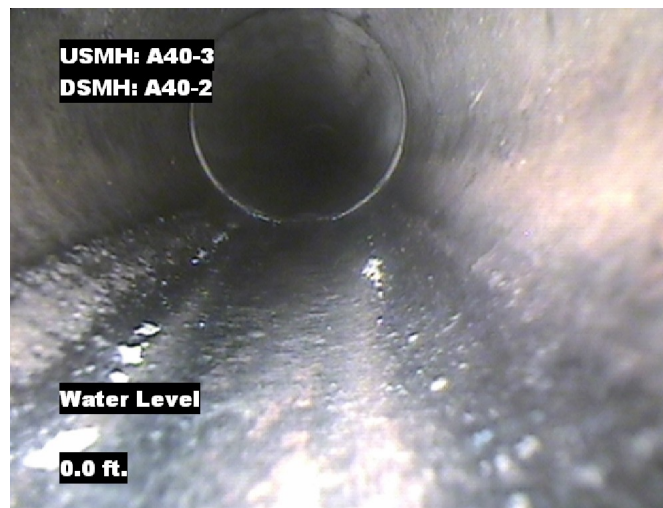
Distance: 0.0 ft. Grade: 0
Condition: Water Level
Remarks: N/A

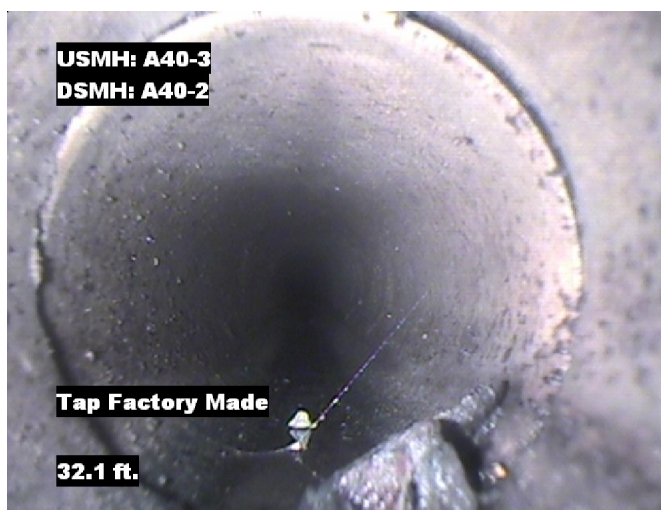
Distance: 32.1 ft. Grade: 0
Condition: Tap Factory Made
Remarks: N/A

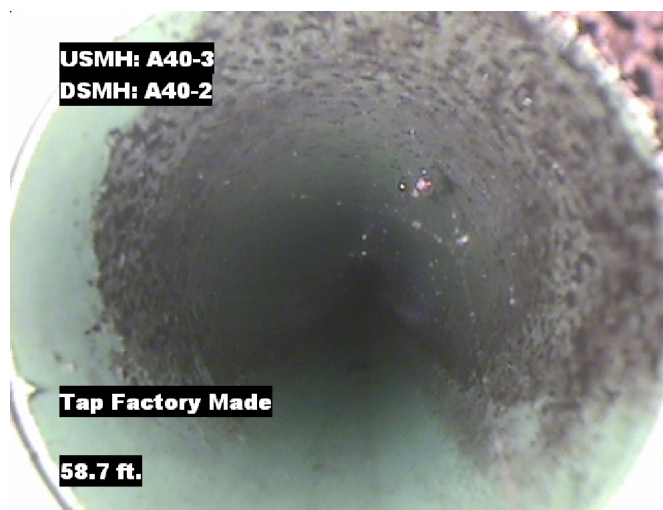
Distance: 58.7 ft. Grade: 0
Condition: Tap Factory Made
Remarks: N/A

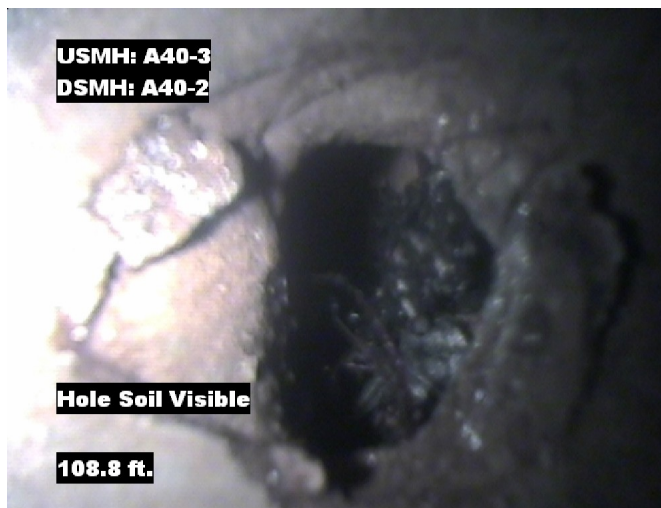
Distance: 108.8 ft. Grade: 5
Condition: Hole Soil Visible
Remarks: N/A

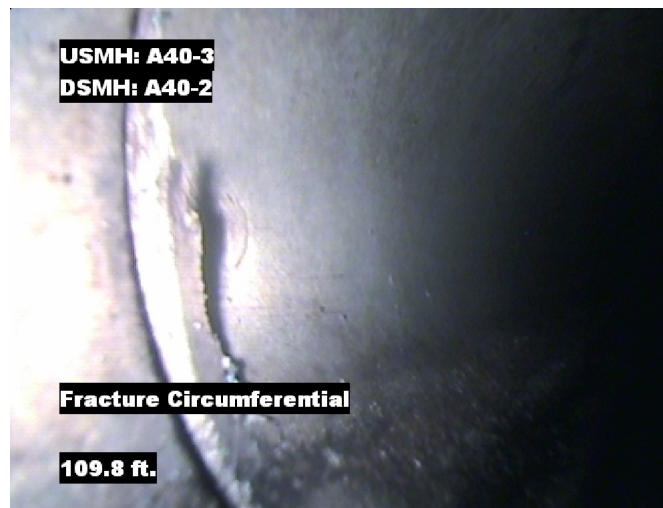
Distance: 109.8 ft. Grade: 2
Condition: Fracture Circumferential
Remarks: N/A

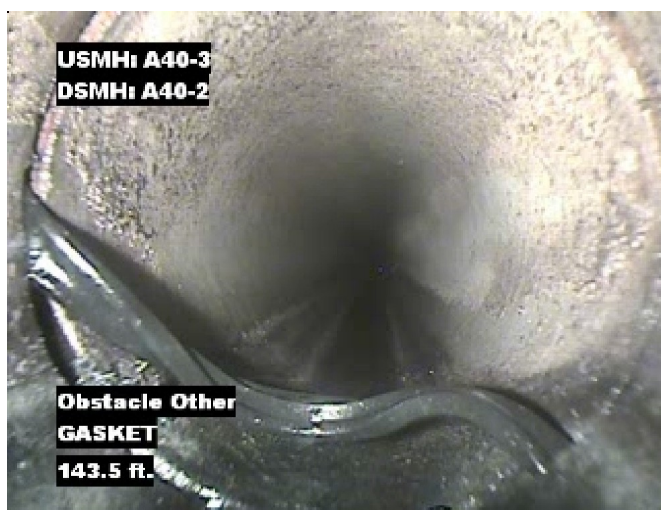
Distance: 143.5 ft. Grade: 2
Condition: Intruding Sealing Ring Loose/Poorly Fitting
Remarks: N/A

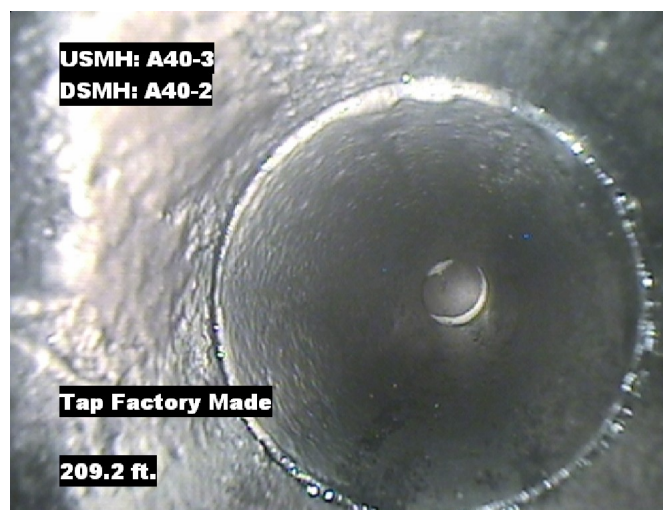
Distance: 209.2 ft. Grade: 0
Condition: Tap Factory Made
Remarks: N/A

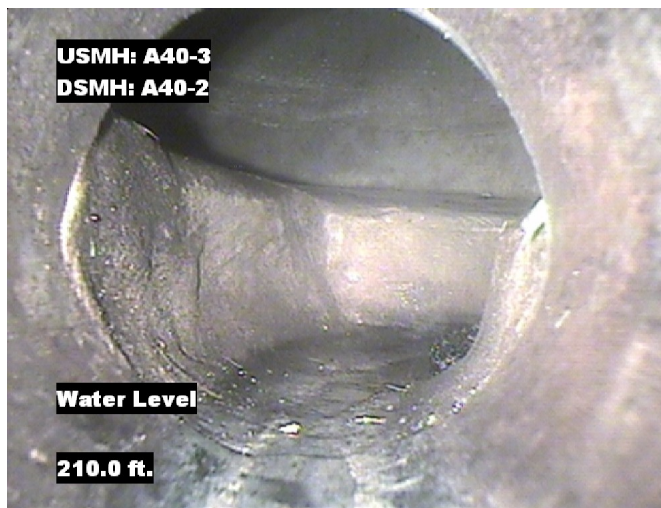
Distance: 210.0 ft. Grade: 0
Condition: Water Level
Remarks: N/A

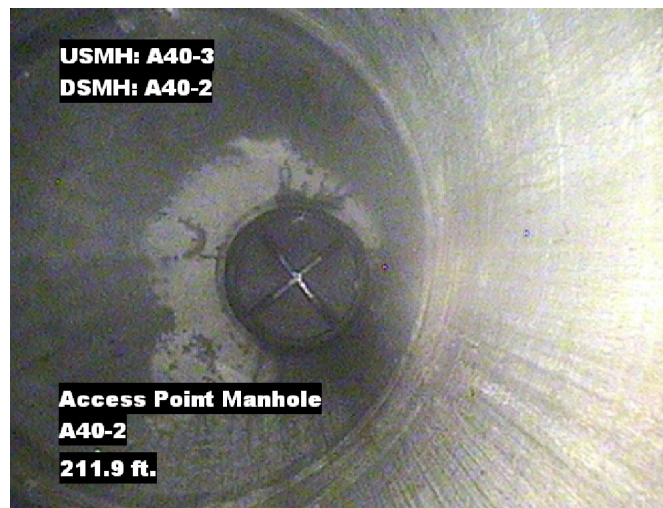
Distance: 211.9 ft. Grade: 0
Condition: Access Point Manhole
Remarks: A40-2
