Defect Listing

Pipe Segment Refere... A40-4_A40-3	City Oliver Springs	Street Butler mill Rd	Material Concrete Pipe (non-...	Location C... Light High...	Sewer Use Sanitary
Upstream MH A40-4	Total Length 362	Year Laid	Shape Circular	Location Details	
DS Manhole A40-3	Length surveyed 362	Year Renewed	Height 8	Width 8	Pipe Joint... 4

SPR N/A	MPR N/A	PO Number 4397-03	Customer GRW
SPRI N/A	MPRI N/A	Work Order 4397-02	Purpose Pre-Rehabilitation Survey
QSR N/A	QMR N/A		
OPR N/A	Surveyed By Charlie Gordon	Direction Downstream	Date 20150819
OPRI N/A	Certificate Number U-615-07000491	Pre-Cleaning Jetting	Time 06:46
	Date Cleaned 20150819	End Time 07:10	Weather Light Rain
			Additional Info

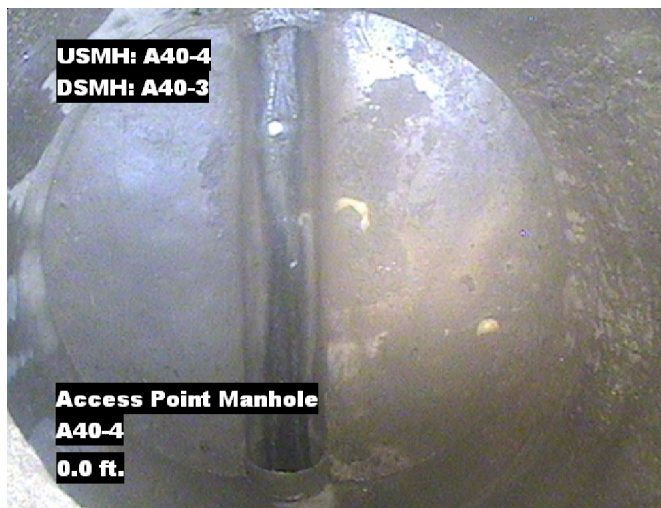
Distance: 0.0 ft. Grade: 0
Condition: Access Point Manhole
Remarks: A40-4

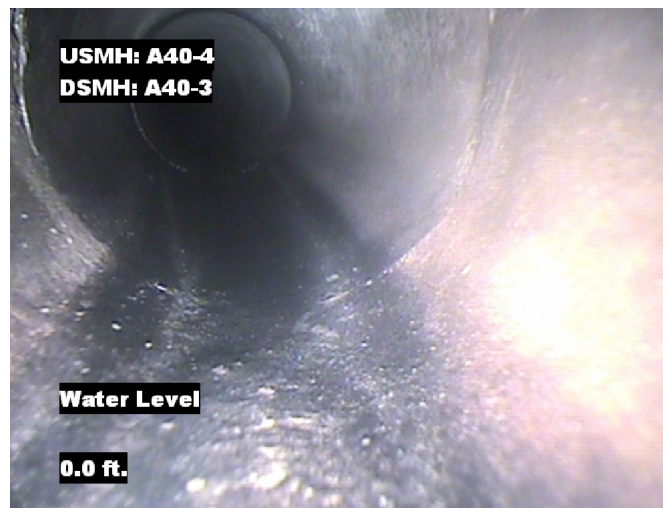
Distance: 0.0 ft. Grade: 0
Condition: Water Level
Remarks: N/A

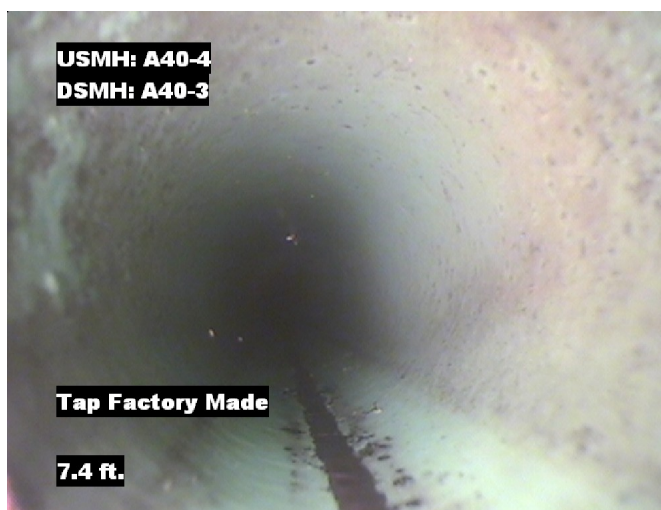
Distance: 7.4 ft. Grade: 0
Condition: Tap Factory Made
Remarks: N/A

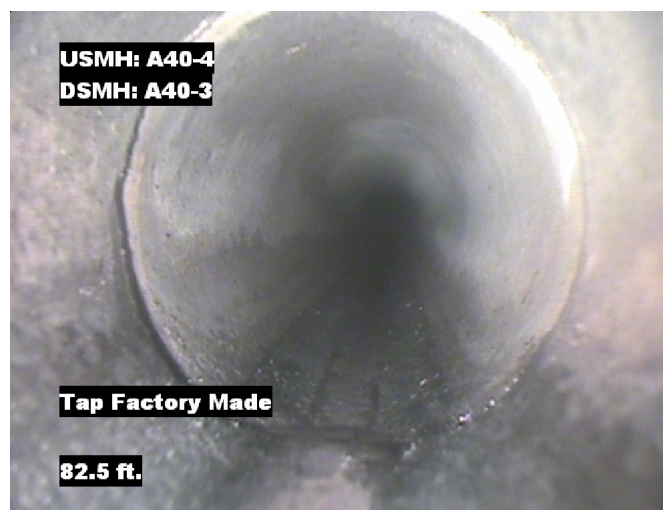
Distance: 82.5 ft. Grade: 0
Condition: Tap Factory Made
Remarks: N/A

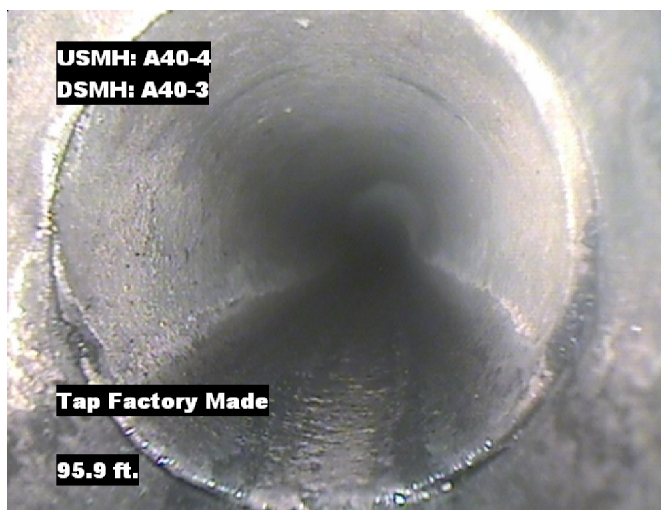
Distance: 95.9 ft. Grade: 0
Condition: Tap Factory Made
Remarks: N/A

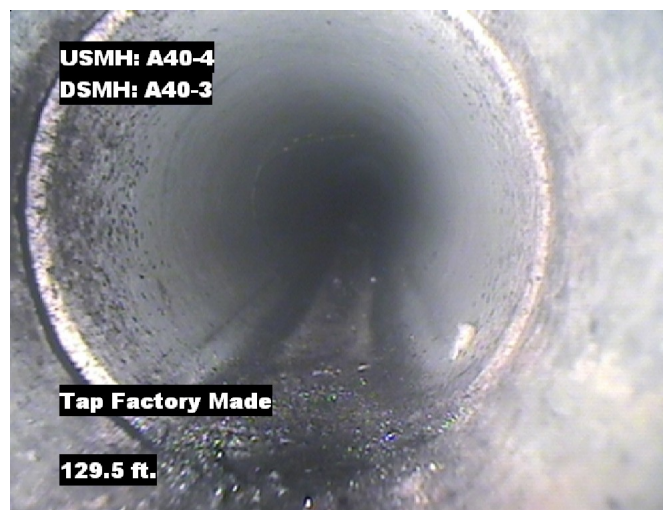
Distance: 129.5 ft. Grade: 0
Condition: Tap Factory Made
Remarks: N/A

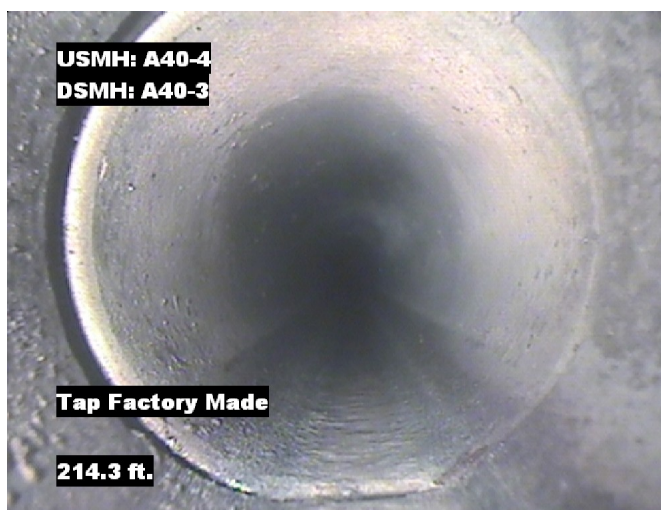
Distance: 214.3 ft. Grade: 0
Condition: Tap Factory Made
Remarks: N/A

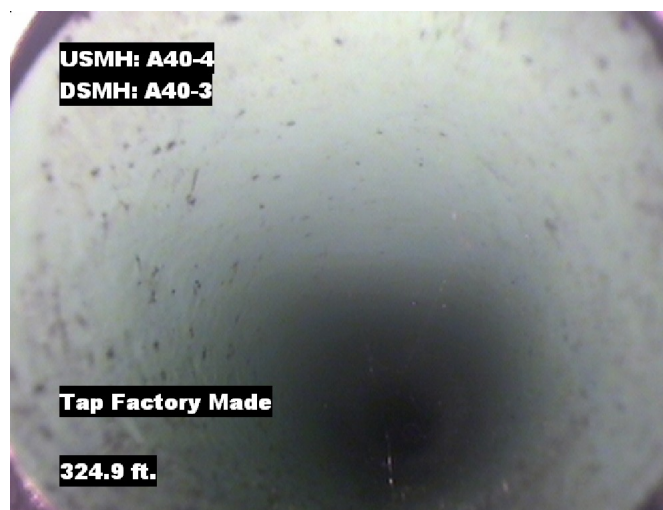
Distance: 324.9 ft. Grade: 0
Condition: Tap Factory Made
Remarks: N/A

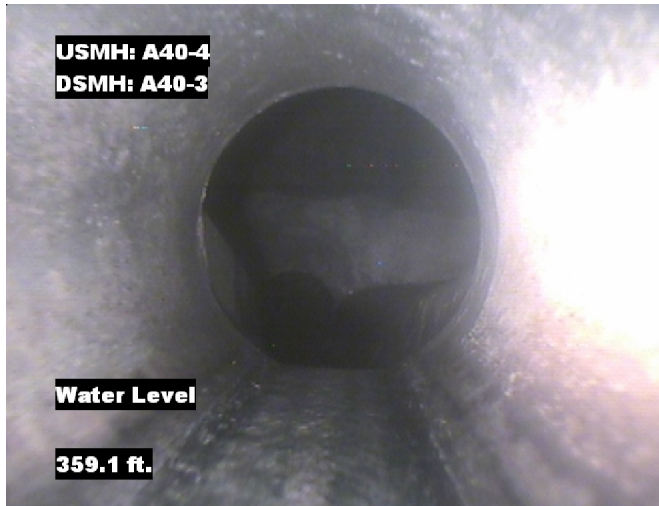
Distance: 359.0 ft. Grade: 0
Condition: Water Level
Remarks: N/A

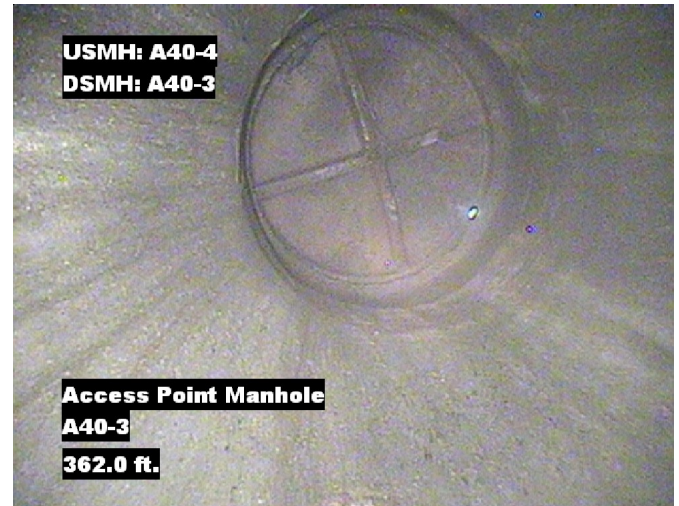
Distance: 362.0 ft. Grade: 0
Condition: Access Point Manhole
Remarks: A40-3
