Defect Listing

Pipe Segment Refere... A41-1_A40-1	City Oliver Springs	Street Hill Cir	Material Concrete Pipe (non-...	Location C... Easement/R...	Sewer Use Sanitary
Upstream MH A41-1	Total Length 240.2	Year Laid	Shape Circular	Location Details	
DS Manhole A40-1	Length surveyed 240.2	Year Renewed	Height 8	Width 8	Pipe Joint... 4

SPR 1	MPR 8	PO Number 4397-03		Customer GRW	
SPRI 1	MPRI 4	Work Order 4397-02		Purpose Pre-Rehabilitation Survey	
QSR 1100	QMR 4200				
OPR 9	Surveyed By Charlie Gordon	Direction Downstream	Date 20150820	Media label	
OPRI 3	Certificate Number U-615-07000491	Pre-Cleaning Jetting	Time 09:00	Weather Damp	
Date Cleaned 20150820			End Time 09:17	Additional Info

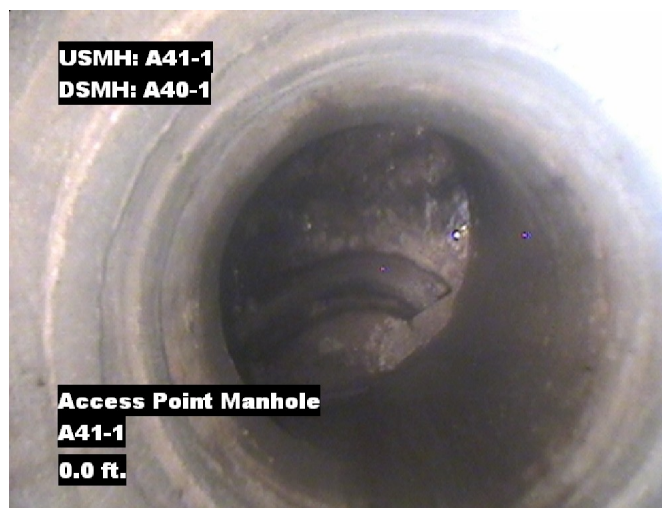
Distance: 0.0 ft. Grade: 0
Condition: Access Point Manhole
Remarks: A41-1

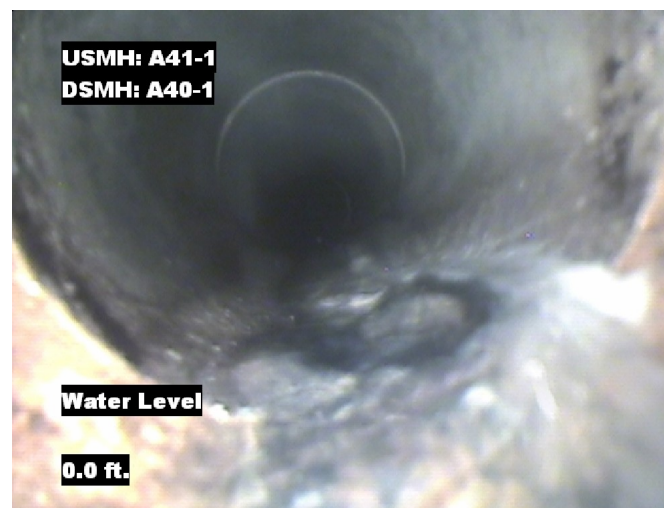
Distance: 0.0 ft. Grade: 0
Condition: Water Level
Remarks: N/A

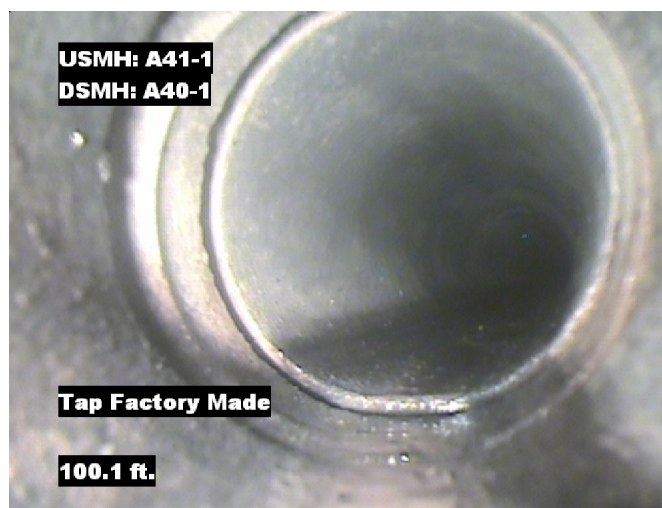
Distance: 100.1 ft. Grade: 0
Condition: Tap Factory Made
Remarks: N/A

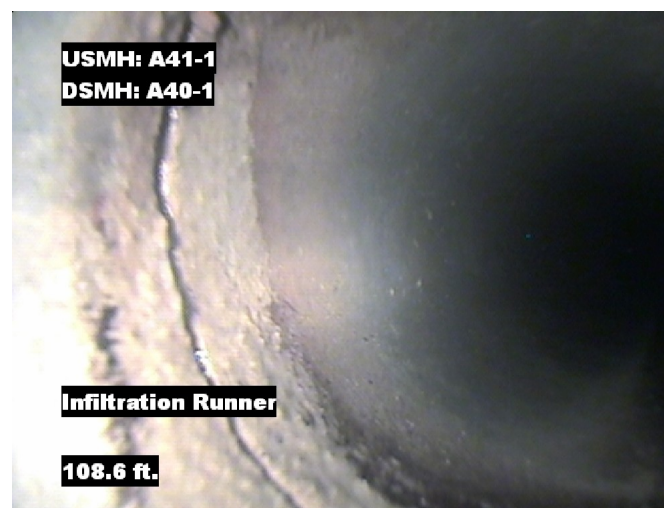
Distance: 108.6 ft. Grade: 4
Condition: Infiltration Runner
Remarks: N/A

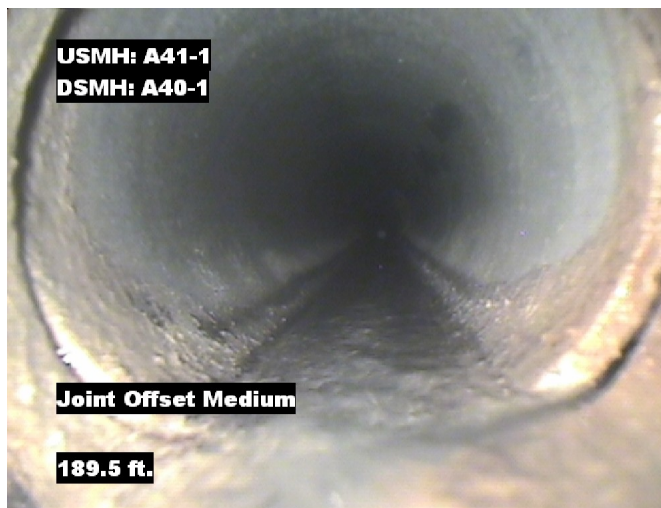
Distance: 189.5 ft. Grade: 1
Condition: Joint Offset Medium
Remarks: N/A

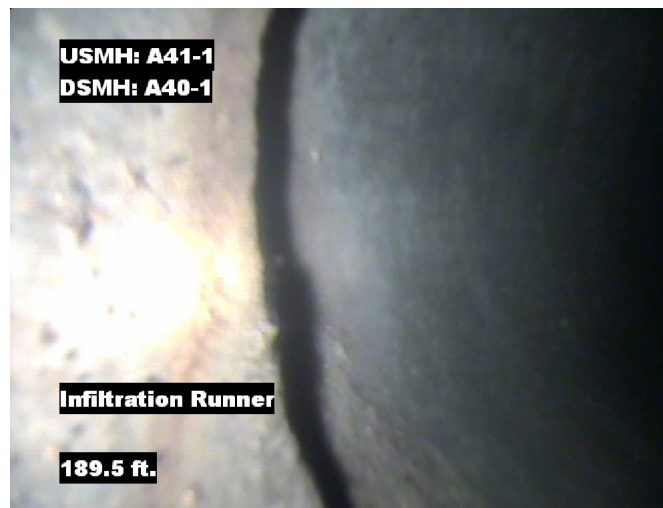
Distance: 189.5 ft. Grade: 4
Condition: Infiltration Runner
Remarks: N/A

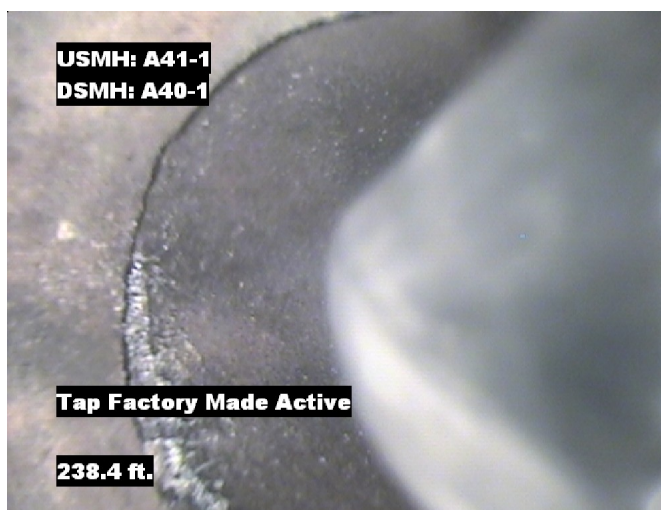
Distance: 238.4 ft. Grade: 0
Condition: Tap Factory Made Active
Remarks: N/A

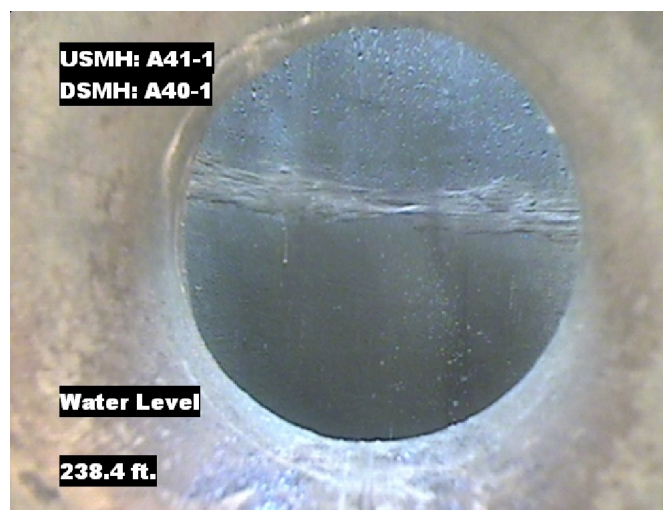
Distance: 238.4 ft. Grade: 0
Condition: Water Level
Remarks: N/A

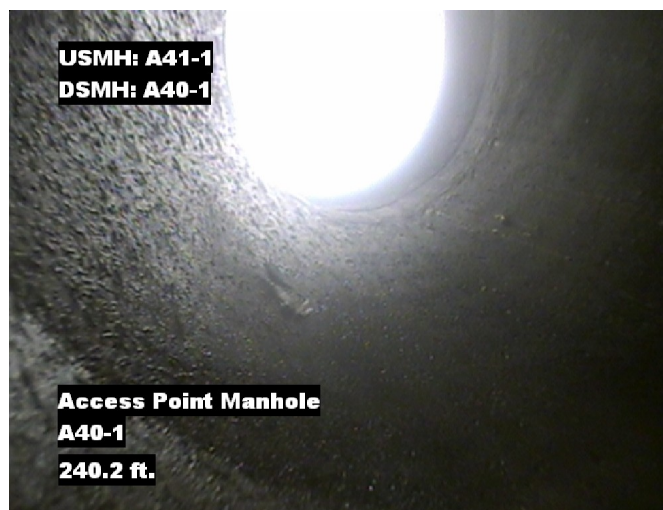
Distance: 240.2 ft. Grade: 0
Condition: Access Point Manhole
Remarks: A40-1
