Defect Listing

Pipe Segment Refere... A41-3_A41-2	City Oliver Springs	Street Center Rd	Material Concrete Pipe (non-...	Location C... Light High...	Sewer Use Sanitary
Upstream MH A41-3	Total Length 146.9	Year Laid	Shape Circular	Location Details	
DS Manhole A41-2	Length surveyed 146.9	Year Renewed	Height 8	Width 8	Pipe Joint... 4

SPR 1	MPR N/A	PO Number 4397-03	Customer GRW
SPRI 1	MPRI N/A	Work Order 4397-02	Purpose Pre-Rehabilitation Survey
QSR 1100	QMR N/A		
OPR 1	Surveyed By Charlie Gordon	Direction Upstream	Date 20150819
OPRI 1	Certificate Number U-615-07000491	Pre-Cleaning Jetting	Time 10:14
	Date Cleaned 20150819	End Time 10:38	Weather Light Rain
			Media label
			Additional Info

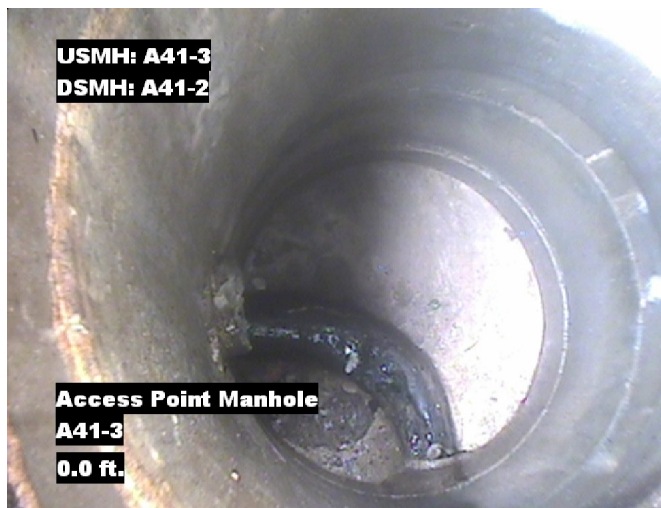
Distance: 0.0 ft. Grade: 0
Condition: Access Point Manhole
Remarks: A41-3

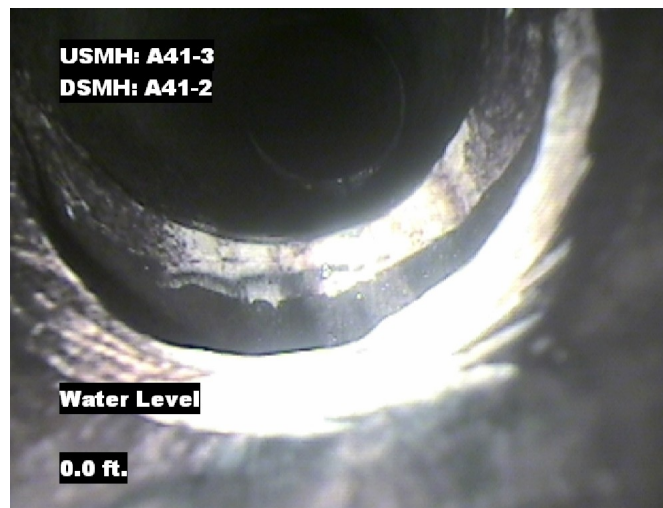
Distance: 0.0 ft. Grade: 0
Condition: Water Level
Remarks: N/A

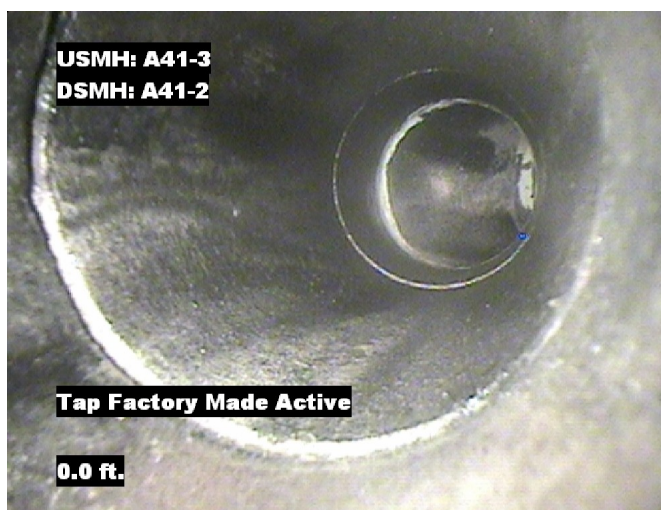
Distance: 0.0 ft. Grade: 0
Condition: Tap Factory Made Active
Remarks: N/A

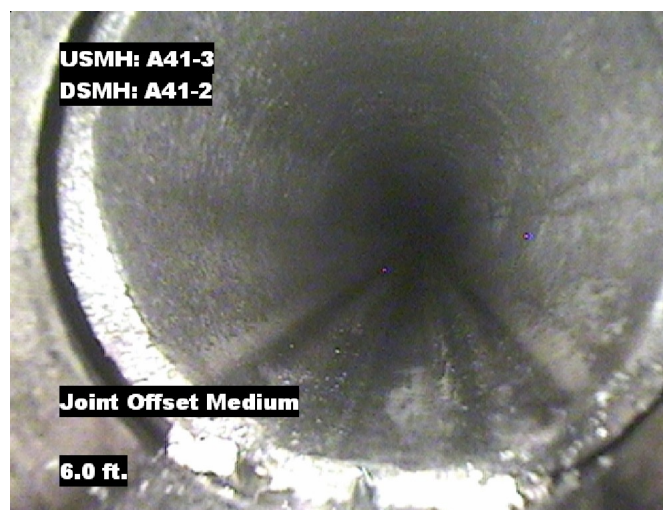
Distance: 6.0 ft. Grade: 1
Condition: Joint Offset Medium
Remarks: N/A

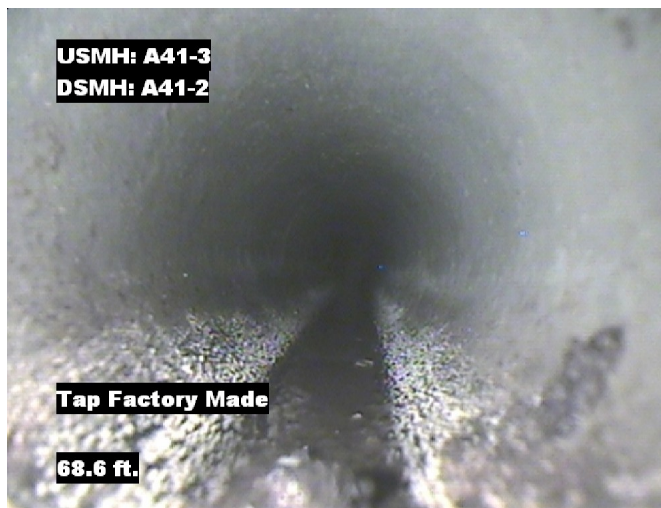
Distance: 68.6 ft. Grade: 0
Condition: Tap Factory Made
Remarks: N/A

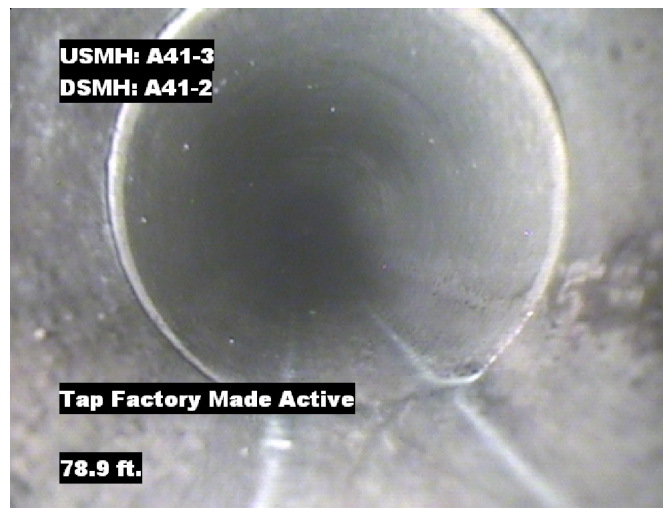
Distance: 78.9 ft. Grade: 0
Condition: Tap Factory Made Active
Remarks: N/A

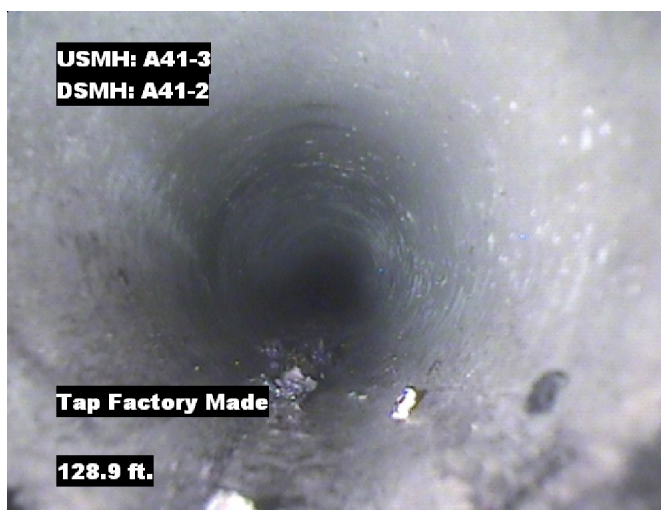
Distance: 128.9 ft. Grade: 0
Condition: Tap Factory Made
Remarks: N/A

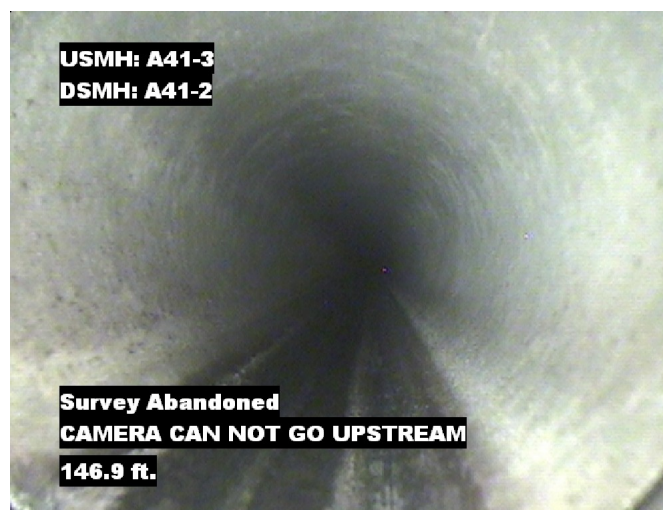
Distance: 146.9 ft. Grade: 0
Condition: Survey Abandoned
Remarks: CAMERA CAN NOT GO UPSTREAM
