## Defect Listing

Pipe Segment Refere... <b>A42-1_A6-19</b>	City <b>Oliver Springs</b>	Street <b>Center Rd</b>	Material <b>Concrete Pipe (non-...</b>	Location C... <b>Light High...</b>	Sewer Use <b>Sanitary</b>
Upstream MH <b>A42-1</b>	Total Length <b>105.6</b>	Year Laid	Shape <b>Circular</b>	Location Details	
DS Manhole <b>A6-19</b>	Length surveyed <b>105.6</b>	Year Renewed	Height <b>8</b>	Width <b>8</b>	Pipe Joint... <b>4</b>

SPR <b>2</b>	MPR <b>1</b>	PO Number <b>4397-03</b>	Customer <b>GRW</b>
SPRI <b>2</b>	MPRI <b>1</b>	Work Order <b>4397-02</b>	Purpose <b>Pre-Rehabilitation Survey</b>
QSR <b>2100</b>	QMR <b>1100</b>		
OPR <b>3</b>	Surveyed By <b>Charlie Gordon</b>	Direction <b>Downstream</b>	Date <b>20150820</b>
OPRI <b>1.5</b>	Certificate Number <b>U-615-07000491</b>	Pre-Cleaning <b>Jetting</b>	Time <b>12:45</b>
	Date Cleaned <b>20150820</b>	End Time <b>12:55</b>	Weather <b>Light Rain</b>
			Media label
			Additional Info

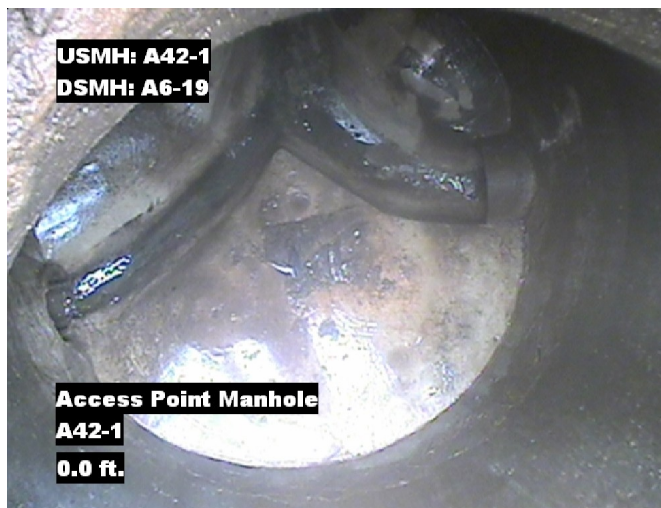
Distance: 0.0 ft. Grade: 0  
Condition: Access Point Manhole  
Remarks: A42-1

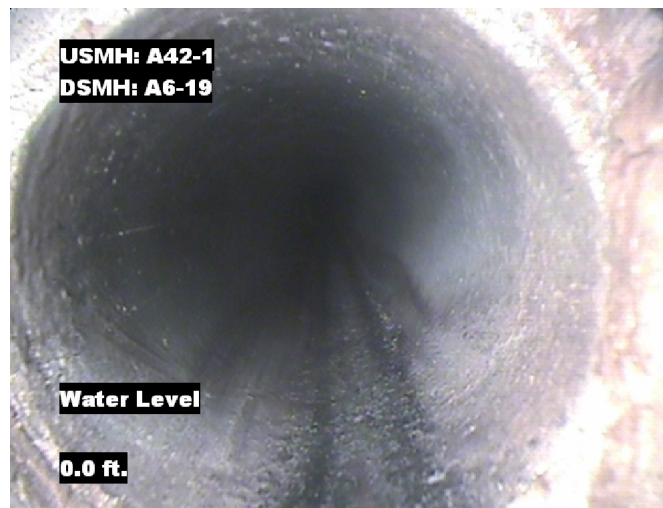
Distance: 0.0 ft. Grade: 0  
Condition: Water Level  
Remarks: N/A

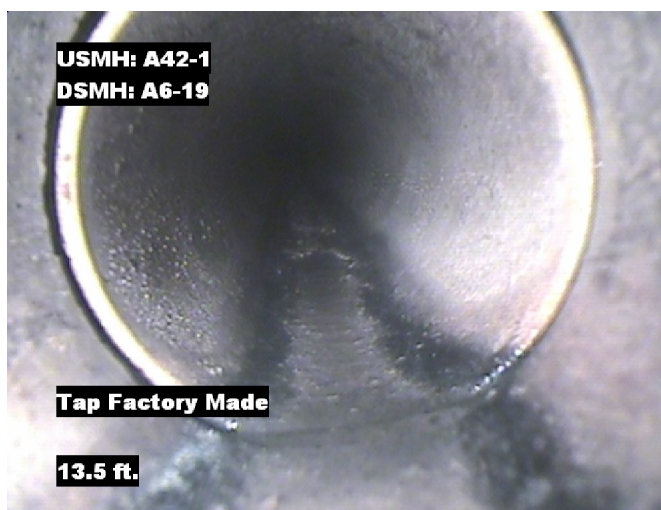
Distance: 13.5 ft. Grade: 0  
Condition: Tap Factory Made  
Remarks: N/A

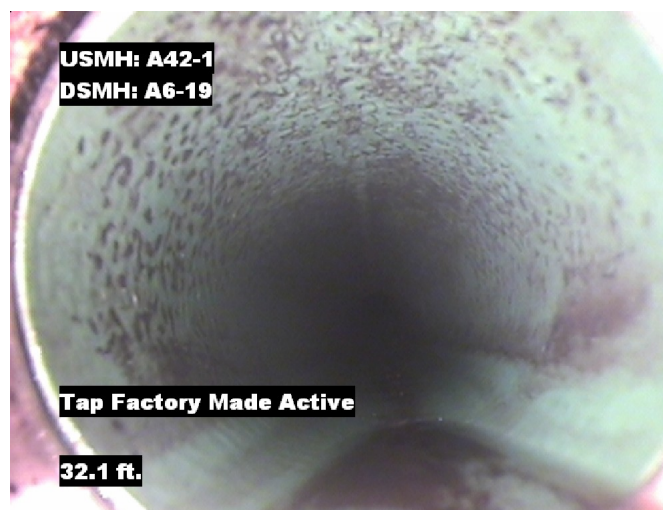
Distance: 32.1 ft. Grade: 0  
Condition: Tap Factory Made Active  
Remarks: N/A

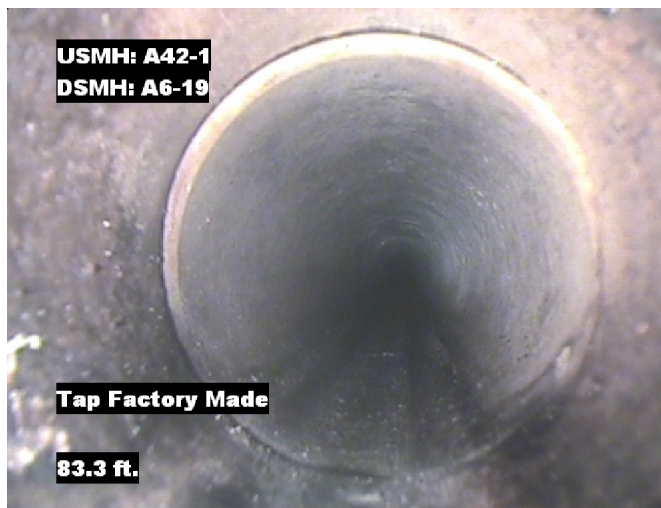
Distance: 83.3 ft. Grade: 0  
Condition: Tap Factory Made  
Remarks: N/A

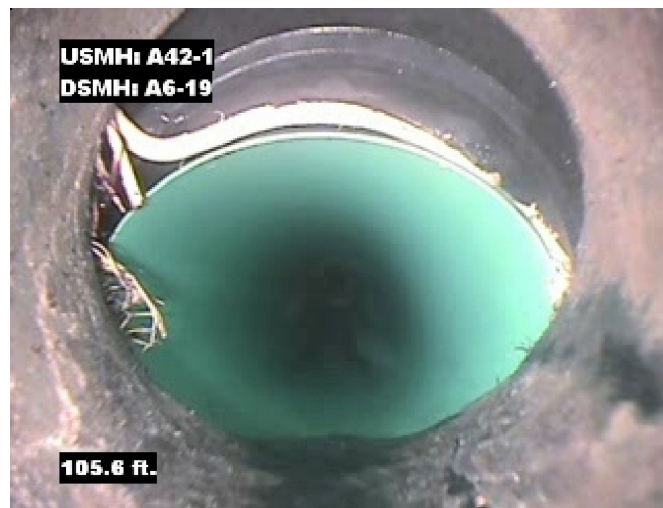
Distance: 105.5 ft. Grade: 2  
Condition: Joint Offset Large  
Remarks: N/A

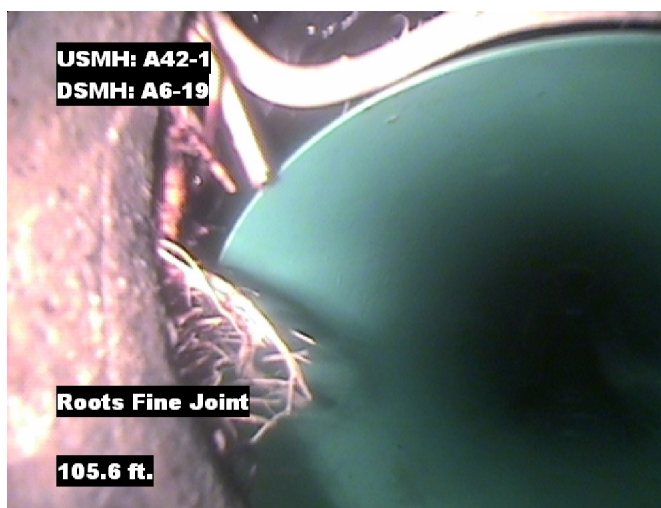
Distance: 105.6 ft. Grade: 1  
Condition: Roots Fine Joint  
Remarks: N/A

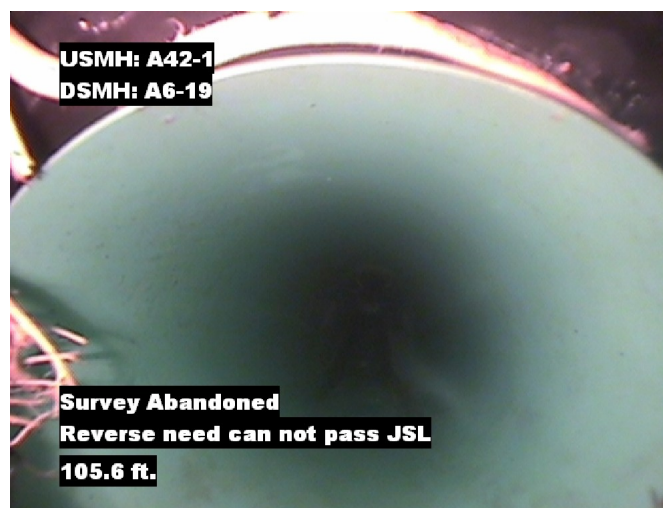
Distance: 105.6 ft. Grade: 0  
Condition: Survey Abandoned  
Remarks: Reverse need can not pass JOL
