Defect Listing

Pipe Segment Refere... A42-2_A42-1	City Oliver Springs	Street Center Rd	Material Concrete Pipe (non-...	Location C... Light High...	Sewer Use Sanitary
Upstream MH A42-2	Total Length 149.5	Year Laid	Shape Circular	Location Details	
DS Manhole A42-1	Length surveyed 149.5	Year Renewed	Height 8	Width 8	Pipe Joint... 4

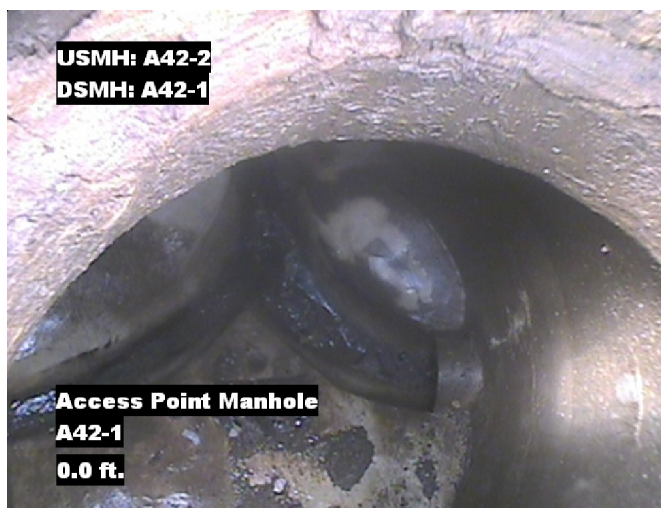
Distance: 0.0 ft. Grade: 0
Condition: Access Point Manhole
Remarks: A42-1

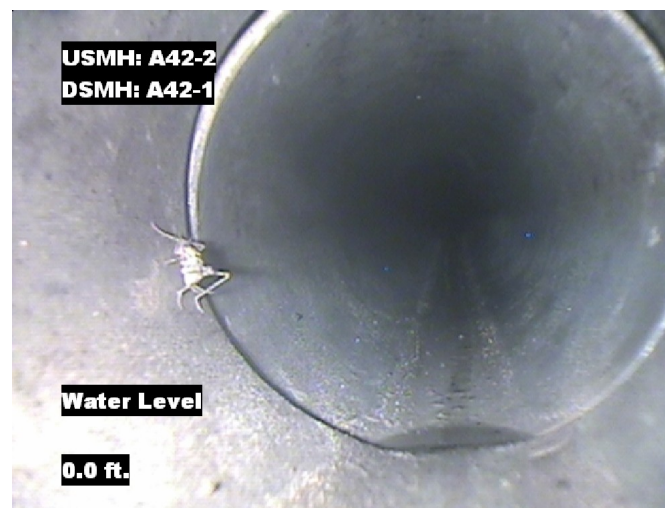
Distance: 0.0 ft. Grade: 0
Condition: Water Level
Remarks: N/A

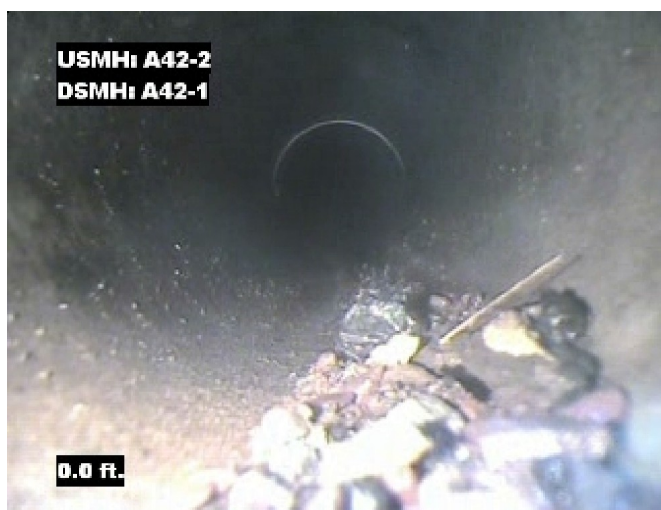
Distance: 0.0 ft. Grade: 2
Condition: Deposits Settled Gravel
Remarks: N/A

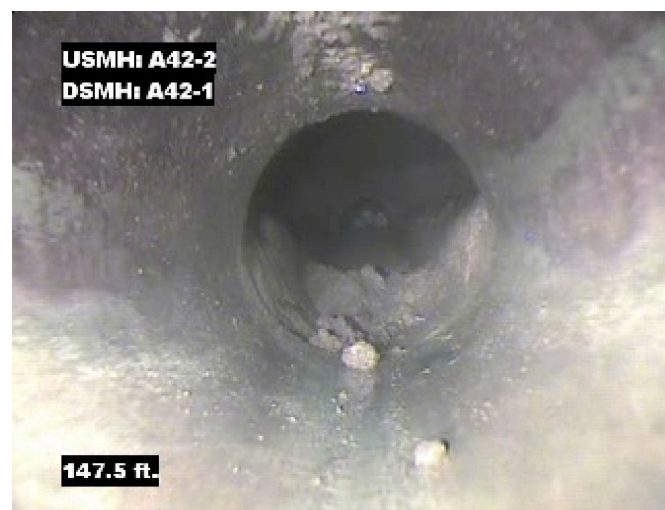
Distance: 147.5 ft. Grade: 2
Condition: Deposits Attached Grease
Remarks: N/A

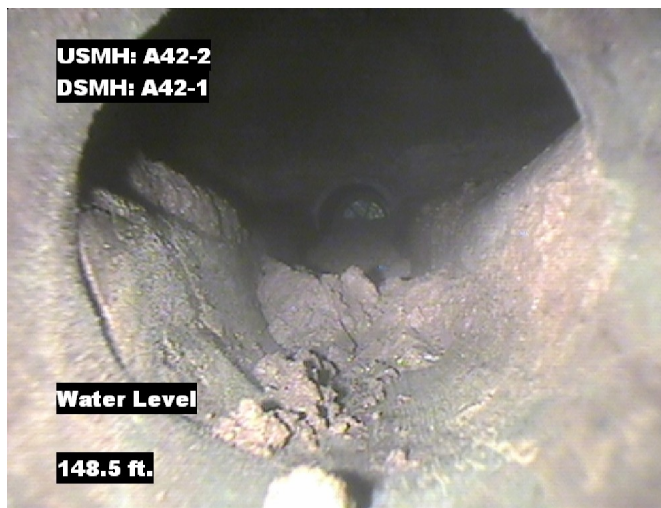
Distance: 148.5 ft. Grade: 0
Condition: Water Level
Remarks: N/A

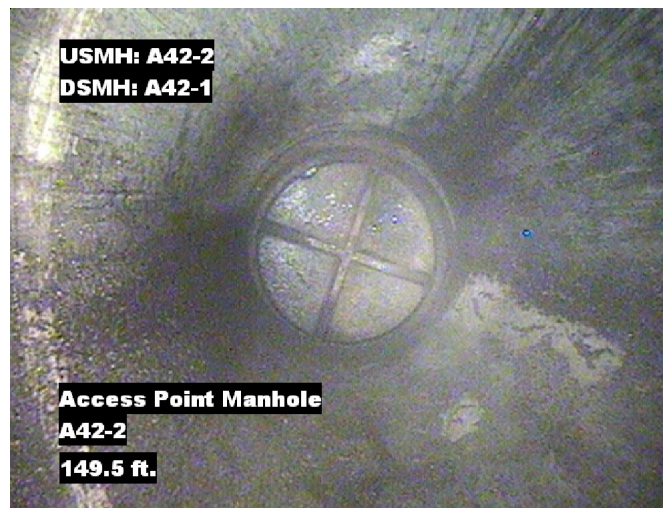
Distance: 149.5 ft. Grade: 0
Condition: Access Point Manhole
Remarks: A42-2
