Defect Listing

Pipe Segment Refere		City		Street	Mat	Material		Sewer Use	
A43-1_A6-19A		Oliver Springs		Highway 61	Concrete F	Concrete Pipe (non		Sanitary	
Upstream MH A43-1		Total Length 174.4		Year Laid	Shape Circular		Location Details		
DS Manhole		Length surveyed		Year Renewed	Height	Width	Pipe Joint		
A6-19A		174.4			8	8	4		
SPR	7	MPR	6	PO Number 4397-03			Customer		
CDDI	2.5	MDDI	2			G		GRW	
SPRI	3.5	MPRI	3	Work Order			Purpose		
QSR	5121	QMR	4121	4397-02		Pre-		urvey	
OI	PR	Surveyed By		Direction	Date		Media label		
1	3	Charlie_Gordon		Upstream	20150901				
OF	PRI	Certificate Number		Pre-Cleaning	Time		Weather		
3.3		U-615-07000491		Jetting	10:27		Dry		
		Date C	leaned		End Time		Additional Info		
		2015	0901		10:38

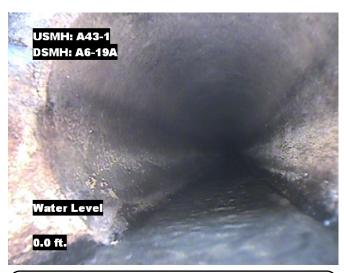
Distance: 0.0 ft. Grade: 0

Condition: Water Level

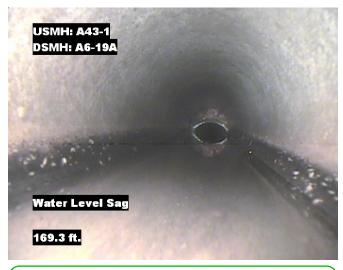
Distance: 169.3 ft. Grade: 2

Condition: Water Level Sag

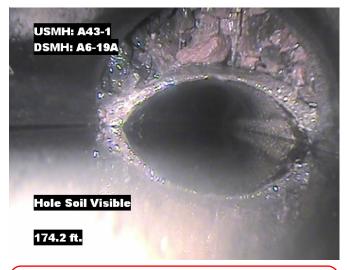
Distance: 174.2 ft. Grade: 5

Condition: Hole Soil Visible

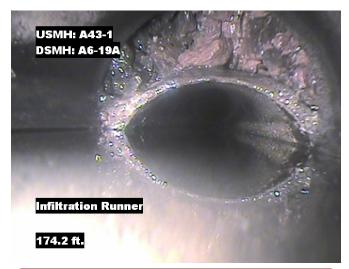
Distance: 174,2 ft. Grade: 4

Condition: Infiltration Runner

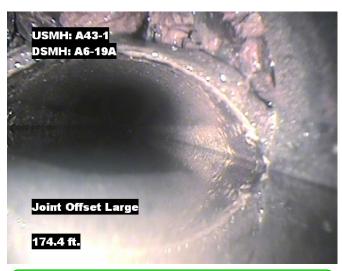
Distance: 174.4 ft. Grade: 2

Condition: Joint Offset Large

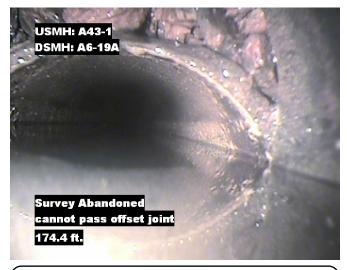
Distance: 174.4 ft. Grade: 0

Condition: Survey Abandoned **Remarks:** cannot pass offset joint
