Defect Listing

Pipe Segment Refere... A43-2_A43-1	City Oliver Springs	Street Highway 61	Material Concrete Pipe (non-...	Location C... Main Highw...	Sewer Use Sanitary
Upstream MH A43-2	Total Length 272.8	Year Laid	Shape Circular	Location Details	
DS Manhole A43-1	Length surveyed 272.8	Year Renewed	Height 8	Width 8	Pipe Joint... 4

SPR N/A	MPR 6	PO Number 4397-03		Customer GRW	
SPRI N/A	MPRI 3	Work Order 4397-02		Purpose Pre-Rehabilitation Survey	
QSR N/A	QMR 4121				
OPR 6	Surveyed By Charlie Gordon	Direction Downstream	Date 20150901	Media label	
OPRI 3	Certificate Number U-615-07000491	Pre-Cleaning Jetting	Time 09:08	Weather Dry	
Date Cleaned 20150901			End Time 09:22	Additional Info

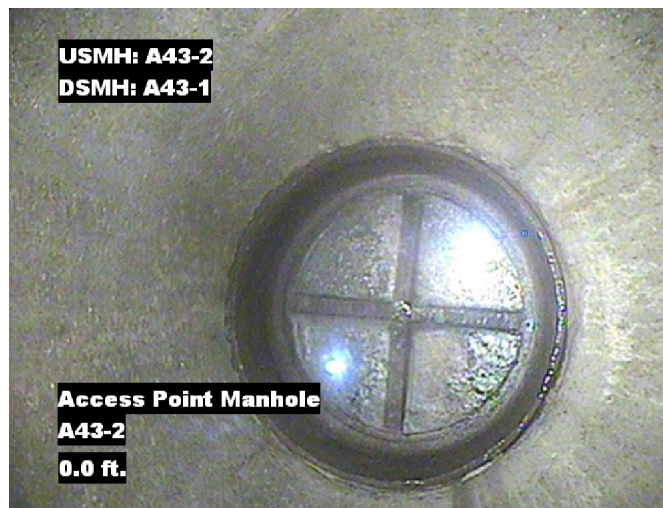
Distance: 0.0 ft. Grade: 0
Condition: Access Point Manhole
Remarks: A43-2

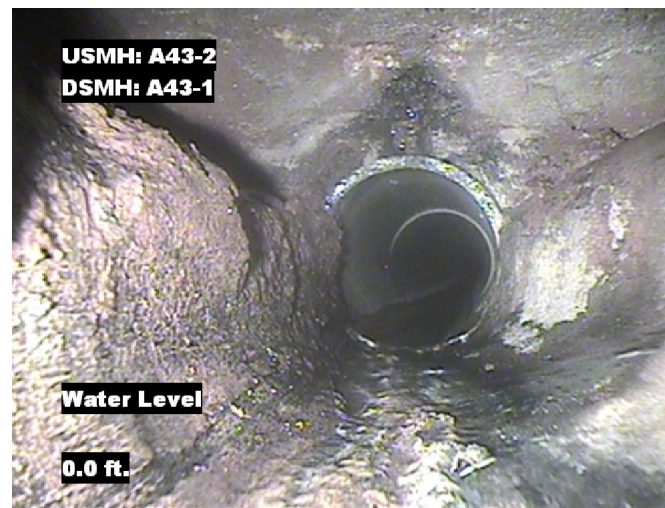
Distance: 0.0 ft. Grade: 0
Condition: Water Level
Remarks: N/A

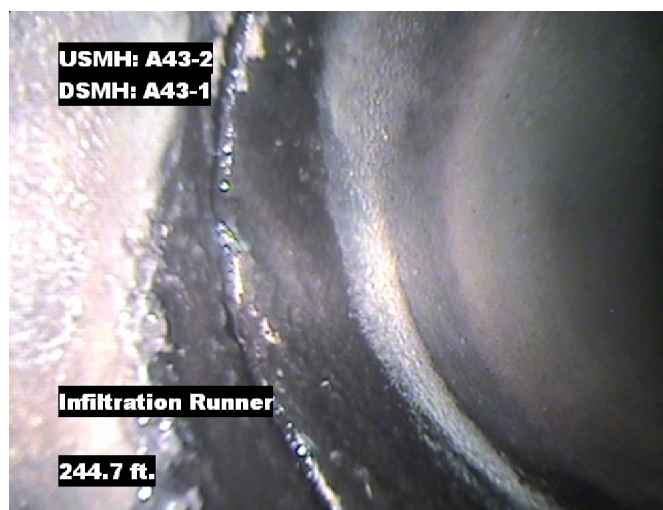
Distance: 244.7 ft. Grade: 4
Condition: Infiltration Runner
Remarks: N/A

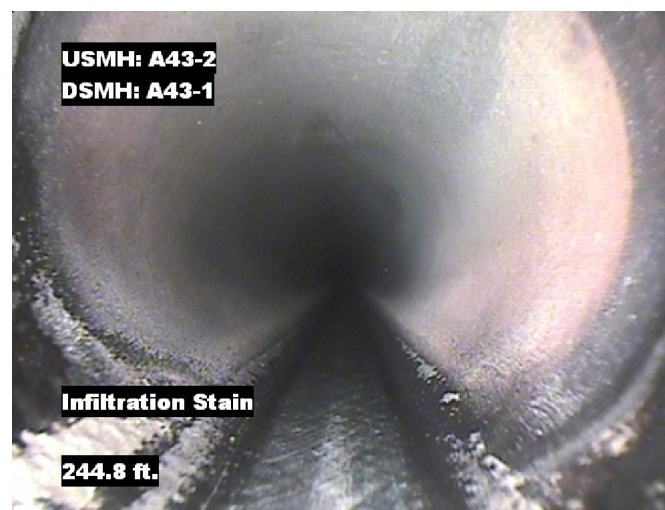
Distance: 244.8 ft. Grade: 0
Condition: Infiltration Stain
Remarks: N/A

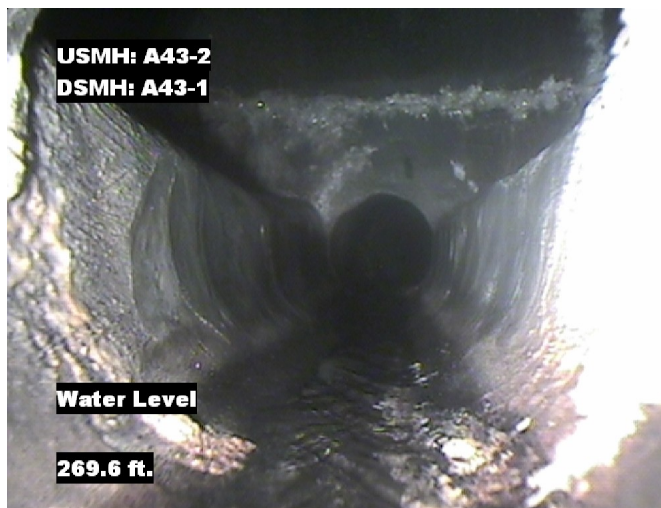
Distance: 269.6 ft. Grade: 0
Condition: Water Level
Remarks: N/A

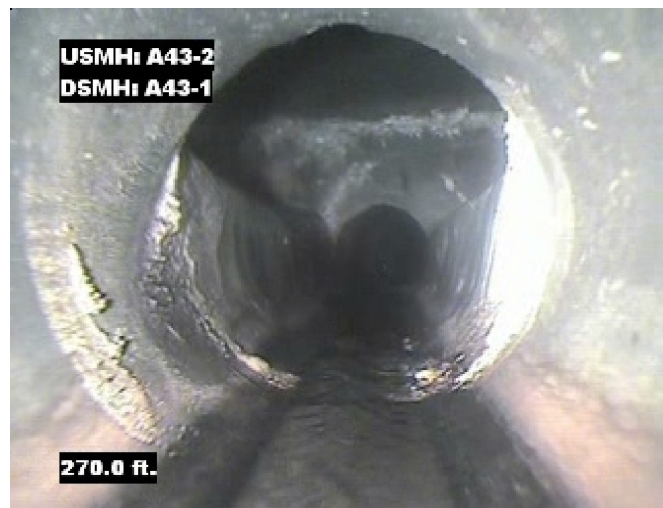
Distance: 270.0 ft. Grade: 2
Condition: Deposits Attached Encrustation
Remarks: N/A

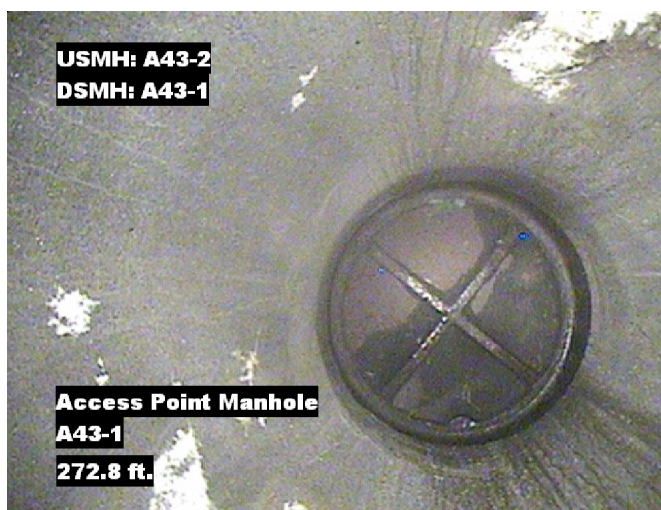
Distance: 272.8 ft. Grade: 0
Condition: Access Point Manhole
Remarks: A43-1
