## Defect Listing

Pipe Segment Refere... <b>A43-3_A43-2</b>	City <b>Oliver Springs</b>	Street <b>Highway 61</b>	Material <b>Concrete Pipe (non-...</b>	Location C... <b>Main Highw...</b>	Sewer Use <b>Sanitary</b>
Upstream MH <b>A43-3</b>	Total Length <b>280.6</b>	Year Laid	Shape <b>Circular</b>	Location Details	
DS Manhole <b>A43-2</b>	Length surveyed <b>280.6</b>	Year Renewed	Height <b>8</b>	Width <b>8</b>	Pipe Joint... <b>4</b>

SPR <b>7</b>	MPR <b>7</b>	PO Number <b>4397-03</b>	Customer <b>GRW</b>
SPRI <b>3.5</b>	MPRI <b>3.5</b>	Work Order <b>4397-02</b>	Purpose <b>Pre-Rehabilitation Survey</b>
QSR <b>5121</b>	QMR <b>4131</b>		
OPR <b>14</b>	Surveyed By <b>Charlie Gordon</b>	Direction <b>Downstream</b>	Date <b>20150901</b>
OPRI <b>3.5</b>	Certificate Number <b>U-615-07000491</b>	Pre-Cleaning <b>Jetting</b>	Time <b>08:48</b>
	Date Cleaned <b>20150901</b>	End Time <b>09:06</b>	Weather <b>Dry</b>
			Additional Info

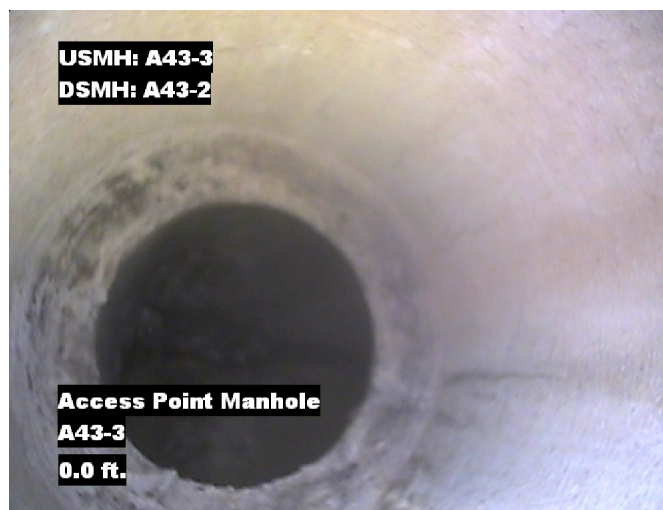
Distance: 0.0 ft. Grade: 0  
Condition: Access Point Manhole  
Remarks: A43-3

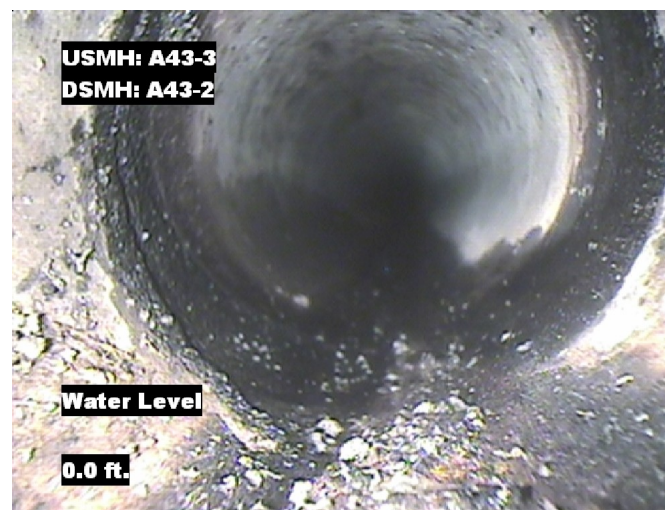
Distance: 0.0 ft. Grade: 0  
Condition: Water Level  
Remarks: N/A

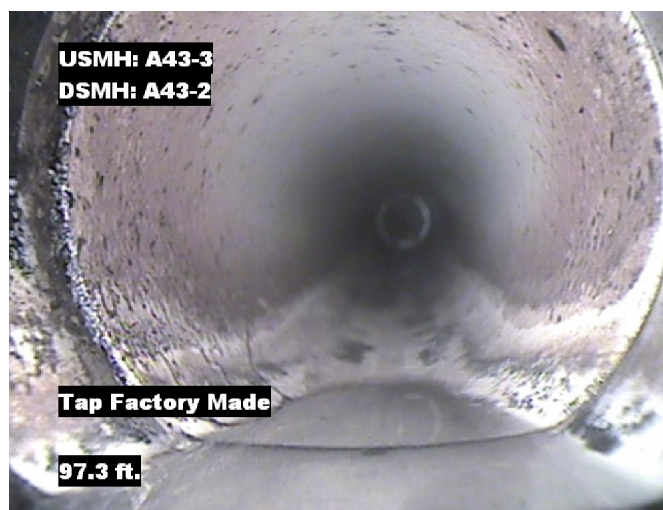
Distance: 97.3 ft. Grade: 0  
Condition: Tap Factory Made  
Remarks: N/A

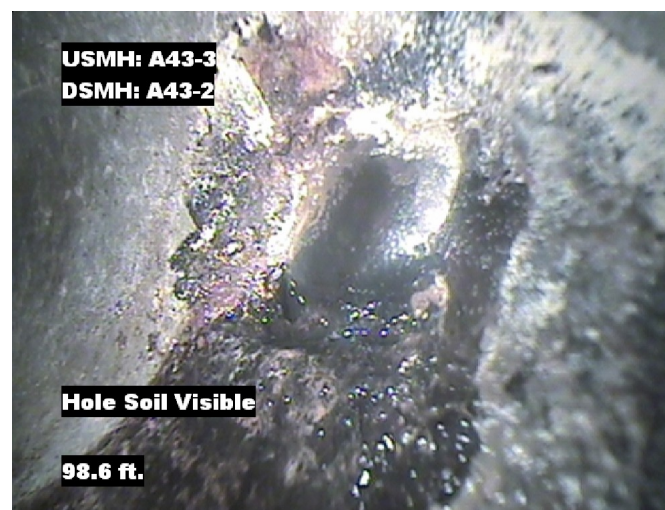
Distance: 98.6 ft. Grade: 5  
Condition: Hole Soil Visible  
Remarks: N/A

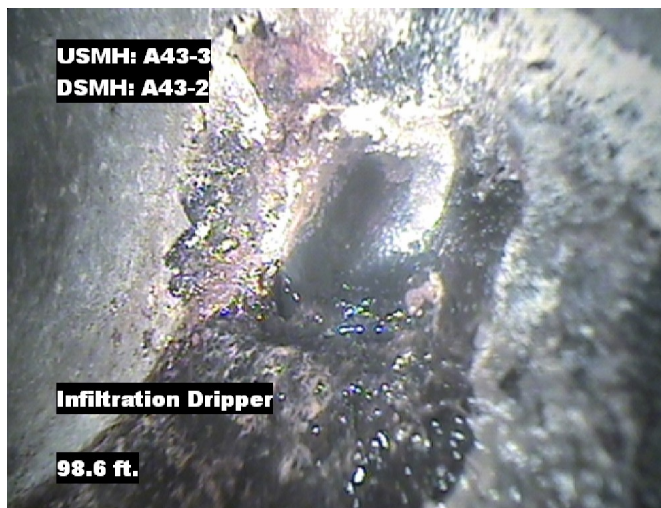
Distance: 98.6 ft. Grade: 3  
Condition: Infiltration Dropper  
Remarks: N/A

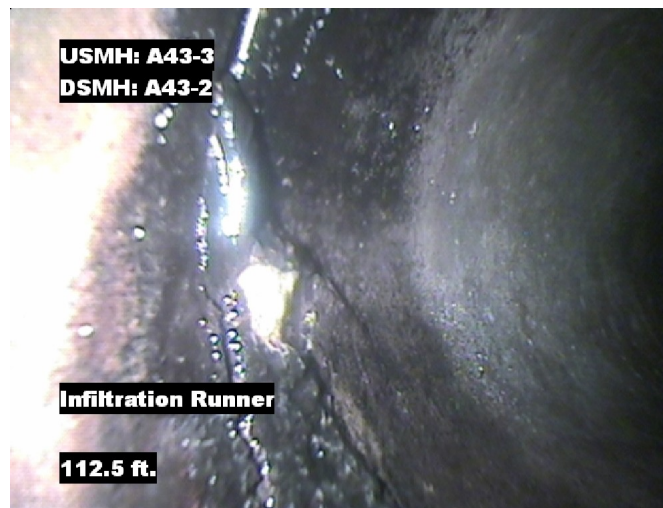
Distance: 112.5 ft. Grade: 4  
Condition: Infiltration Runner  
Remarks: N/A

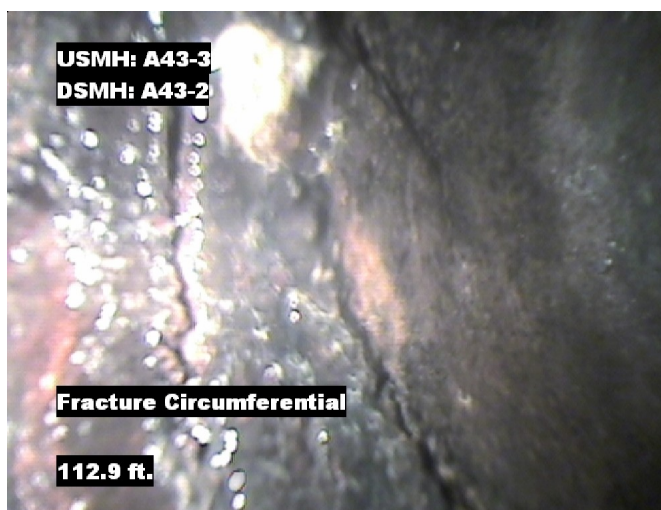
Distance: 112.9 ft. Grade: 2  
Condition: Fracture Circumferential  
Remarks: N/A

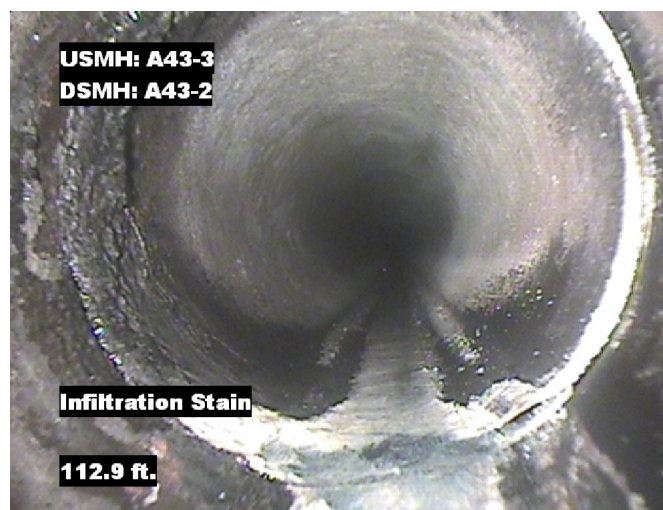
Distance: 112.9 ft. Grade: 0  
Condition: Infiltration Stain  
Remarks: N/A

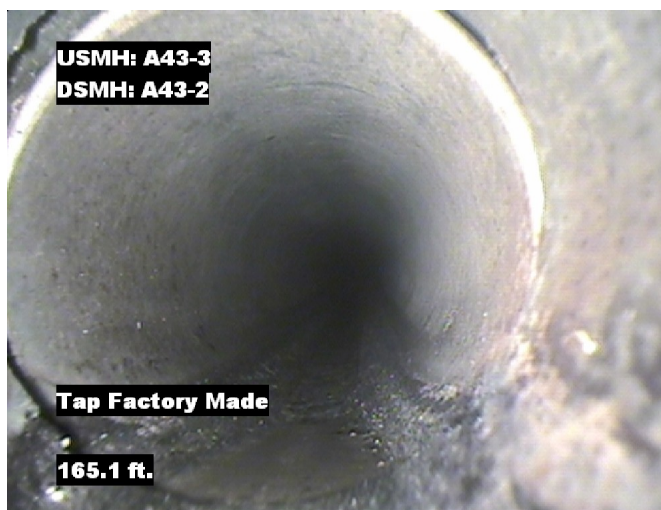
Distance: 165.1 ft. Grade: 0  
Condition: Tap Factory Made  
Remarks: N/A

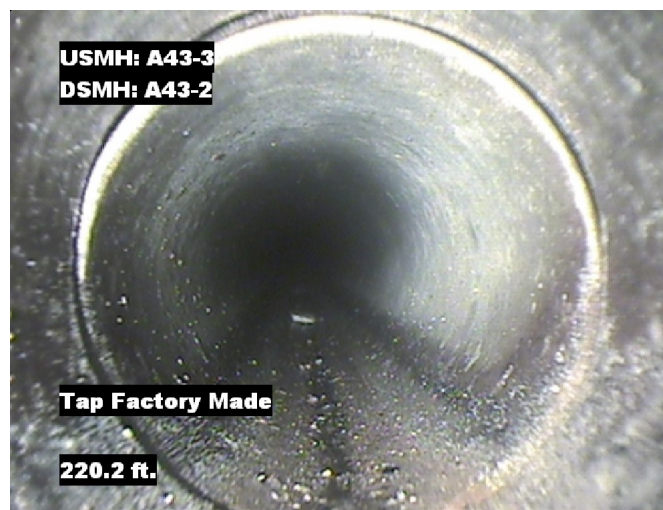
Distance: 220.2 ft. Grade: 0  
Condition: Tap Factory Made  
Remarks: N/A

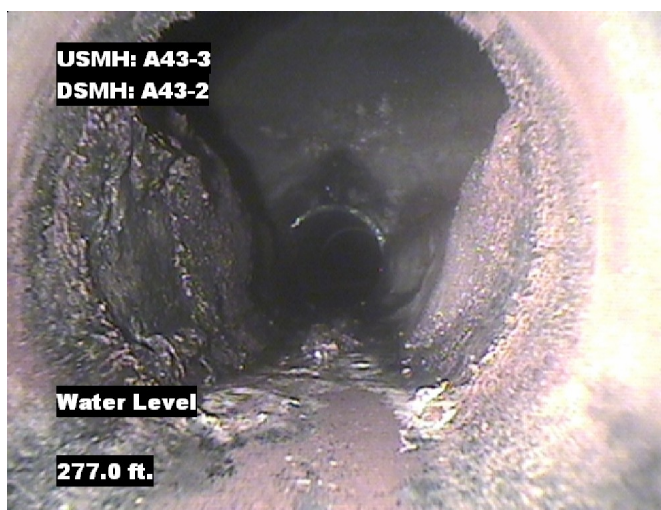
Distance: 276.9 ft. Grade: 0  
Condition: Water Level  
Remarks: N/A

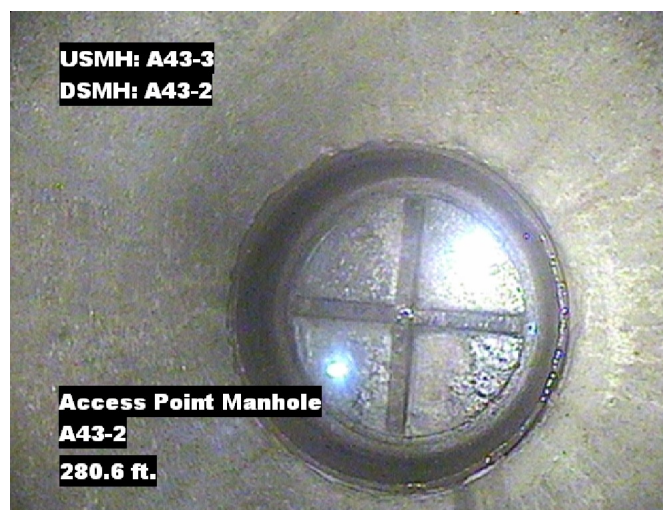
Distance: 280.6 ft. Grade: 0  
Condition: Access Point Manhole  
Remarks: A43-2
