## Defect Listing

Pipe Segment Refere... <b>A44-1_A44-2</b>	City <b>Oliver Springs</b>	Street <b>Hen Valley Rd.</b>	Material <b>Concrete Pipe (non-...</b>	Location C... <b>Light High...</b>	Sewer Use <b>Sanitary</b>
Upstream MH <b>A44-1</b>	Total Length <b>277.6</b>	Year Laid	Shape <b>Circular</b>	Location Details	
DS Manhole <b>A44-2</b>	Length surveyed <b>277.6</b>	Year Renewed	Height <b>8</b>	Width <b>8</b>	Pipe Joint... <b>4</b>

SPR <b>N/A</b>	MPR <b>16</b>	PO Number <b>4397-03</b>	Customer <b>GRW</b>
SPRI <b>N/A</b>	MPRI <b>2.3</b>	Work Order <b>4397-02</b>	Purpose <b>Pre-Rehabilitation Survey</b>
QSR <b>N/A</b>	QMR <b>3225</b>		
OPR <b>16</b>	Surveyed By <b>Charlie Gordon</b>	Direction <b>Upstream</b>	Date <b>20150828</b>
OPRI <b>2.3</b>	Certificate Number <b>U-615-07000491</b>	Pre-Cleaning <b>Jetting</b>	Time <b>09:46</b>
	Date Cleaned <b>20150828</b>	End Time <b>10:03</b>	Weather <b>Dry</b>
			Media label
			Additional Info

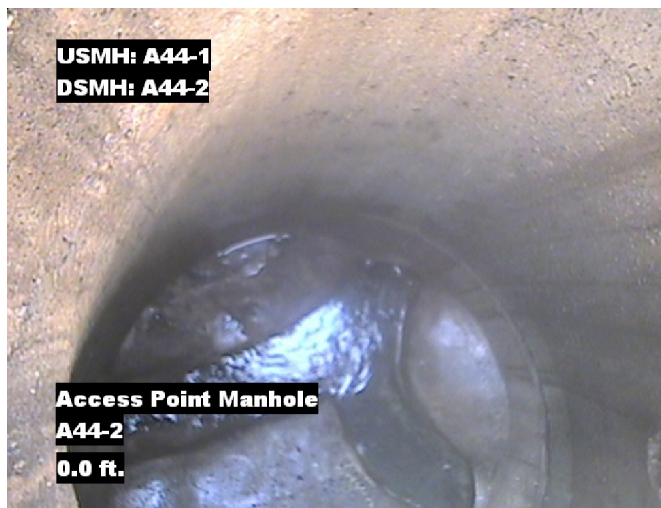
Distance: 0.0 ft. Grade: 0  
Condition: Access Point Manhole  
Remarks: A44-2

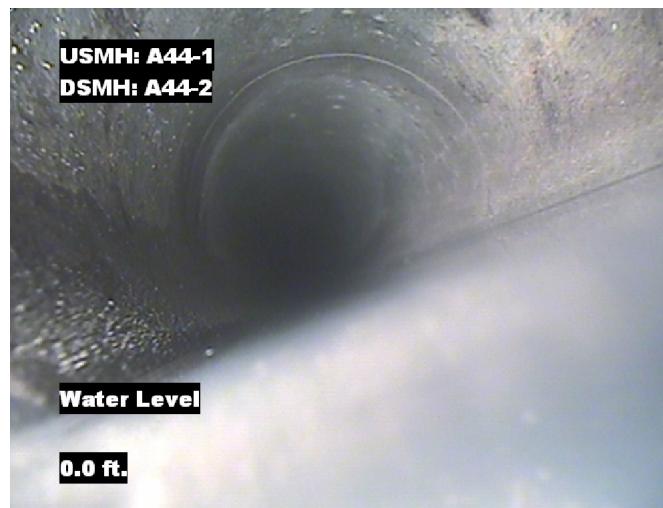
Distance: 0.0 ft. Grade: 0  
Condition: Water Level  
Remarks: N/A

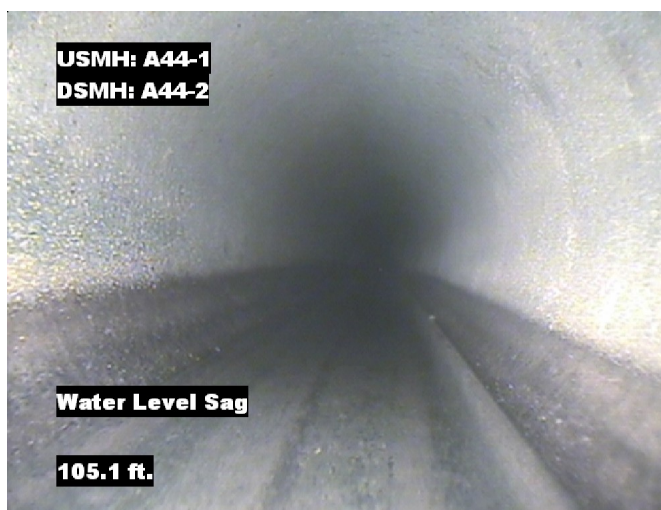
Distance: 105.1 ft. Grade: 2  
Condition: Water Level Sag  
Remarks: N/A

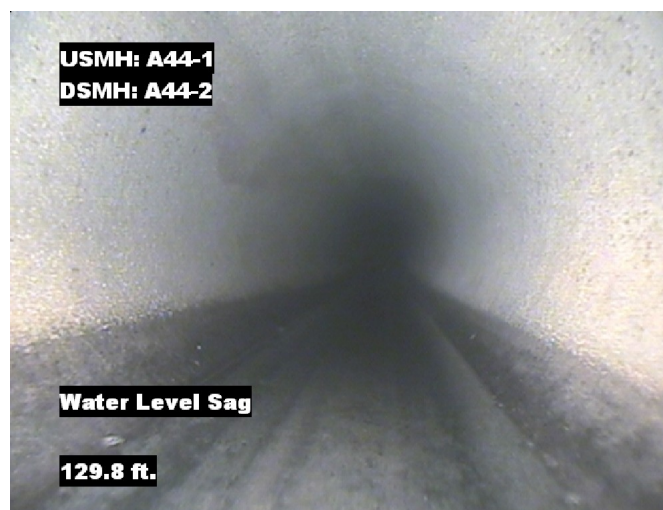
Distance: 129.7 ft. Grade: 2  
Condition: Water Level Sag  
Remarks: N/A

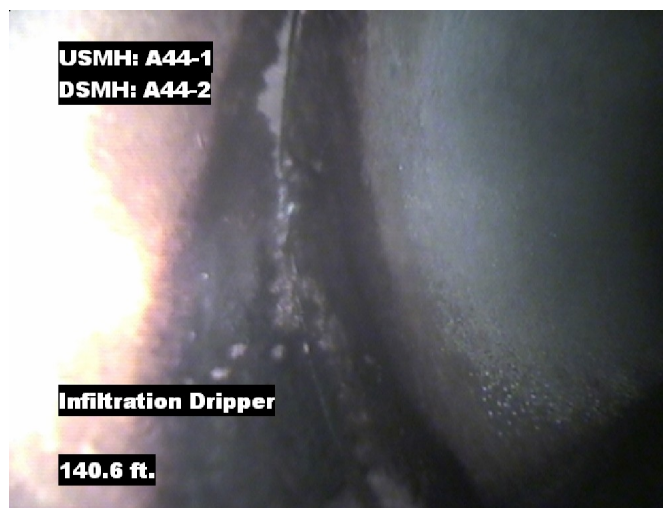
Distance: 140.6 ft. Grade: 3  
Condition: Infiltration Dropper  
Remarks: N/A

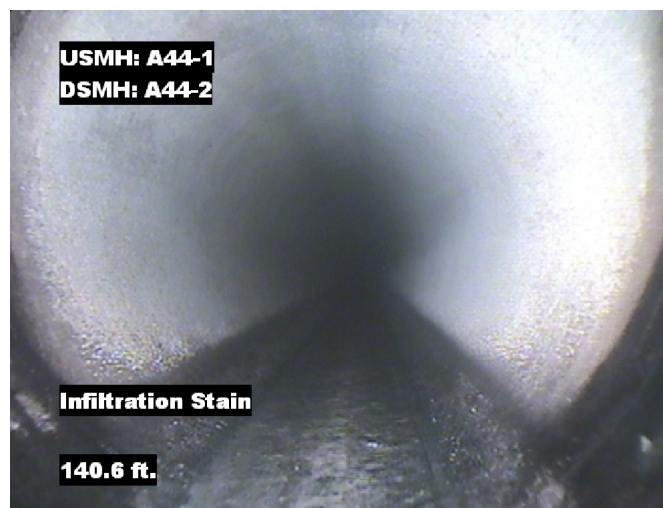
Distance: 140.6 ft. Grade: 0  
Condition: Infiltration Stain  
Remarks: N/A

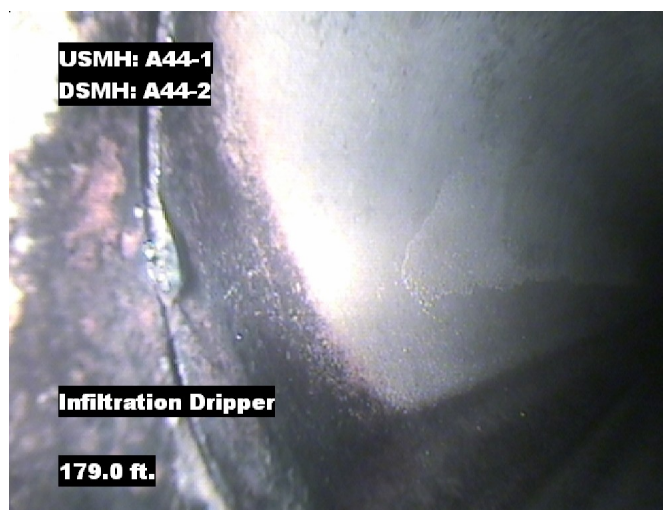
Distance: 179.0 ft. Grade: 3  
Condition: Infiltration Dropper  
Remarks: N/A

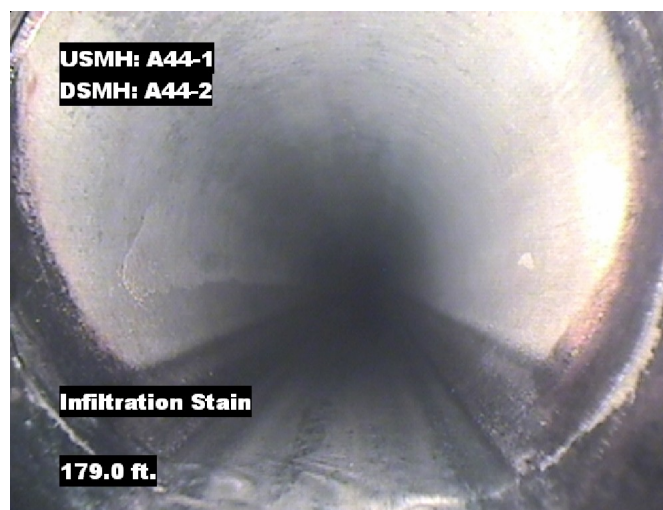
Distance: 179.0 ft. Grade: 0  
Condition: Infiltration Stain  
Remarks: N/A

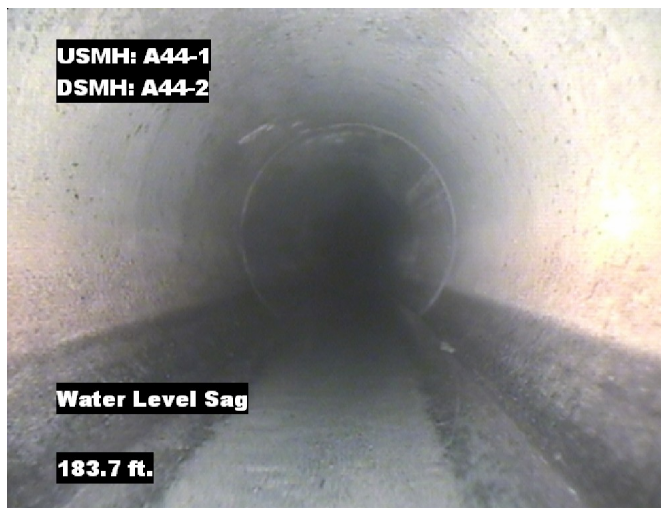
Distance: 183.7 ft. Grade: 2  
Condition: Water Level Sag  
Remarks: N/A

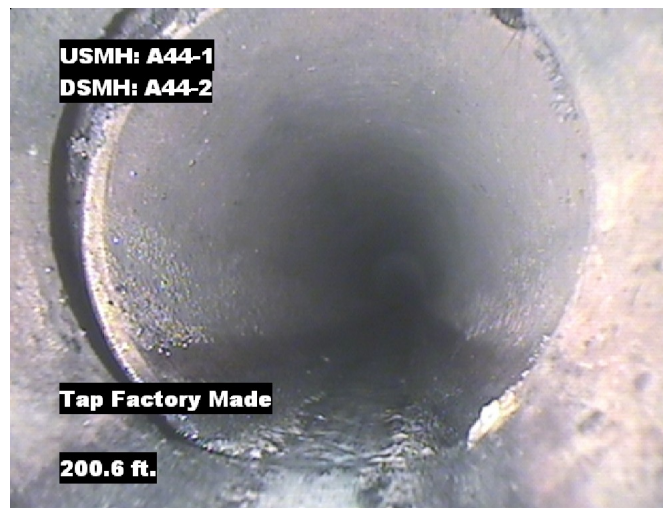
Distance: 200.6 ft. Grade: 0  
Condition: Tap Factory Made  
Remarks: N/A

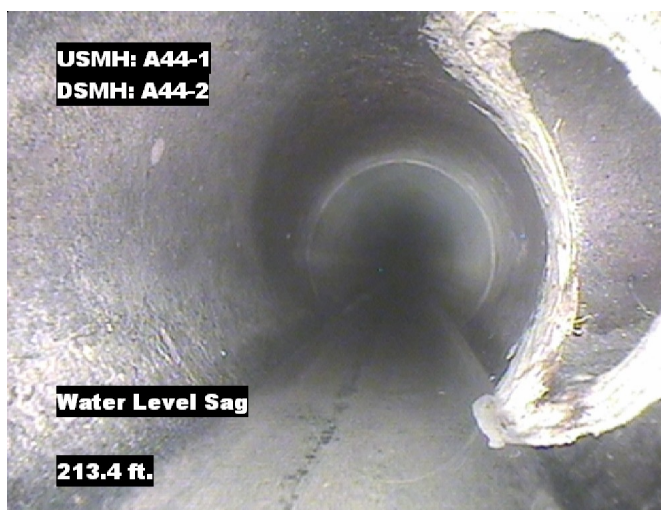
Distance: 213.4 ft. Grade: 2  
Condition: Water Level Sag  
Remarks: N/A

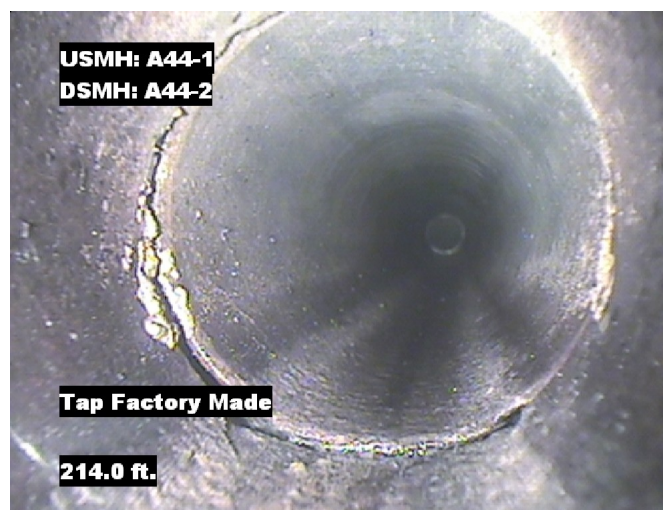
Distance: 214.0 ft. Grade: 0  
Condition: Tap Factory Made  
Remarks: N/A

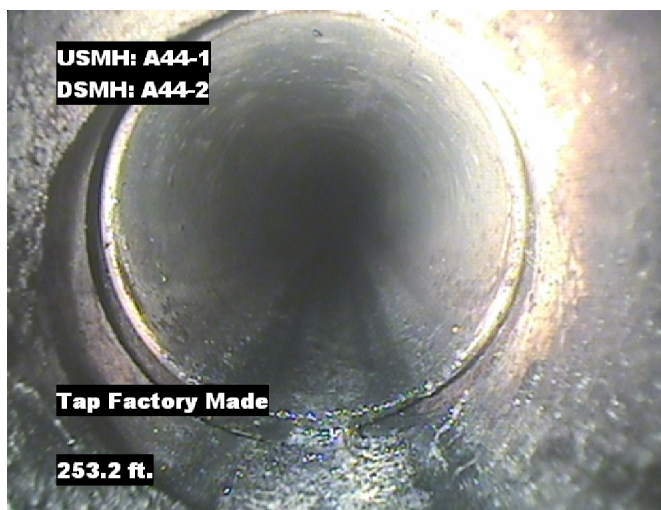
Distance: 253.2 ft. Grade: 0  
Condition: Tap Factory Made  
Remarks: N/A

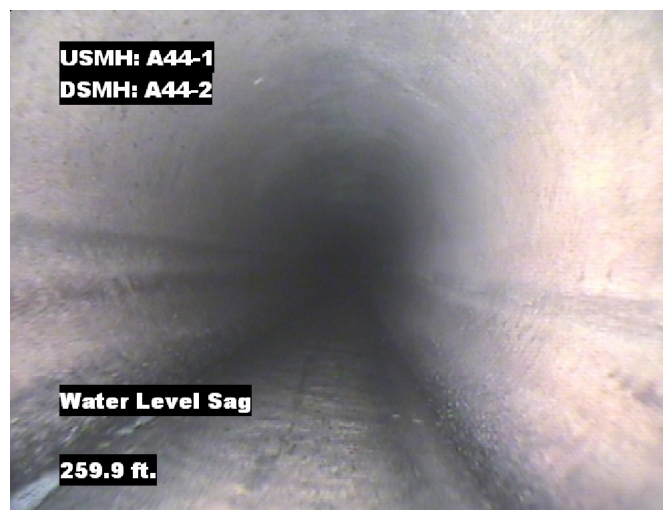
Distance: 259.9 ft. Grade: 2  
Condition: Water Level Sag  
Remarks: N/A

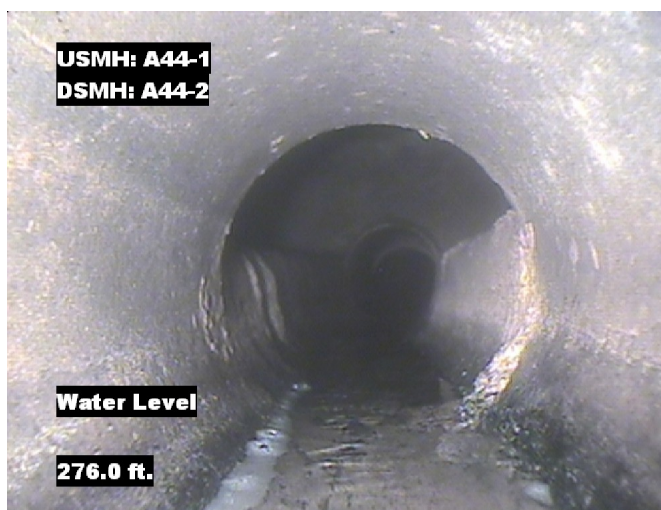
Distance: 276.0 ft. Grade: 0  
Condition: Water Level  
Remarks: N/A

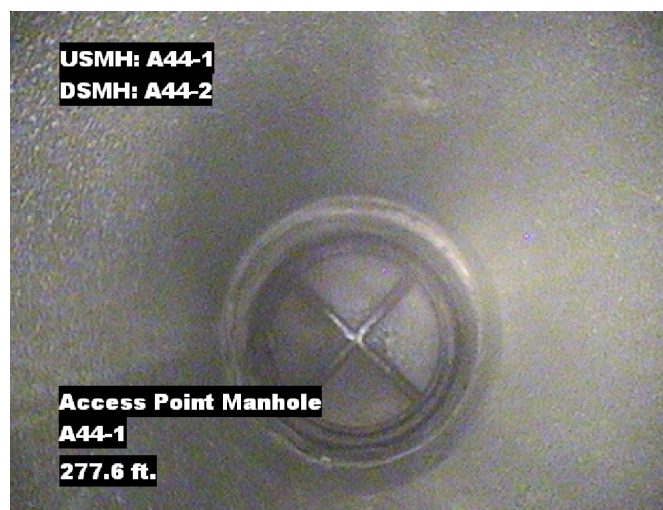
Distance: 277.6 ft. Grade: 0  
Condition: Access Point Manhole  
Remarks: A44-1
