Defect Listing

Pipe Segment Refere... A44-2_A6-17	City Oliver Springs	Street Hen Valley Rd.	Material Concrete Pipe (non-...	Location C... Yard	Sewer Use Sanitary
Upstream MH A44-2	Total Length 110.4	Year Laid	Shape Circular	Location Details	
DS Manhole A6-17	Length surveyed 110.4	Year Renewed	Height 8	Width 8	Pipe Joint... 4

SPR 6	MPR 16	PO Number 4397-03	Customer GRW
SPRI 3	MPRI 2.7	Work Order 4397-02	Purpose Pre-Rehabilitation Survey
QSR 4121	QMR 4132		
OPR 22	Surveyed By Charlie Gordon	Direction Downstream	Date 20150827
OPRI 2.8	Certificate Number U-615-07000491	Pre-Cleaning No Pre-Cleaning	Time 14:51
	Date Cleaned	End Time 15:06	Weather Dry
		Additional Info DOWNSTREAM MANHOLE

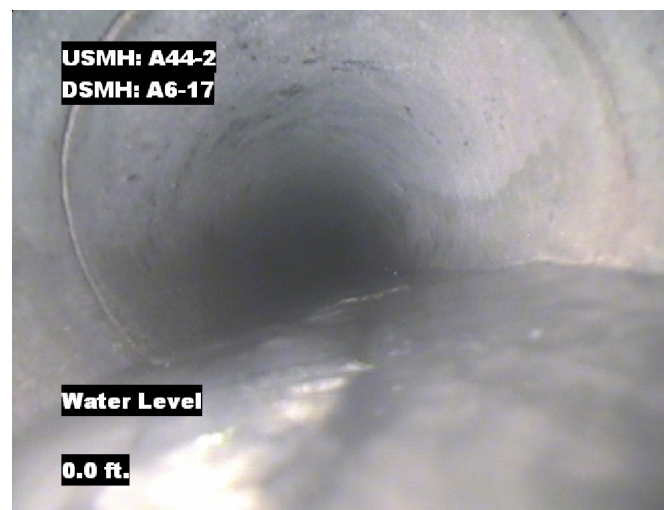
Distance: 0.0 ft. Grade: 0
Condition: Water Level
Remarks: N/A

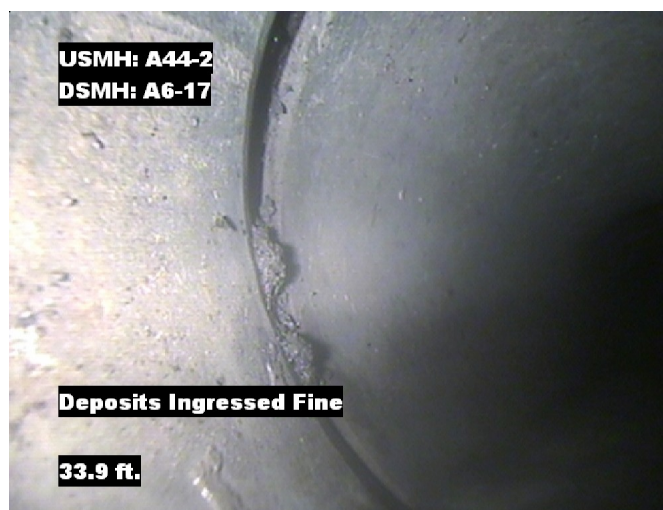
Distance: 33.9 ft. Grade: 2
Condition: Deposits Ingressed Fine
Remarks: N/A

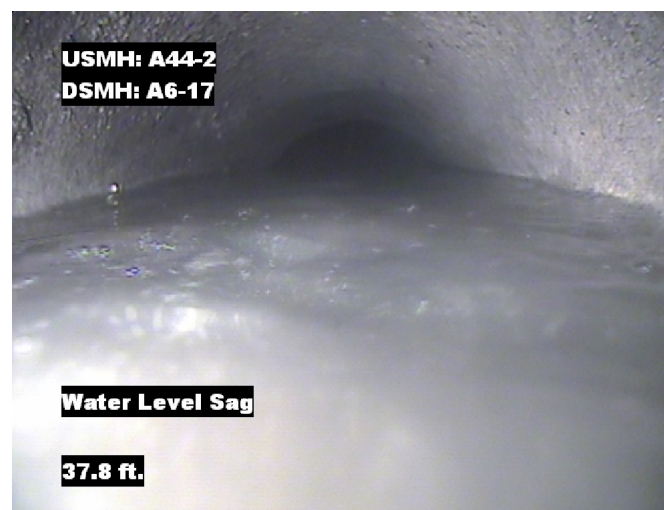
Distance: 37.8 ft. Grade: 3
Condition: Water Level Sag
Remarks: N/A

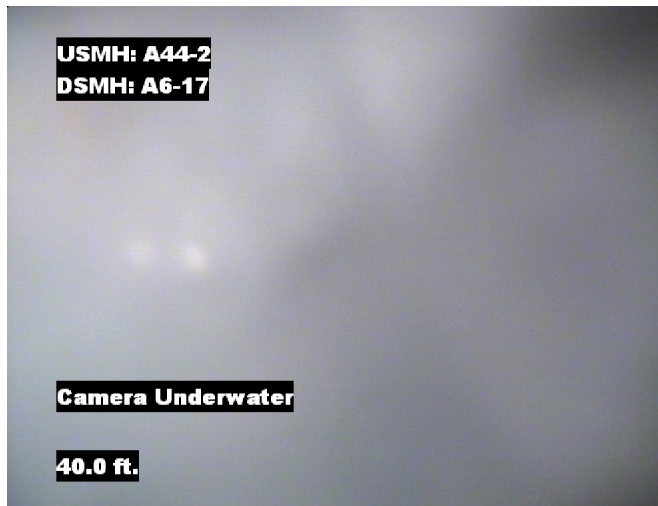
Distance: 40.0 ft. Grade: 4
Condition: Camera Underwater
Remarks: N/A

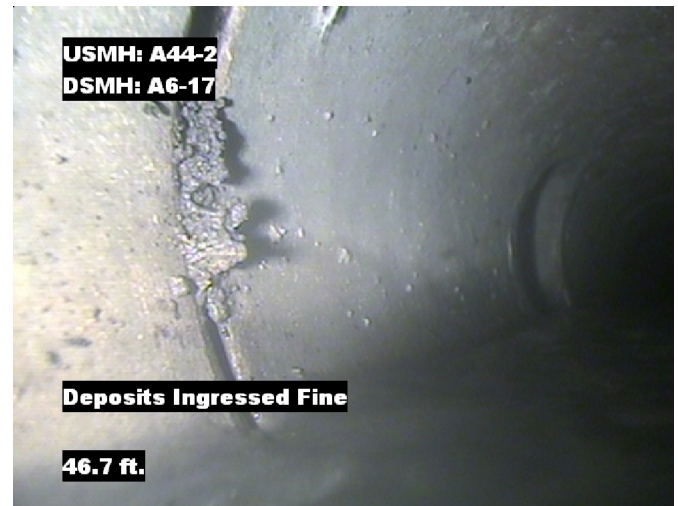
Distance: 46.7 ft. Grade: 2
Condition: Deposits Ingressed Fine
Remarks: N/A

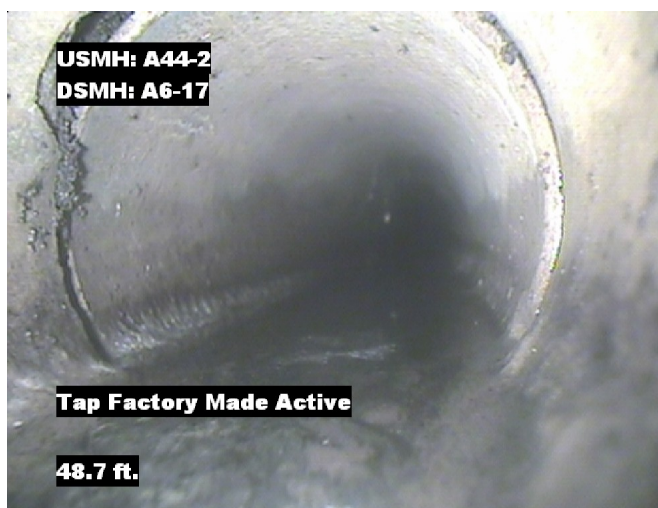
Distance: 48.7 ft. Grade: 0
Condition: Tap Factory Made Active
Remarks: N/A

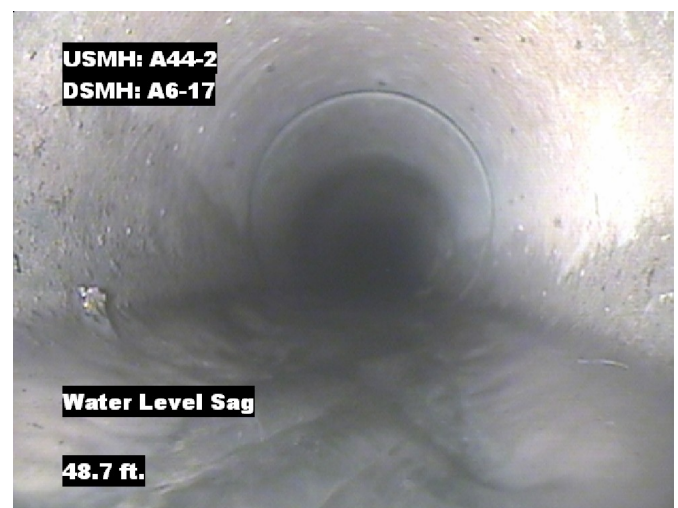
Distance: 48.7 ft. Grade: 3
Condition: Water Level Sag
Remarks: N/A

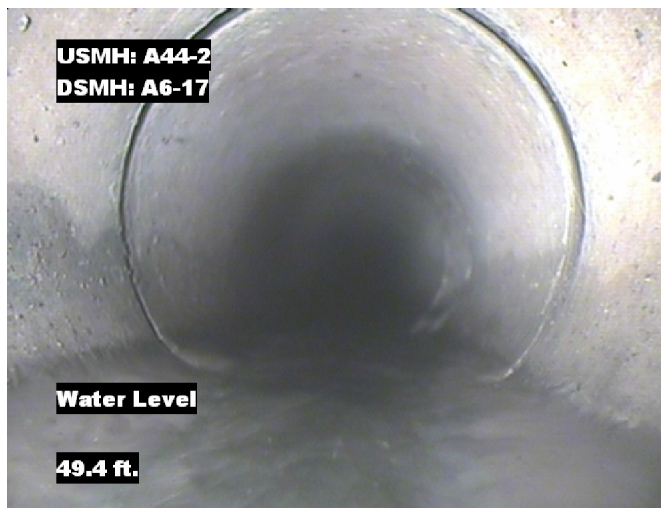
Distance: 49.3 ft. Grade: 0
Condition: Water Level
Remarks: N/A

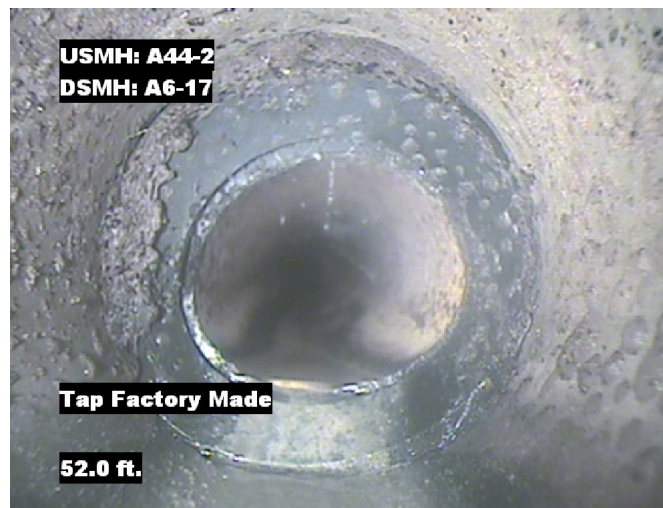
Distance: 52.0 ft. Grade: 0
Condition: Tap Factory Made
Remarks: N/A

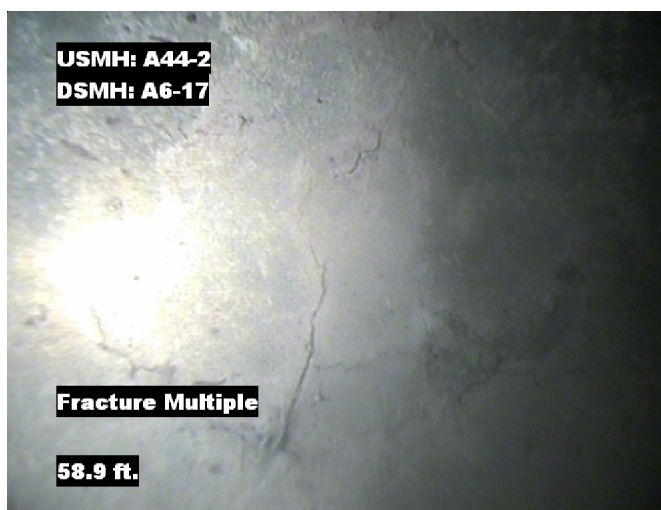
Distance: 58.9 ft. Grade: 4
Condition: Fracture Multiple
Remarks: N/A

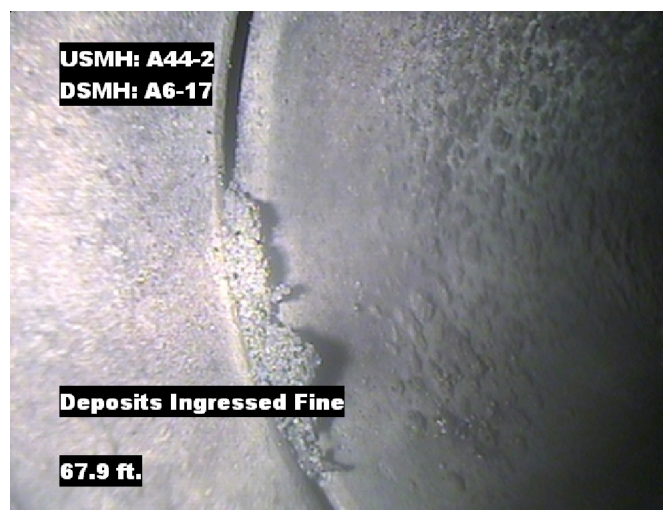
Distance: 67.9 ft. Grade: 2
Condition: Deposits Ingressed Fine
Remarks: N/A

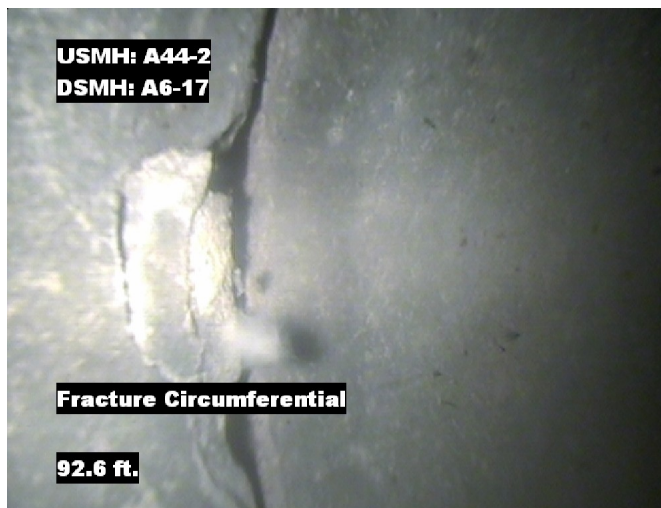
Distance: 92.6 ft. Grade: 2
Condition: Fracture Circumferential
Remarks: N/A

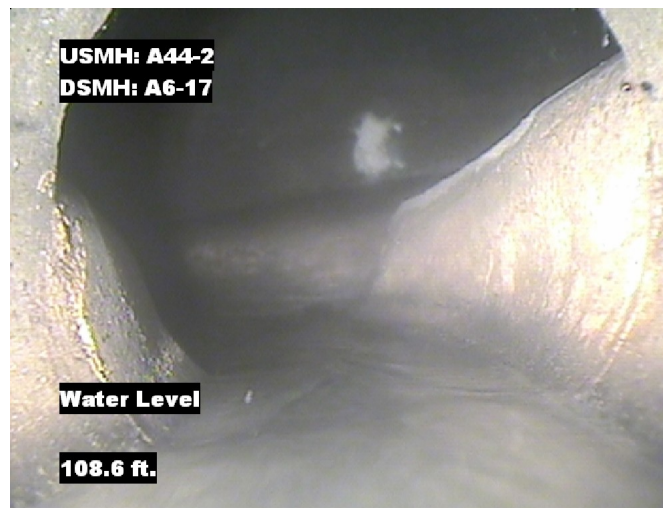
Distance: 108.6 ft. Grade: 0
Condition: Water Level
Remarks: N/A
