Defect Listing

Pipe Segment Refere... A44-3_A44-2	City Oliver Springs	Street Hen Valley Rd.	Material Concrete Pipe (non-...	Location C... Light High...	Sewer Use Sanitary
Upstream MH A44-3	Total Length 203	Year Laid	Shape Circular	Location Details Middle of the road	
DS Manhole A44-2	Length surveyed 203	Year Renewed	Height 8	Width 8	Pipe Joint... 4

SPR N/A	MPR 6	PO Number 4397-03	Customer GRW
SPRI N/A	MPRI 2	Work Order 4397-02	Purpose Pre-Rehabilitation Survey
QSR N/A	QMR 2300		
OPR 6	Surveyed By Dustin	Direction Downstream	Date 20150807
OPRI 2	Certificate Number U-214-06020262	Pre-Cleaning Jetting	Time 13:20
	Date Cleaned 20150807	End Time 13:34	Weather Dry
			Media label
			Additional Info

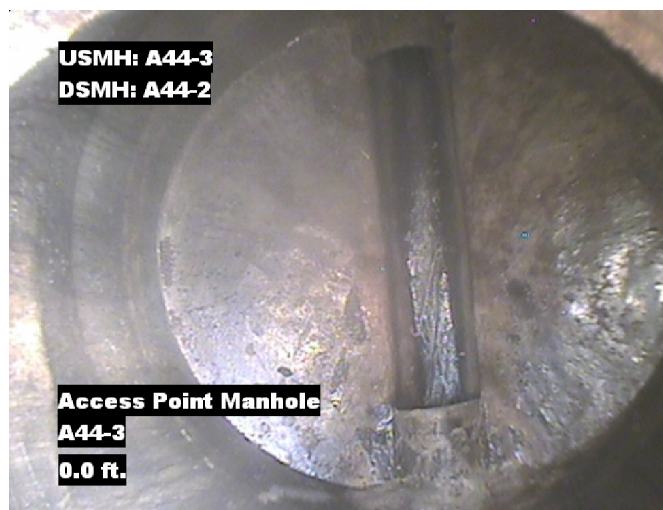
Distance: 0.0 ft. Grade: 0
Condition: Access Point Manhole
Remarks: A44-3

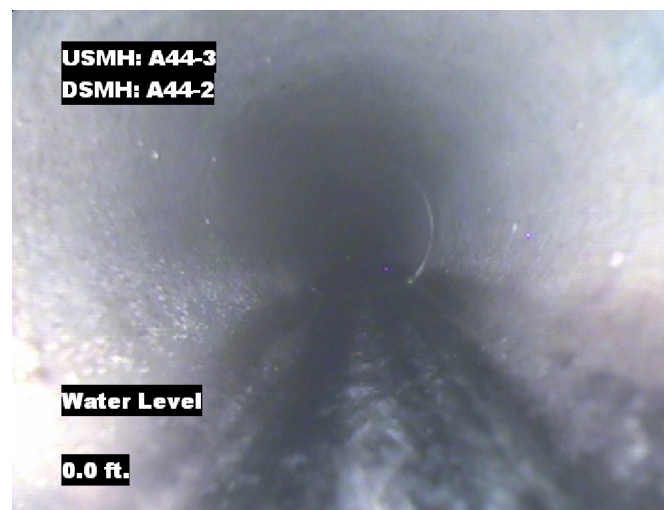
Distance: 0.0 ft. Grade: 0
Condition: Water Level
Remarks: N/A

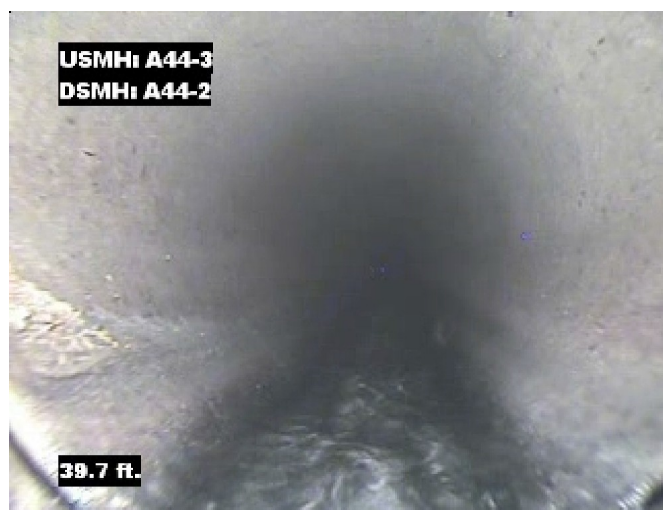
Distance: 39.6 ft. Grade: 2
Condition: Deposits Attached Grease
Remarks: N/A

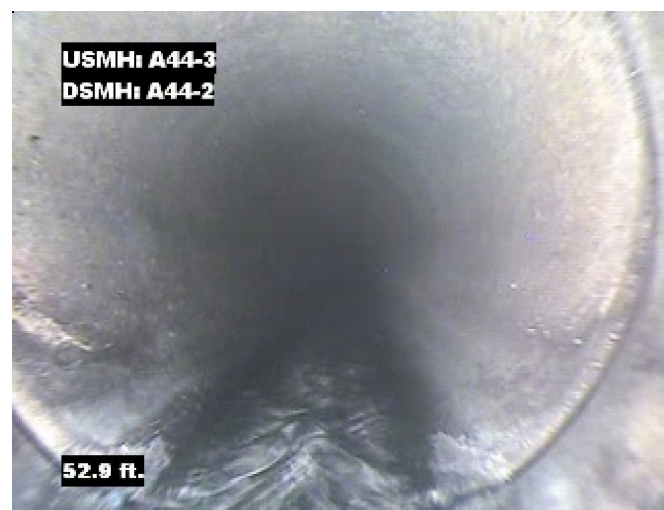
Distance: 52.7 ft. Grade: 2
Condition: Deposits Attached Grease
Remarks: N/A

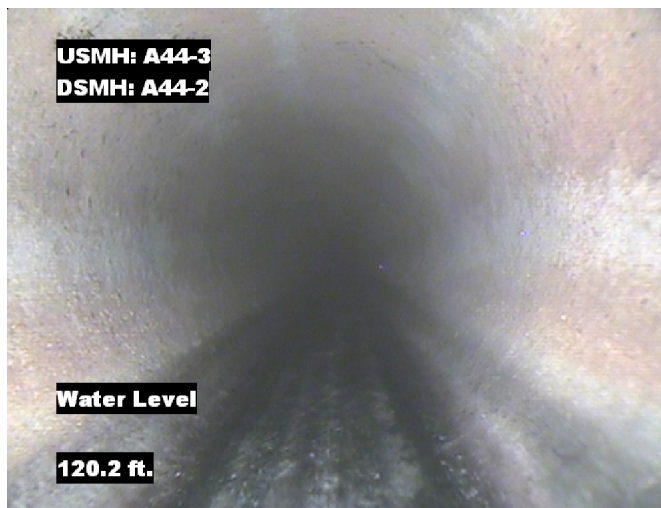
Distance: 120.2 ft. Grade: 0
Condition: Water Level
Remarks: N/A

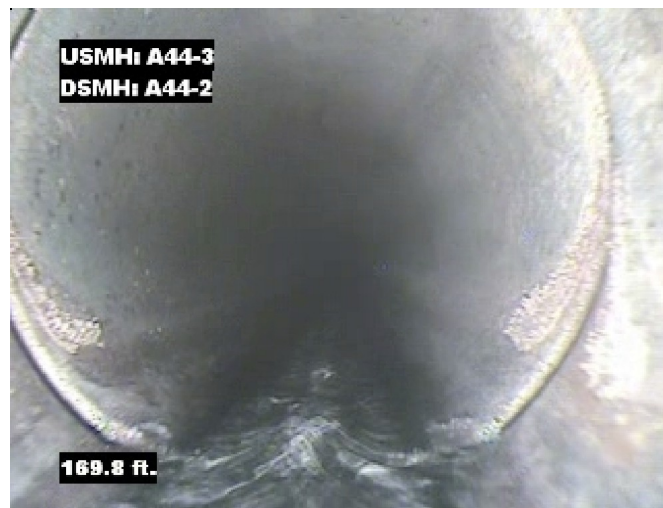
Distance: 169.8 ft. Grade: 2
Condition: Deposits Attached Grease
Remarks: N/A

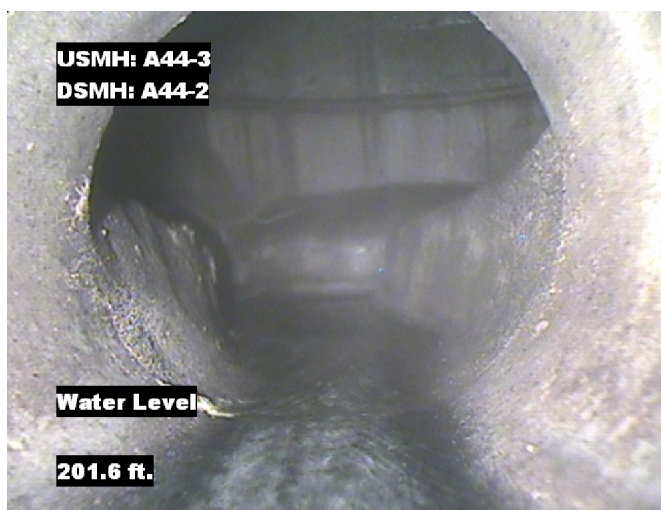
Distance: 201.6 ft. Grade: 0
Condition: Water Level
Remarks: N/A

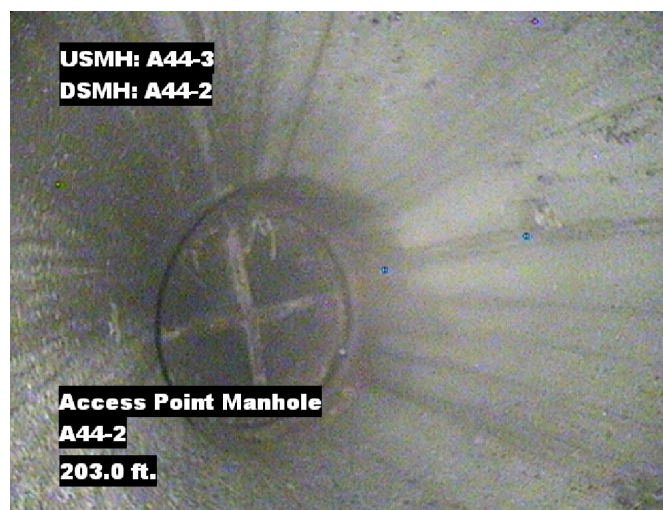
Distance: 203.0 ft. Grade: 0
Condition: Access Point Manhole
Remarks: A44-2
